## PRACTICAL REHABILITATION OF BUILDINGS IN CRITICAL CONDITIONS

W LOBO-QUINTERO<sup>1</sup>

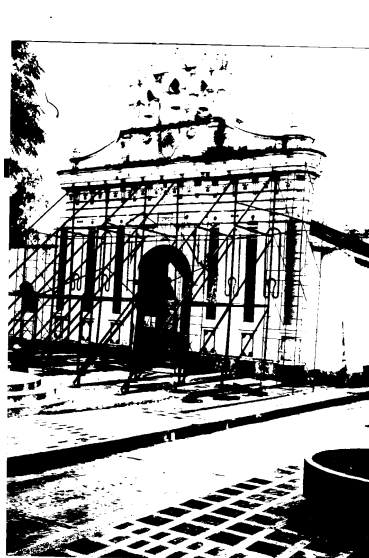
This is a church built with earthen walls and adobe bricks, whose wooden roof and tiles were removed during the rainy season. This deteriorated walls, counterforts and plaster, cracked the arcades of the altar and rocked the frontis considered of historic value. The cracking of the arches was accelerated by the lateral pressure. The shoring of the frontis, was recommended to stop the rocking against vibrating movements, impact or seismic

Fig. 5. Frontis of Barinitas Church (R-2). Fig. 6. Details of crown connection beams (R-2).

effects (Fig. 4). Crown beams were built on top of the earthen walls in horizontal rings, anchored at the corners and intermediate supports (Fig. 5).

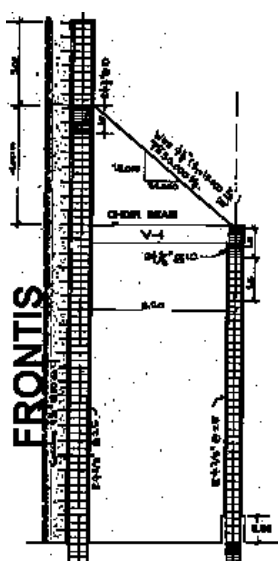
Fig. 7. Detail of the Choir against the Frontis (R-2).

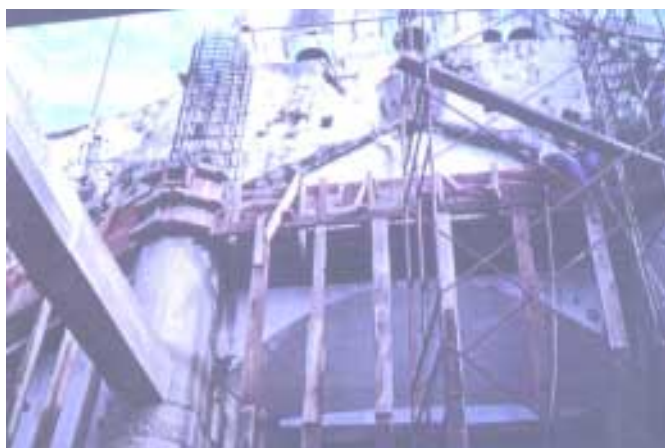
Fig. 8. The Church in construction (R-2).

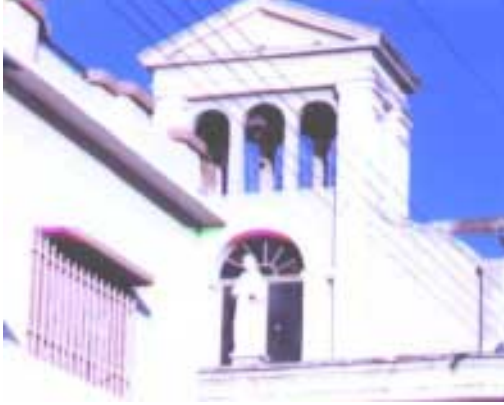
**Fig. 9. Original Facade (R-3).**

This is a building of masonry walls with and arched roof of thickness 11 cm., span of 8.5 m. and a dome of 6 m. height, 15 cm. of thickness and 7.5 m. of diameter (Fig. 9). The damages in the masonry columns (60 cm x 60 cm. and 7.5 m. de heigth), began by the dynamic lateral pressure generated by the traffic, and the horizontal push of the arched roof. The dome showed cracks in the meridians occasioning rupture of the beams that transmit their loads to the arches. The choir was built against the Frontis of a wooden and brass structure, with fractured masonry columns; which was substituted by a reinforced concrete structure.

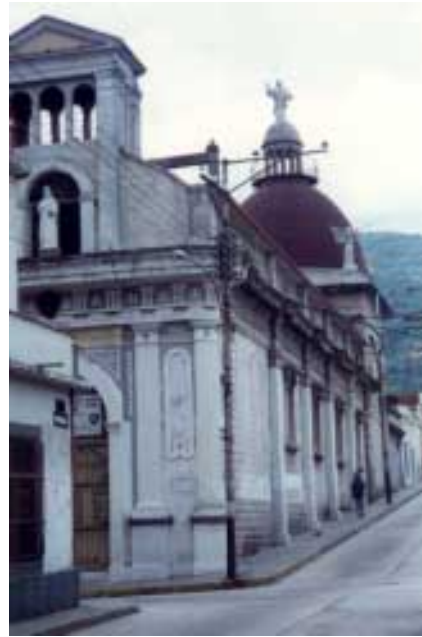
**Fig. 10. Rehabilitated Facade (R-3).**

This church was found in a state of progressive deterioration, lack of maintenance, filtration of roofs, lateral overloads due to traffic and frequent of the continuous tremors (Fig. 13). The global evaluation recommended immediate shoring; the columns were substituted for a reinforced concrete arched frame (Fig. 11), with crown beams over the walls. A system of spread foundations was designed with double beam connections and retaining walls on the side street. The arched roof was substituted totally eliminating the exterior beams (Fig. 10 and 12).

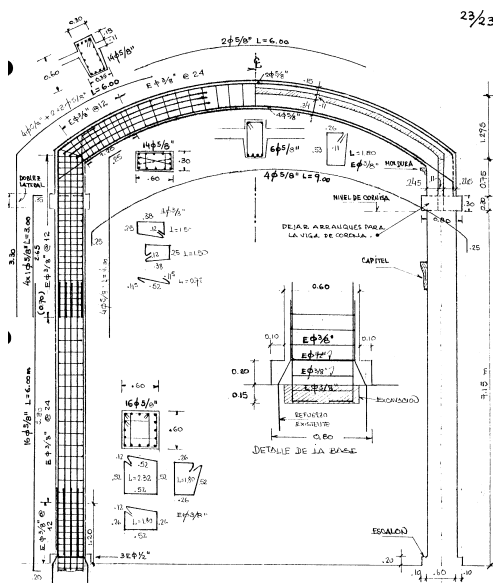
**Fig. 11. Principal arched frame (R-3).**

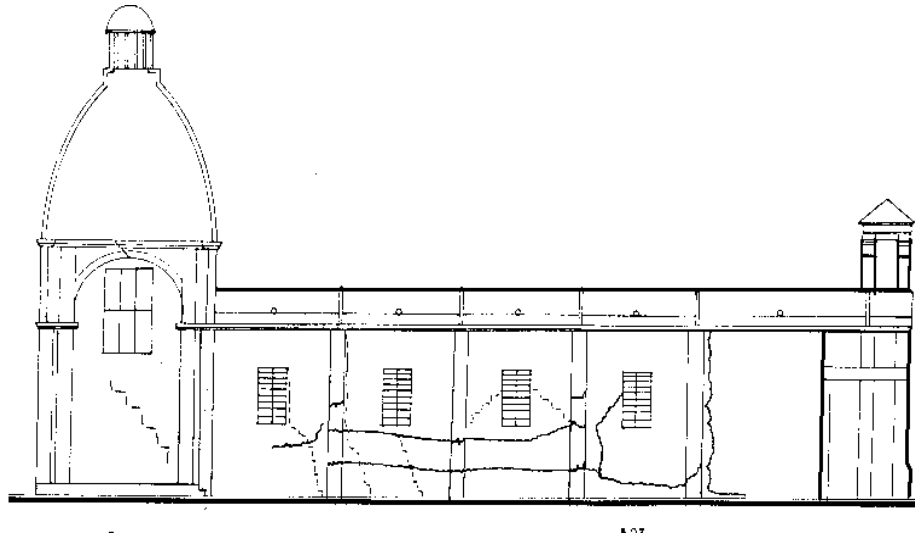
**Fig. 13. Cracks in lateral facade of the church (R-3).**

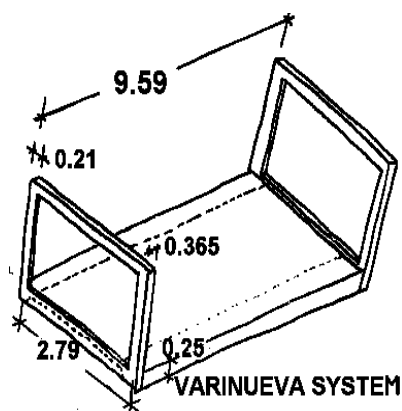
This building has two blocks, one of these with three floors, the first floor of reinforced concrete and the others with precast concrete type “Varinueva” of U shaped with extremal frames, longitudinal beams and a connection slab (Fig. 14 and 15). A high seismic torsion in the basement, no connection and disalignment of elements, vertical discontinuity and deficient support. The cracks were injected cavities were filled with epoxies, walls were built on the ground level, the topping of slabs to uniformize and rigidize the diaphragm, steel plates were attached to reinforce beams; columns were reinforced using jacketing with transverse ties. To design and reinforce the columns ultimate strength interaction diagrams was prepared (Fig. 16) The non rehabilitated structure is shown in Fig. 17, and the rehabilitated building in Fig. 18.

**Fig. 14. Detail of Varinueva System (R-4).**

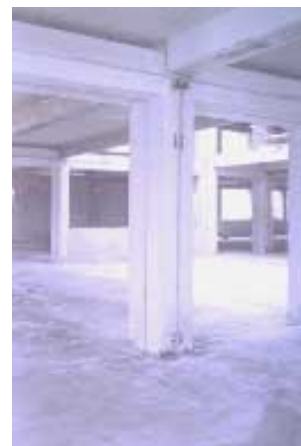
**Fig. 15. Prefabricated building in construction (R-4)**

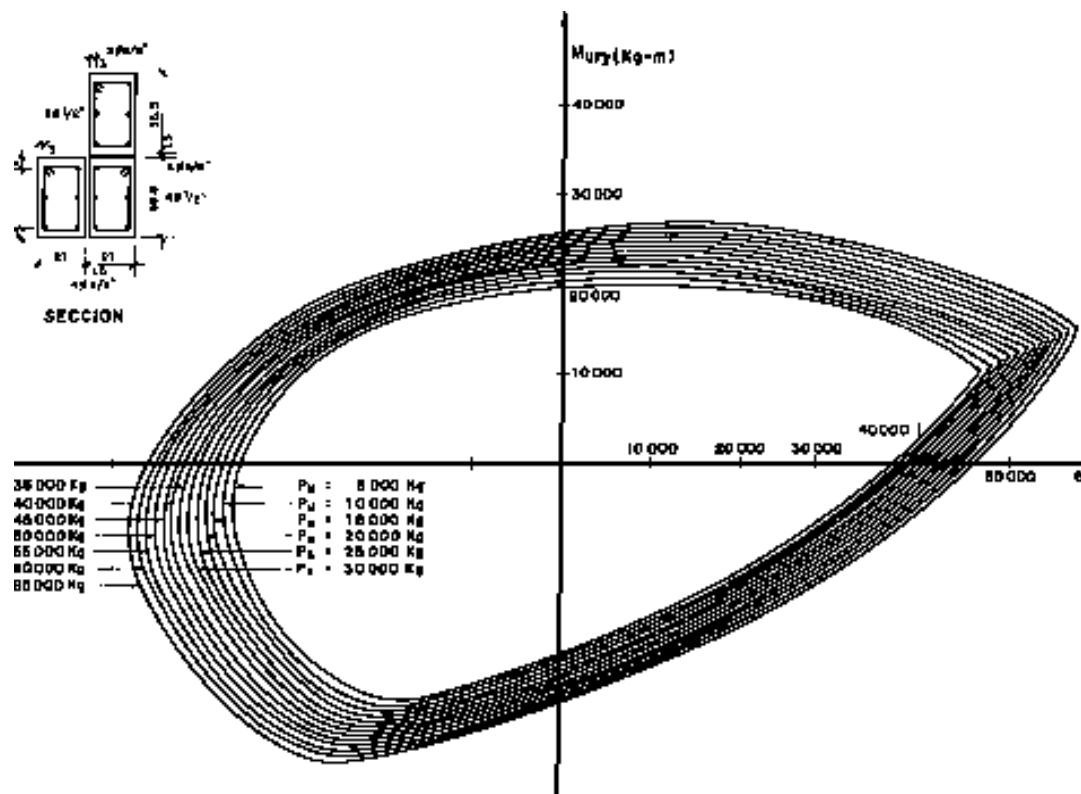
Fig. 16. Interaction Diagrams for three columns of the Varinueva System (R-4).

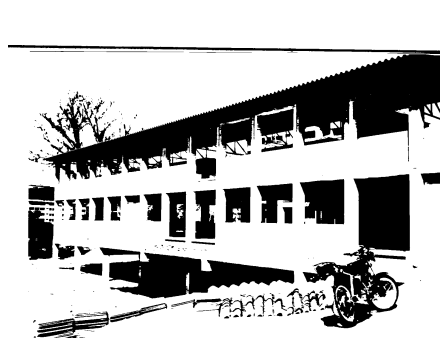
Fig. 17. Hospital to rehabilitate. (R-4).

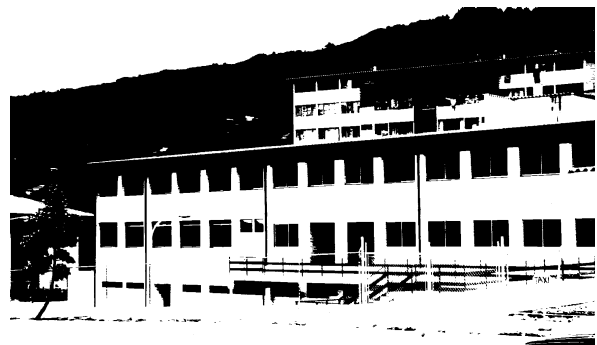
Fig. 18. Rehabilitated Hospital (R-4).
