Analysis of damages and its relations with seismic intensity

ABSTRACT: This paper presents a study of the buildings behaviour in the zone that resulted most affected ($I_{MM} = IX$) by the November 23, 1977 earthquake ($M = 7.4$) in San Juan, Argentina. The buildings were classified according to their functions and architectural design. At each group, the damages are analyzed in relation to the shaking level produced by this earthquake and that produced by the January 15, 1944 earthquake ($M = 7.8$) in San Juan city.

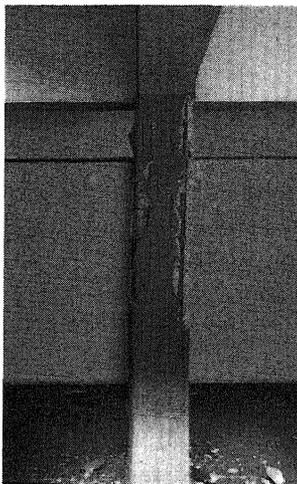
From a general of point of view, the damages were due to: short column, torsional effect, cantilever fault, difference of stiffness and strength at different structural plane for the same storey and between different storeys (Fig. 3). They were produced by deficiency in the Architectural Design and the Structural solutions.

FIGURE 3 - SHEAR FAILURES IN SCHOOL BUILDING'S COLUMNS

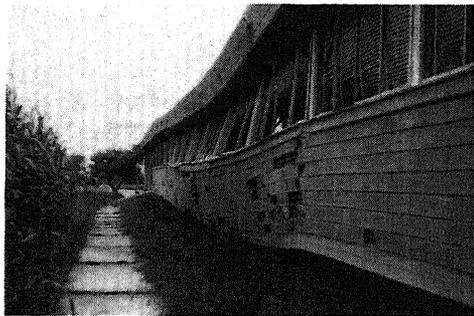
FIGURE 4 - CANTILEVER AND SHORT COLUMNS IN SCHOOLS BUILDING

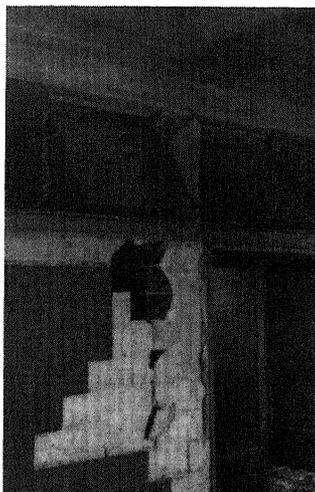
FIGURE 5 - SHORT COLUMNS IN SCHOOL BUILDING

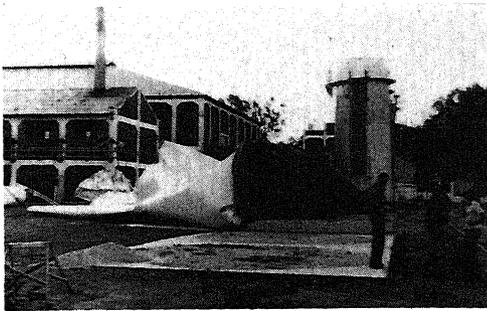
In the Industrial Buildings which are in general Vineries, the damages were mainly produced by anchor faults, shell bulging of the cylindrical metallic tanks used to store wine. Some of them collapsed. This depended on its slenderness and the volume contained (Fig. 6).

FIGURE 6 - ANCHOR FAULT IN CILINDRICAL METALLIC TANKS

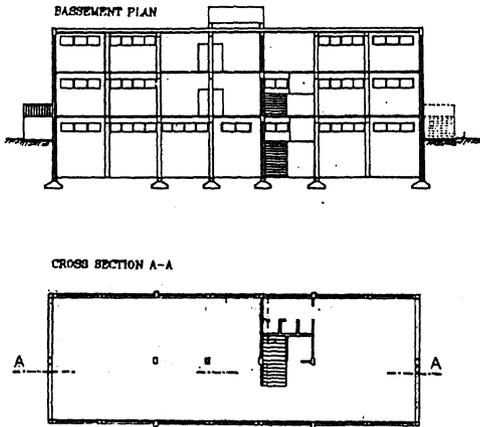
FIGURE 7 - LD.I.A. BUILDING

In order to find an answer to this question, the Earthquake Research Institute Building (I.D.I.A.) of the National University of San Juan, was analyzed. It consists of two storeys and a basement (Fig.7). Some columns in the basement and the masonry walls covering all the building suffered shear damages.

Being $I_s = 0.6$ and considering the amount of damage observed in this building, it can be assumed that I_{s0} will approximately be equal to I_s .
