The collapse of the Struve Slough Bridge during the 1989 Loma Prieta earthquake in different seismic code perspectives

ABSTRACT: The collapse of the bridges on California Highway 1 near Watsonville, known as the Struve Slough Bridge during the 1989 Loma Prieta earthquake in Northern California is described. The Struve Slough Bridge consisted of two parallel structures erected in 1964. This paper describes both the structural and the geotechnical aspects of the damage, and presents a comparison of the American and the Canadian codes. Reference is made to the American seismic design code practice at the time of the bridge design and construction.

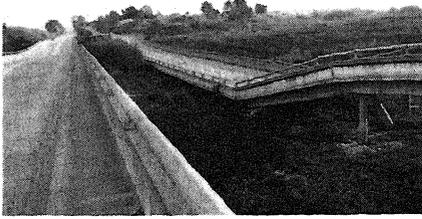
Figure 2 presents a general view from the northern abutment. The collapsed southbound structure is seen with displaced columns. A significant amount of movement can also be observed at the northbound structure. The top of the deck with protruding columns is shown in Figures 3 and 4. Those columns of 381 mm (15 in.) diameter (see Figures 2 to 7) were extensions of piles into transverse cap beams. Most columns suffered severe cracking at the tops, buckling of the longitudinal reinforcement and fracture of vertical confining wires. Some of the columns were sheared off at the start of the transverse cap beams. Seven spans of the northbound structure collapsed and dropped almost 1.52 m (5 ft.) onto the damaged columns. Ten spans of the southbound bridge dropped approximately 2.44 m to 3.05 m (8 ft.

Figure 2. General view of the damaged Struve Slough Bridge near Watsonville

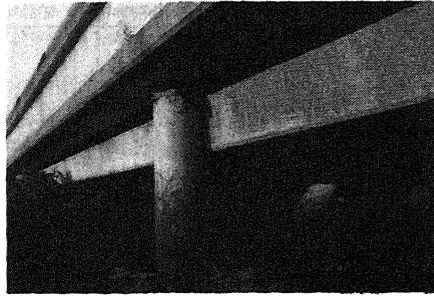
to 10 ft.) to the ground surface. A few columns sheared inside the transverse cap beams, were displaced by almost 30.48 cm to 60.95 cm (1 ft. to 2 ft.) and punched through the deck. Although the collapse was in the vertical direction, the southbound structure was displaced horizontally by about 60.96 cm (2 ft.).

Figure 5. A side column of the bent, sheared off and displaced

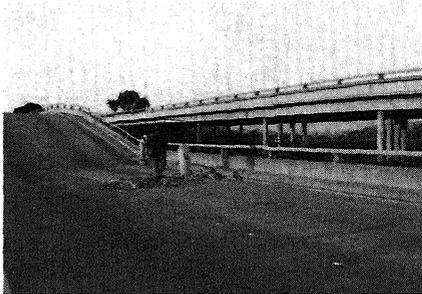
Figure 3. Columns punched through the southbound deck

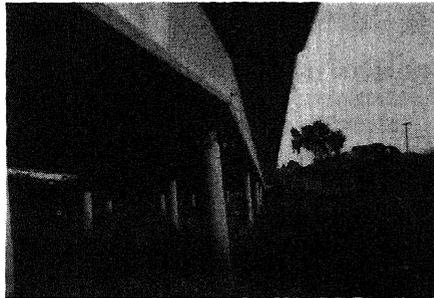
Cable restrainers installed in 1984 performed as intended holding the separate decks together during the earthquake. Thus, T-decks did not disintegrate in both northbound and southbound structures. However, the central portion of the deck of the southbound bridge collapsed completely due to loss of supports and columns punching through the deck.

Figure 6. Disfigured southbound structure

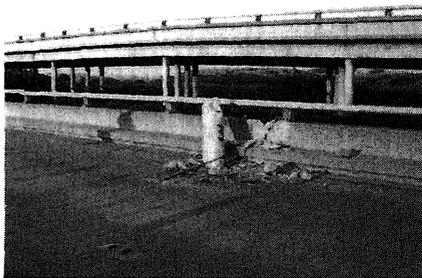
Figure 4. A column remained in the vertical portion after piercing through the deck.

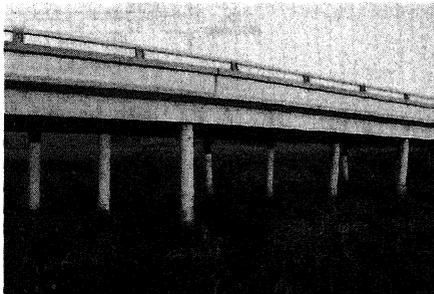
Figure 7. The central portion of the northbound structure severely damaged
