March 13, 1992 Erzincan (Turkey) earthquake

M. Erdik, O. Yuzugullu & C. Karakoc

ABSTRACT: Erzincan City has been stricken by numerous earthquakes. That of 1939 ($M_s=7.8$) destroyed the entire city and killed thousands of people. The city was then relocated. The main shock of March 13, 1992 and its aftershocks killed about 500 people, injured 2800, damaged 11 000 houses and caused the collapse of 180 buildings. There were pronounced site effects and many instances of liquefaction and landslides. Damage to various types of construction, the good behavior of others and post-earthquakes experience underline lessons taught by earthquakes in other parts of the world, and teach us new lessons. Although plans existed for disaster response and mitigation, their implementation was hampered by lack of rehearsal.

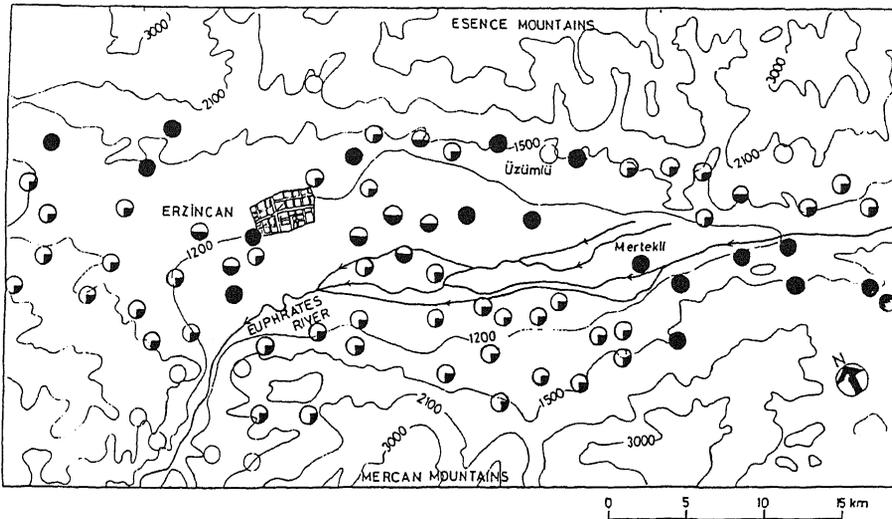
Main-shock intensities are depicted in fig 3.

Fig 3. Damage distribution in and around Erzincan Basin. Shading indicates the percentage of medium plus heavy damage. 0.25% of total dwelling stock: one-fourth circle shaded (\approx MSK VI); 25-50%: half circle shaded (\approx MSK VI-VIII); more than 50%: whole circle shaded (\approx MSK VII-VIII).

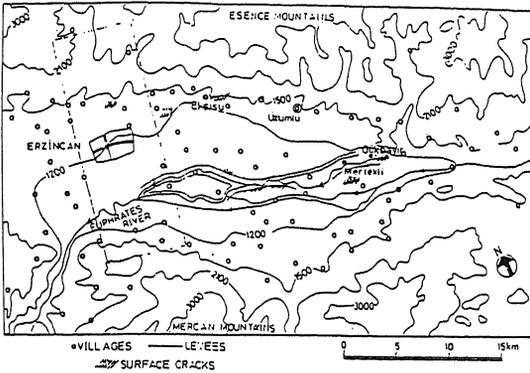
The main event and some large aftershocks triggered numerous small landslides, rock-falls and avalanches throughout the region. Most slides occurred along the steeper slopes of the road cuts, blocking transportation routes and damaging road surfaces of localities with high water table and granular soils. Fig 7 shows the distribution of surface cracks and instances of liquefaction. Fissuring and settling of sediments damaged irrigation facilities. Compaction of saturated materials was often associated with ejection of water-silt mixtures and formation of sand mounds.

Fig 7. Regional distribution of surface cracks and liquefaction.

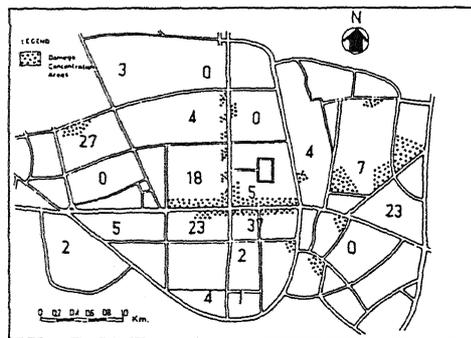
A map showing damage concentration and percentage of collapsed buildings by district is given in fig 9. Maps are also available with percentages of various degrees of damage. Causes of damage are analyzed below.

1. Reinforced concrete buildings. The main causes of failure or damage were: soft story (chiefly the first story), lack of redundancy (all columns in one story failing simultaneously; very few structures with shearwalls), concrete quality (mean concrete strengths 100 kg/cm² in damaged structures), poor connections (insufficient confinement and poor detailing), short columns (hence brittle failure), structural alterations (stories added), inadequate repair (plastering rather than retrofitting), torsion (mostly in structures at ends of groups of buildings), pounding (with slabs at different elevations in adjoining buildings) and strong-beam-weak-column (causing damage concentration in columns).

Fig 9. Percentage of collapsed buildings in each district. Dots indicate damage concentration.
