Investigation of damages on reinforced concrete buildings caused by the 1990 Philippine-Luzon earthquake

ABSTRACT: The earthquake which occurred on Luzon island of the Philippines on July 16, 1990 caused great damage to many local buildings. The object of this paper is to investigate in detail the observed nature and the possible causes of damage to eight reinforced concrete buildings. The evaluation of the seismic capacity of these buildings are performed by applying the "Japanese Standard for Evaluation of Seismic Capacity of Existing Reinforced Concrete Buildings". It was found out that the presence of concrete hollow block walls greatly affected the seismic capacity of the buildings.

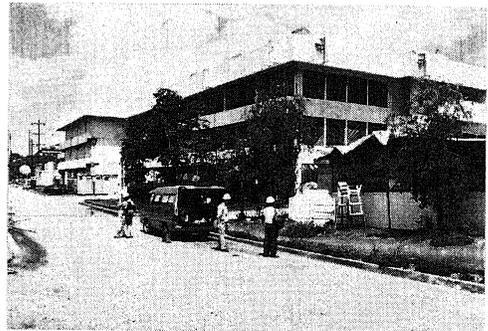
Fig. 3 Overall view of building No. 1

Condition of the damage : Of the two buildings that were built with the same specifications, one was destroyed and the other was severely damaged. Figure 3 shows the severely damaged building. There were shear cracks and bond slip failures in almost all of its columns (Figure 4). Its side columns, in the longitudinal direction in particular, had shear cracks and had been transformed into short columns due to the presence of oblong windows on top of the CHB walls and right under the girders. The residual relative rotation measured on the columns on the first floor ranged from 1/200 to 1/100. It is assumed that there was such a difference in the degree of damage between the two buildings, in part, because one (which was destroyed) was built on a filled-up ground while the other (which was severely damaged) was built on a cut ground.

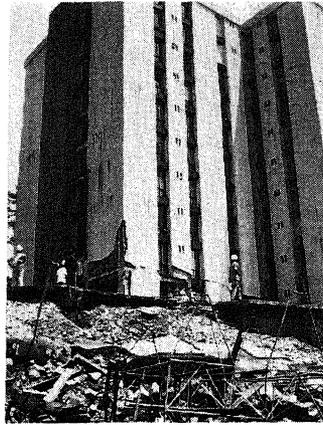
Fig.6 Overall view of building No.2

Condition of the damage : Figure 6 shows an overall view of the building. There were bending shear failures in the columns in the southeastern part of the first floor, and the main reinforcing bars buckled. There were shear failures in the capitals of the columns near the entrance, which were caused by the columns' transformation into short columns due to the presence of CHB walls (Figure 7).

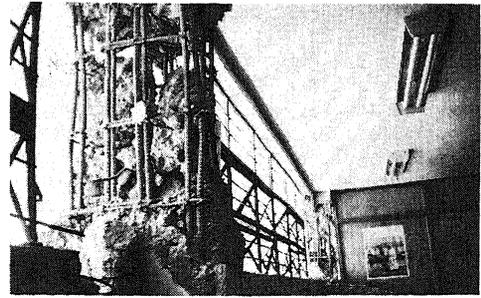
Fig.10 Shear failure in Column with CHB wall

in the reinforced concrete columns, which were transformed into short columns due to the presence of CHB walls in rows B and E, were the most noteworthy damage (see Figure 10). Many internal and external CHB walls collapsed and there were many cracks in them. It should be noted that no damage was caused to the girders and floors with long spans, to the columns at the second floor, neither to the extension of the existing building.

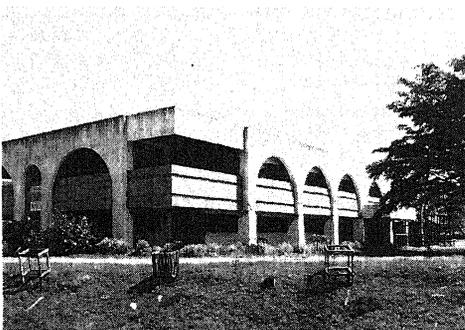
Fig.9 Overall View of Building No.6

Condition of the damage : Figure 9 shows an overall view of this building. Shear failures
