Evaluation of the failure of the Hotel Las Olas building as a consequence of the 22nd of April earthquake in Costa Rica

A.I.Uzategui & E.D.Thomson
 University of the Andes, Merida, Venezuela

ABSTRACT: A study of the partial collapse of the Hotel Las Olas during the 22 of April earthquake in Costa Rica both in the elastic and inelastic range is presented. From the analysis, the failure of two of the ground floor columns is concluded to be due to the presence of a masonry wall which reduced the clear span of these columns, making them behave as short columns that attracted a very large shear force and caused them to fail in a brittle manner, resulting in the partial collapse of the building.

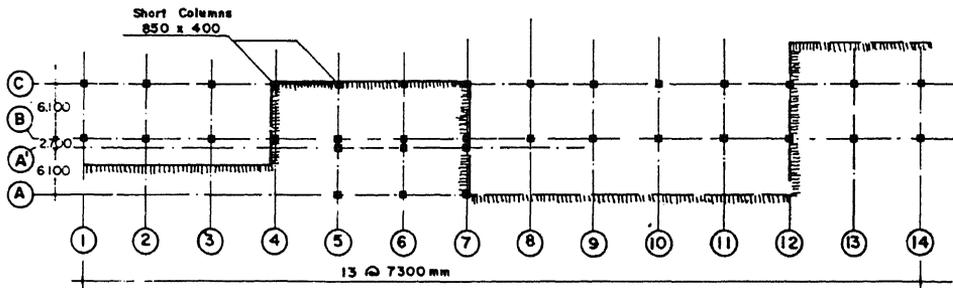
FIGURE 1.a PLAN VIEW

The building collapsed partially during the earthquake in three bays due to the failure of two base columns (see Figure 1). Another column in the smaller block also failed.

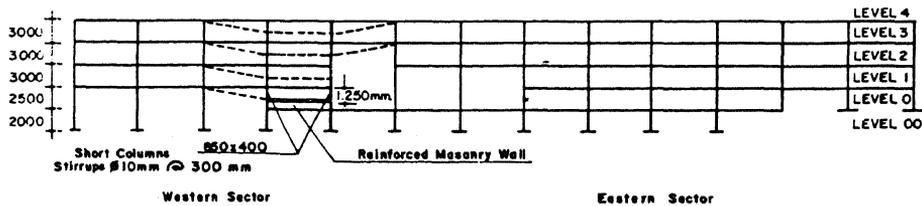
FIGURE 1.b.- FRAME C

The structure is formed by R.C. beams and columns, and prefabricated R.C. slabs with a cast-in-situ concrete topping. In the longitudinal direction (B and C axes) there are two very long frames of 94900 mm length that have 13 bays of 7300 mm each. Frame C is very irregular as can be seen in Figure 1. Practically there are two structures connected at level 3. Also at the end of the eastern sector there was a reinforced masonry wall of 2100 mm which carried a set of stairs.

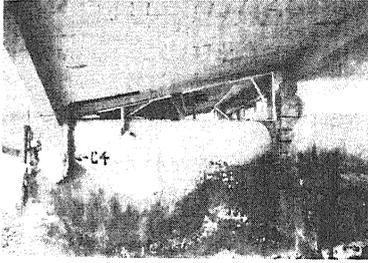
Figure 4. Detail of collapsed column C4

Between the axes 4-5 and B-C, at the top of the retaining wall a reinforced masonry wall was built which braced columns B4, C4 and C5 making them to behave as short columns of 1250 mm in height. As a consequence a great amount of the seismic shear was taken by them. Column B4 in the longitudinal direction had a light and flexible partition wall on one face and a masonry railing on the other. In the transverse direction there was a masonry wall which confined column B4 but not enough to cause a short column behavior. However, columns C4 and C5 were confined by a masonry wall on two faces. This, together with the great flexibility of the slender columns of the western sector produced a great vertical irregularity which eventually caused the collapse of three bays of the building, with a total destruction of the short columns which were totally crushed during the earthquake. In Figure 4 column C4 can be seen to have disappeared completely and the floor slab lying directly on the masonry wall.

From the visual inspection it was observed that the detailing and concrete covers were insufficient, the stirrups at the ends of the columns are separated 300 mm and both these and the longitudinal steel were very corroded. It is assumed that the co-

erosion occurred before the earthquake.

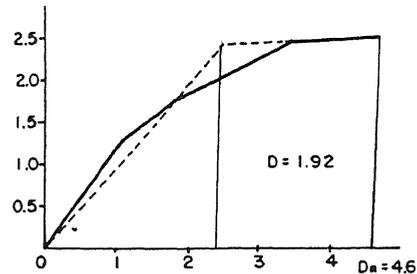
TOP STORY HORIZONTAL DISPLACEMENT
FIGURE 5a - DUCTILITY FACTOR FOR FRAME 4

A linear behavior of the structure was assumed with a maximum ground acceleration of 0.47g, value which was estimated for Puerto Limon by Climent (1991). For the determination of the lateral seismic forces a ductility factor of 2 was used. This value was obtained using a computer program developed at the University of the Andes by Ramirez (1989) and DeBarcia (1991), based on the incremental collapse of the structure (Figures 5,6).

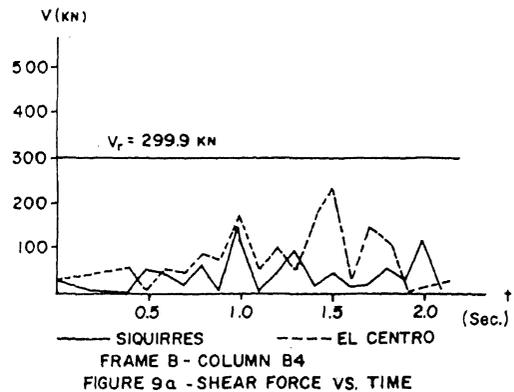
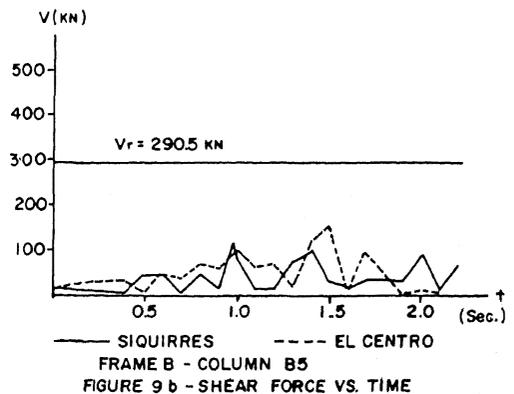
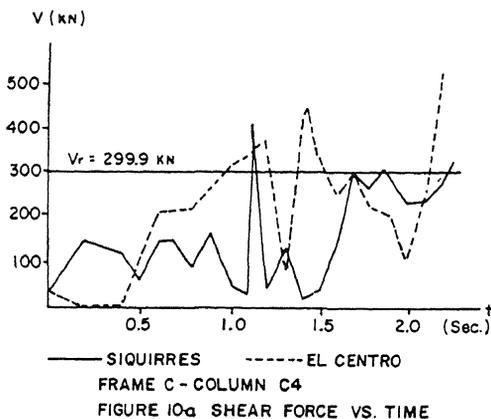
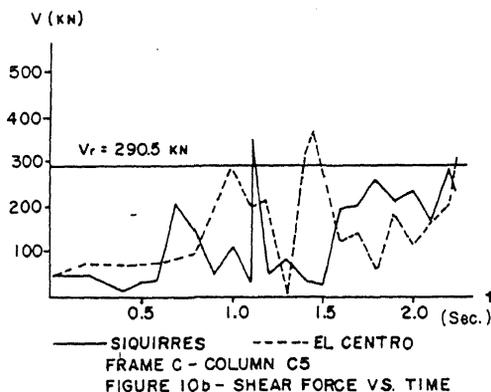
In Figures 9 and 10 the demands and capacities in shear are graphed versus time. In Figure 9, which corresponds to Frame B, the demand never exceeds the capacity for the earthquakes analyzed. In Figure 10a it can be seen that in column C4 with the Siquirres earthquake the shear capacity was exceeded by up to 35% from 1.12 to 1.15 secs and with the El Centro earthquake up to 80% from 0.98 to 1.21 secs, from 1.38 to 1.54 secs and from 2.11 to 2.25 secs. In Figure 10b it can be seen that in column C5 with the Siquirres earthquake the shear capacity was exceeded mainly from 1.11 to 1.13 secs and with the El Centro earthquake from 1.40 to 1.50 secs. The axial force remained near constant during the periods of time considered.
