The Boca del Tocuyo earthquake of April 30, 1989 in Venezuela

Alfonso Malaver

Universidad Catolica Andres Bello, Caracas, Venezuela

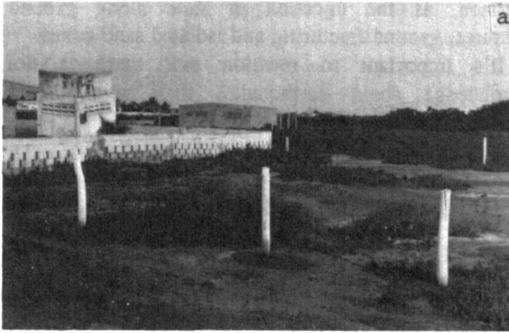
The most outstanding characteristic of this earthquake was the liquefaction of the soil in Boca del Tocuyo, Tocuyo de La Costa and Chichiriviche, on the eastern coast of Falcón State (Figure 3).

The areas where liquefaction occurred in Boca del Tocuyo are close to the sea and along the banks of the Tocuyo River; in Tocuyo de la Costa, they were along the Tocuyo River, and in Chichiriviche it occurred near to the coast line.

In the test soil bores made by De Santis et al. (1990), it was found that the liquefaction occurred between 0.20m and 4.00m of depth, in a sedimentary environment associated with abandoned meanders and fluvial-deltaic deposits with sand and silt; a typical geotechnic profile from a zone where liquefaction occurred is the following: from 0 to 4.00m fine grey loose sand; from 4.00 to 8.00m medium dense fine grey sand; from 8.00 to 11.00m clayey sand loose to medium and from 11.00 to 15.00m medium dense fine sand.

Figure 3 Liquefaction effects at Boca del Tocuyo. a) Settelement of water tank and sand boil; b) Sand boil detail

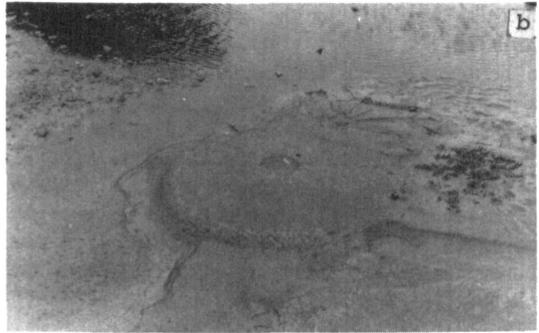
surface, as the injection of sand along ground fissures, ground fracturing and isolated sand cones.

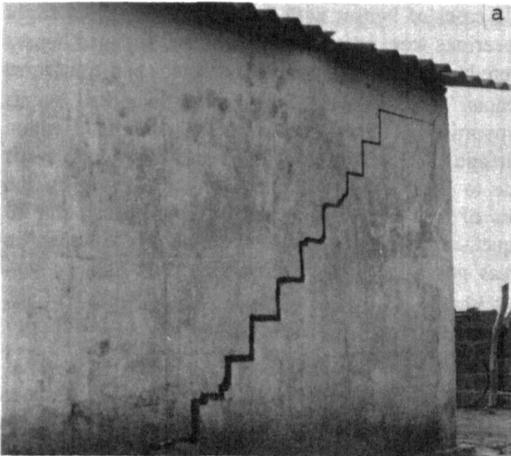
120 cases of houses with damage ranging from slight to serious were reported. Most of the damaged houses were built reinforced concrete columns and transverse beams, and smaller longitudinal wooden beams supporting a lightweight roof. The most common damage consisted of cracks in the clay-block walls due to differential settlement brought about by the loss of load carrying capacity of the ground due to liquefaction (Figure 4a). In the case of the houses in areas not affected by liquefaction, the damage was due to lack of anchoring between the walls of the houses, corrosion of the steel reinforcement and poor construction quality.

Figure 4 Damage in typical constructions of the area. a) Cracking due to settlement; note light roof; b) Fallen parts of church front

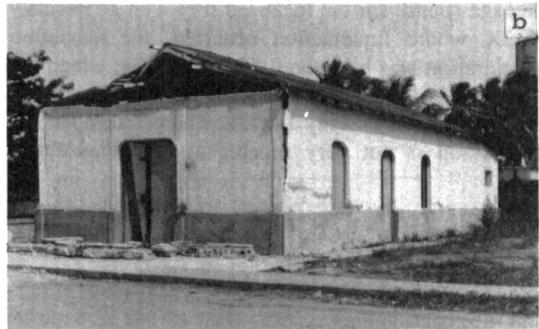
Two churches were damaged. The first, built more than 20 years ago, had a lightweight roof supported by small wooden beams which were held up, in turn, by concrete columns and the perimeter walls. The damage consisted of a fallen parapet from the main facade, due to lack of anchoring, and the failure of three of the wooden beams that held up the roof (Figure 4b).

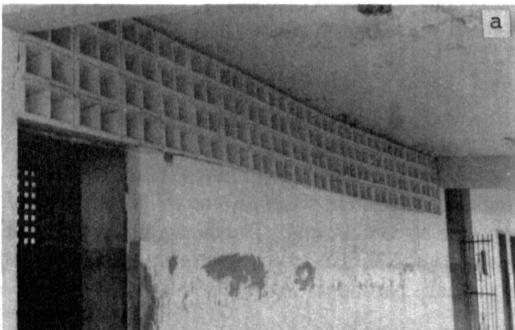
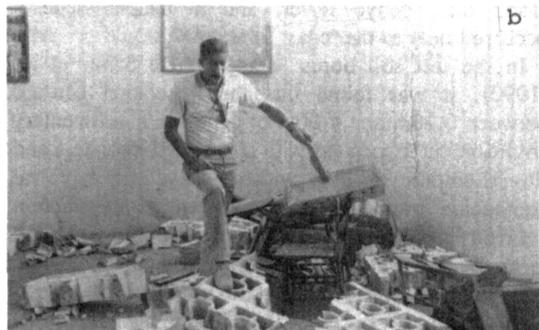
Figure 5 Ventilacion blocks in partition walls at Tocuyo de La Costa school. a) Displaced; b) Fallen in room class

Damage occurred in two 2-story reinforced concrete school buildings. The damage consisted of longitudinal and vertical cracks in the masonry partitions, gaps between the columns and the walls and some fallen ventilation blocks due to lack of anchorage and maintenance (Figure 5).
