Bridge damage caused by liquefaction during the 22 April 1991 Costa Rica earthquake

T.L.Youd, K.M.Rollins, A.F.Salazar & R.M.Wallace
Civil Engineering Department, Brigham Young University, Provo, Utah, USA

Abstract: Liquefaction-induced lateral spreads during the April 22, 1991 Costa Rican earthquake (magnitude 7.7), caused extensive damage to bridges in the highway and railway systems. Lateral displacements as great as 2 m pushed piles and abutments from under decks collapsing at least 7 bridges and severely damaging several others. In one instance, the highway bridge over the Rio Estrella, the foundation resisted ground displacements, which were as great as 2 m near the bridge. In addition, ground failures disrupted about 30 percent of the highway pavement and misaligned several sections of railway grade in lowland areas. This investigation documents ground displacements and related damage at one highway and three railroad bridge sites.

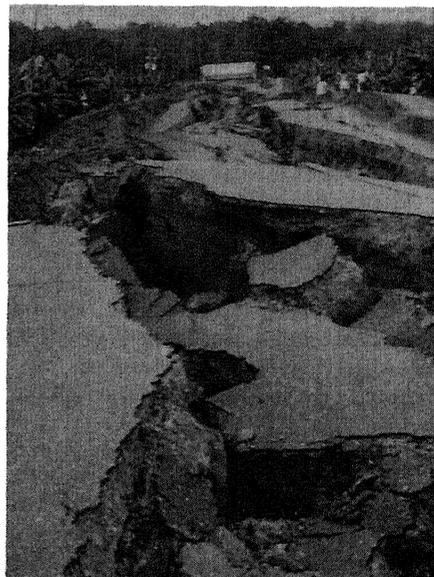
Within the epicentral region, liquefaction was rather pervasive in these lowland areas. For example, the EERI reconnaissance team (EERI, 1991) estimated that about thirty percent of the highway pavement in these areas was disrupted by fissures, scarps and ground settlements caused by liquefaction (Figure 2). Similarly, several segments of railway grade were misaligned by the ground movements. The greatest damage occurred river crossings, however, where bridge decks were thrust over abutments, piers shifted riverward, and fills settled as much as 2 m. These displacements and the consequent damage are the subject of this report.

Figure 2. Highway pavement split and shattered by liquefaction-induced ground failure. A fallen truss of the Río Estrella highway bridge is visible in the background. View looking northward. (Photograph courtesy of Laboratorio de Ingenieria Sismica, University of Costa Rica)

The highway bridge over the Rio Estrella incorporated two 75-m long trusses and a 25-m long plate girder section. During the earthquake the ends of the two trusses fell from their common support and dropped into the river (Figure 9). Other damage at the site included spalling of concrete at the tops of the piles supporting the north abutment, and as much as 2 m settlement of the fill behind the south abutment (Figure 10). The roadway approach south of the bridge settled, broke up and spread laterally as a consequence of liquefaction of the underlying soils (Figure 2). During our survey, we walked through banana plantations near

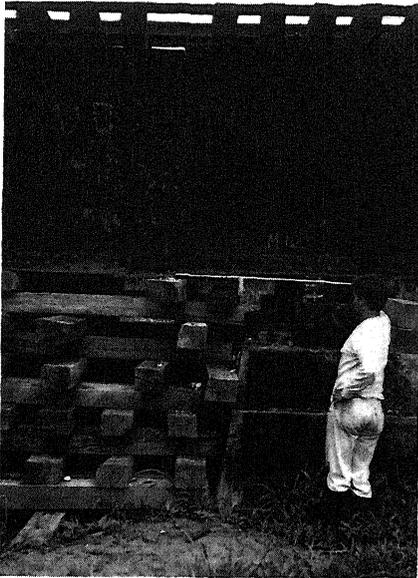
Figure 3. Bridge pier pushed 120 cm out from under plate girder bridge section that was reset on temporary shoring after the earthquake. (After EERI, 1991)

By the time of our visit, the railroad had been temporarily repaired by placing the plate girder sections on cribs of timber shoring and by releveling the truss and girder sections. In so doing, the rails had been restored approximately to their pre-earthquake elevations and alignment. This temporary repair allowed trains to cross the bridge at reduced speed and also provided a reference for us to measure displacement of the shifted piers. Figure 3 shows one of the timber shorings supporting plate girders and a measurement being made of the distance between a seating plate on the plate girder and its former anchorage on the shifted pier.

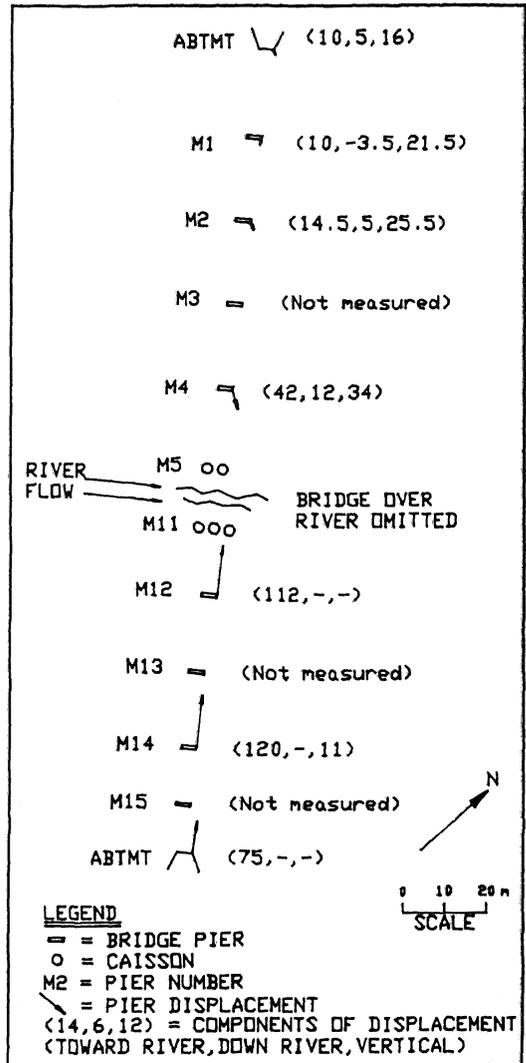
compiled a site map showing positions of bridge foundations, elevation contours, and major fissures and sand boils visible at the time of our investigation (Figure 4). Vectors on the figure show amounts and components of displacement for most of the bridge piers.

On the northwest side of the river, displacements increased riverward from 11 cm horizontal and 16 cm vertical at the abutment to 44 cm horizontal and 34 cm vertical at Pier M4, the pier nearest the river. On the southeast side of the river, horizontal displacements increased from 75 cm horizontal at the abutment to 120 cm at the Pier M12, the pier nearest the river. At each bank of the river, the girder-truss connections were supported on two 2.8-m diameter steel-lined and concrete-filled caissons. Each of those caissons tilted 4 to 5 degrees with the tops moving 66 cm and 120 cm riverward on the northwest and southeast sides of the river, respectively. Those displacements sheared the bridge connectors from the caisson, but the truss sections remained upright on the caisson. The floodplain soils pushed past the caissons on both sides of the river, leaving gaps as wide as one meter on the river sides of these shafts. The caissons also rocked back and forth during the earthquake as evidenced by circular voids as wide as 10's of centimeters the bases of the caissons. The floodplain soils also settled around the caissons by as much as 30 cm (Figure 5).

Figure 4. Map of railway bridge piers over floodplain of the Rio Matina. Vectors show pier displacements.

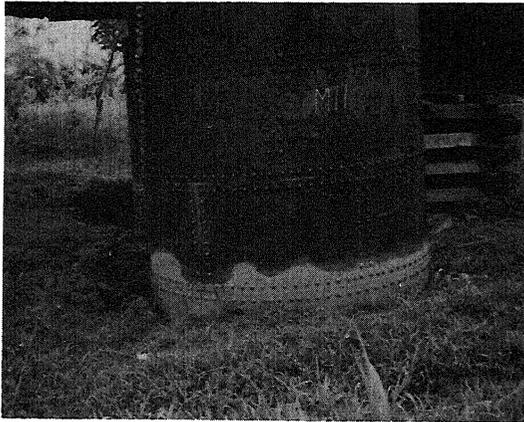
Figure 5. Caisson beneath Rio Matina Bridge that tilted by 4.5 degrees due to lateral ground displacement. Light ring at base shows amount of ground settlement. (After EERI, 1991)

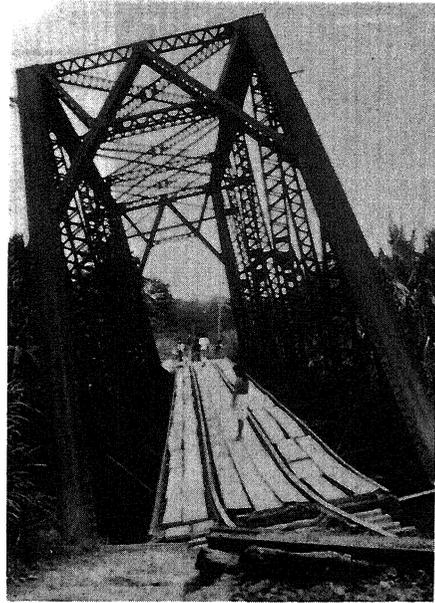
The railway bridge over the Rio Bananito near Bananito Sur is a 50-m long, single-truss structure supported on elliptically-shaped caissons 1.46 m by 2.16 m across the major axes. The caissons are constructed of a 12 mm cast-steel shell filled with concrete. During the April 22 earthquake, ground displacements caused by liquefaction and lateral spreading pushed the supporting caissons out from under the seating plates on both ends of the bridge. This loss of support allowed the truss to tip downstream or eastward by about 15 degrees (Figure 6).

Figure 6. Railway bridge over the Rio Bananito that tipped due to caissons being pushed out from under bridge seatings. (Photograph courtesy of Laboratorio de Ingenieria Sismica, University of Costa Rica)

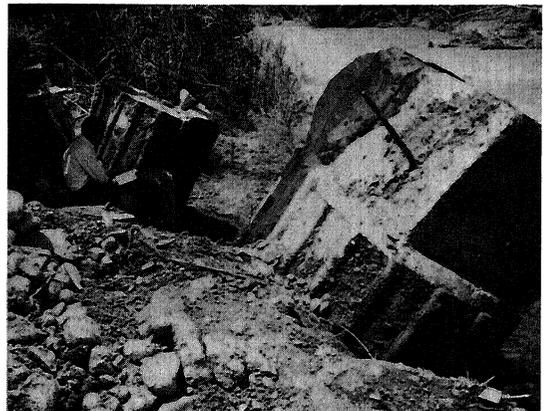
We surveyed the site and measured caisson displacements beneath the bridge. At the northwest end of the bridge, the tops of the caissons shifted displaced 4.3 m and 5.7 m toward the river and the caissons were tilted 26 and 37 degrees, on northeast and southwest sides, respectively (Figure 7). The 0.9-m high capital on the north caisson pulled off during the earthquake and had fallen to the ground by the time of our visit. A concrete wall in the abutment had shifted 2.8 m toward the river and tilted slightly. These measurements indicate that lateral ground displacements beneath the north end of the bridge were between 2.0 m to 2.5 m.

Beneath the southeast end of the truss, the tops of the two supporting caissons were displaced 2.83 m and 1.90 m, respectively, with reference to seating plates on the truss. The greater displacement occurred on the northeast side, the direction in which the truss tilted. The caissons tilted toward the river 19 and 7 degrees, respectively. A retaining wall in the abutment shifted 1.43 m toward the river and tilted slightly. These measurements indicate that horizontal ground displacements beneath the southeast end of the bridge were between 1 m to 1.5 m.

Figure 7. Caissons beneath the Rio Bananito railway bridge that tipped. Caissons were pushed laterally and tilted by as much as 5.7 m (at the top) and inclined by as much as 37 degrees.

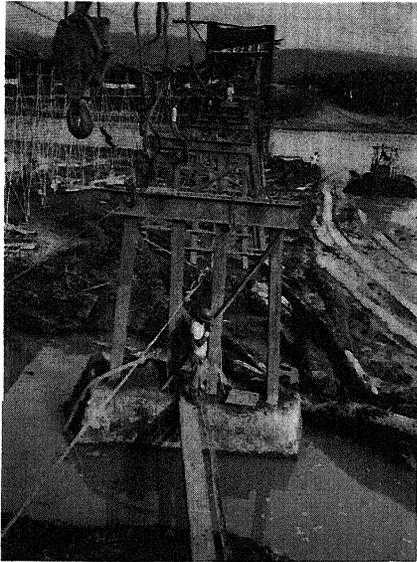
Figure 8 shows piers that previously supported part of the railway bridge over the Rio Estrella near Pandora. The bridge across the floodplain was constructed of simply-supported plate girder spans resting on the steel piers. The spans over the river are steel trusses supported on caissons. During the earthquake, permanent and transient ground and bridge displacements shifted and tilted the piers causing most of the plate girder sections to fall onto the floodplain.

Figure 8. Piers for Rio Estrella railway bridge which tilted during the earthquake and later were uprighted but are out of alignment and no longer equally spaced. The pier nearest the camera shifted 0.8 m to the right; the next pier back shifted 0.8 m toward the camera.

equally spaced and in line before the earthquake, the survey data indicate that the pier nearest the camera in Figure 8 shifted about 0.8 m to the right (in an upstream direction) and the second pier back shifted about 0.8 m inland (away from the river). The other piers shifted as much as 0.15 m and some rotated clockwise a few degrees.

By the time of our visit, the piers had been uprighted by pulling on them with cables attached to the winch on a crane. As can be seen in Figure 8, when the piers were pulled back into a vertical position they were no longer in alignment nor were they equally spaced as they had been.

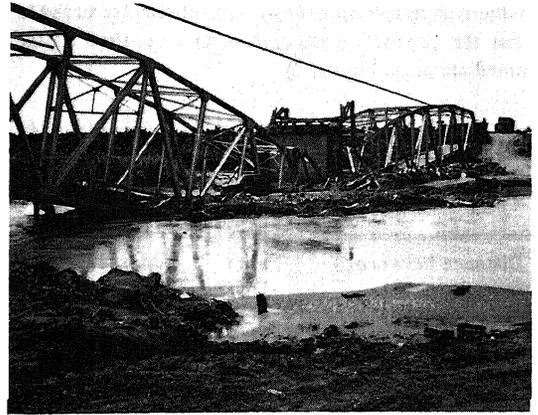
Figure 9. Truss sections that fell from the central pier of highway bridge over the Rio Estrella. Our survey indicates that these piers and abutments remained in their pre-earthquake positions even though the ground shifted toward the river around the south abutment. (After EERI, 1991)

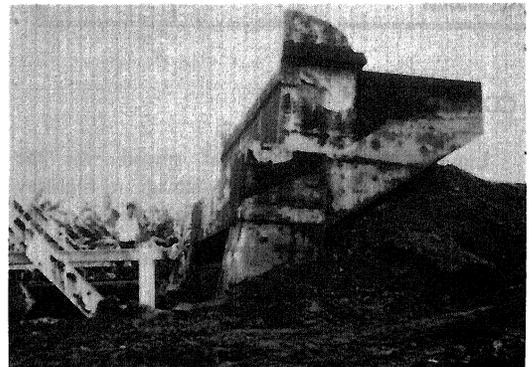
Figure 10. South abutment of the Rio Estrella highway bridge which remained in place even though the fill settled 2 m and nearby ground shifted more than 2 m. (Photograph courtesy of Laboratorio de Ingenieria Sismica, University of Costa Rica)

the south abutment and noted several large fissures, parallel to the river which are indicative of riverward ground displacements of up to 2 m.

southern abutment apparently was sufficiently strong to resist the ground displacements that occurred in the immediate area (Figure 2).
