Microtremor measurements in the disastrous areas by the 1990 Philippine earthquake

ABSTRACT: As members of the damage investigation team of Architectural Institute of Japan, we surveyed structural damage to buildings suffered from the Philippine Earthquake of 16 July 1990 at several disastrous areas in the northern Luzon Island: Baguio, Agoo, and others, from 20th to 30th of September 1990.

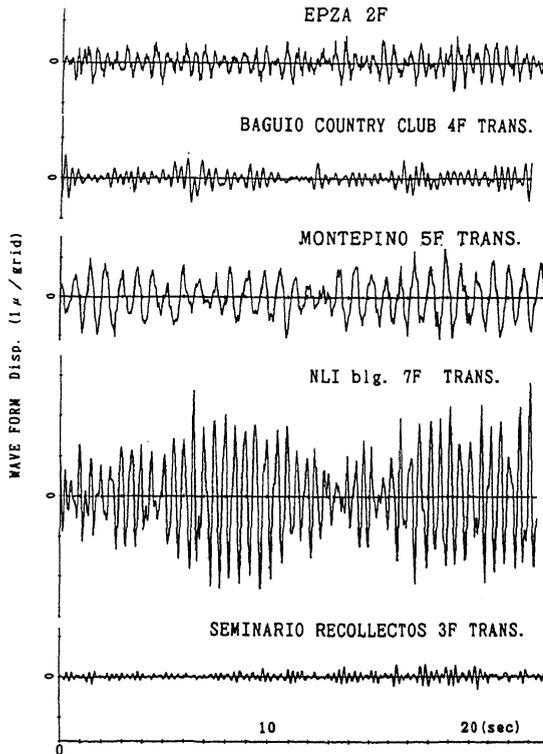
Figure 2. Microtremor records of structures in Baguio

It was difficult to clarify the ground conditions because of traffic noise, but characteristics of the structure was distinct from the wave forms (Fig. 2) and the spectra (Fig. 3). Amplitude of the wave forms was very large comparing with others. Then We estimate that this structure had

Seminario Major Recollectos was located on the hill, the south-west in Baguio. The hall on the slope was badly damaged but the dormitory close to the hall on the flat ground had minor damage. Measurements were taken in the dormitory. The wave forms (Fig. 2) and the spectra (Fig. 3) indicated that this structure was very rigid and ground characteristics was not so soft.

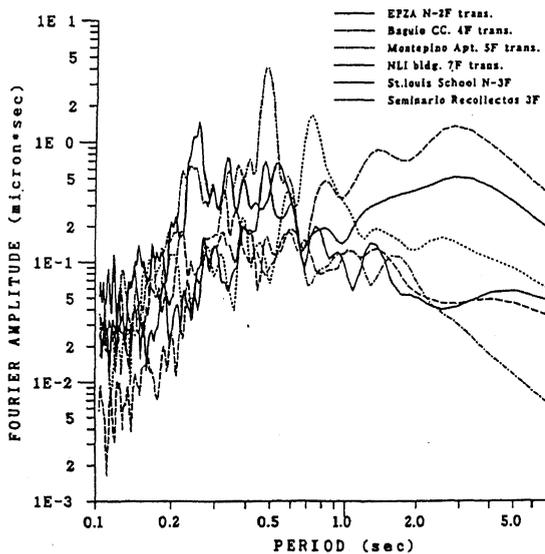
Figure 3. Fourier spectra of the structures in Baguio

soft property and had relatively long natural period. Therefore, it might be thought that there were some causes in this to avoid serious damage.

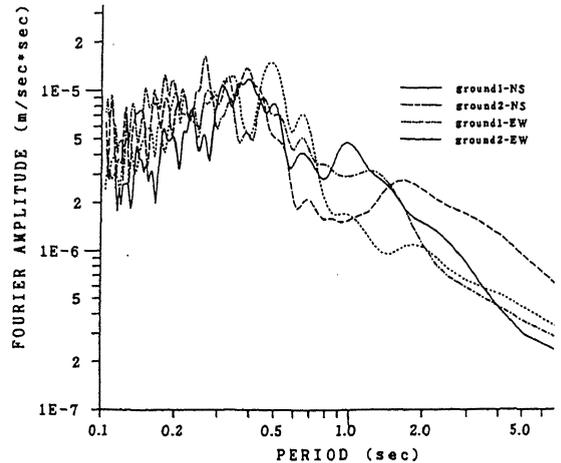
Figure 4. Fourier spectra of the ground at Montepino Condominium

Montepino Condominium was heavily damaged especially columns on the first story but escaped to collapse. Measurements were done on the 2nd and the 5th floor, and on the peripheral ground. The spectra of the ground (Fig. 4) showed peaks about 0.5-0.3 sec. and that of the injured structure gave the peak value about 0.7 sec. as shown in Figure 3. It was guessed that predominant period of this structure before the earthquake had been closer to the period of the ground.

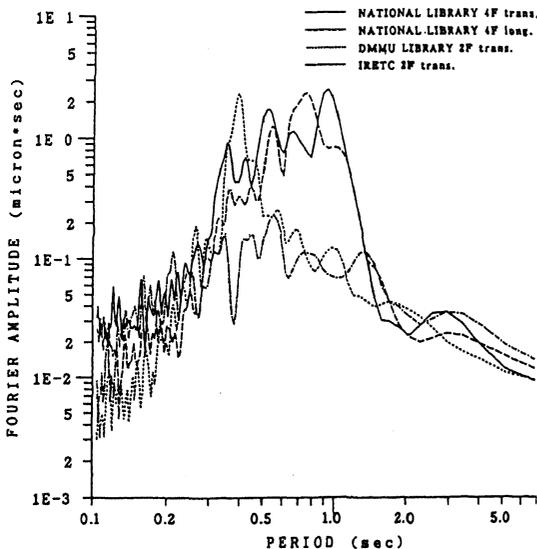
Figure 6. Fourier spectra of the buildings in Agoo and in Manila

Measurements were made on the library and 2 sites on the ground near the buildings in the campus. The observed wave forms in Agoo and their averaged spectra are shown in Figure 6. Results of the measurements suggested that ground of this campus was not so soft against our prospects. The periods of

the suffered library obtained from measurements were longer than that of the peripheral ground. From the results, it was guessed that at the time of the earthquake, as the progress of the destruction of the structural and non-structural member, the fundamental period became longer and then collapse was avoided.

It was seen from the wave forms (Fig. 9) and spectrum (Fig. 6) that the fundamental periods of the structure were 0.8-0.9 sec. and values of the ground were smaller than that of the structure.

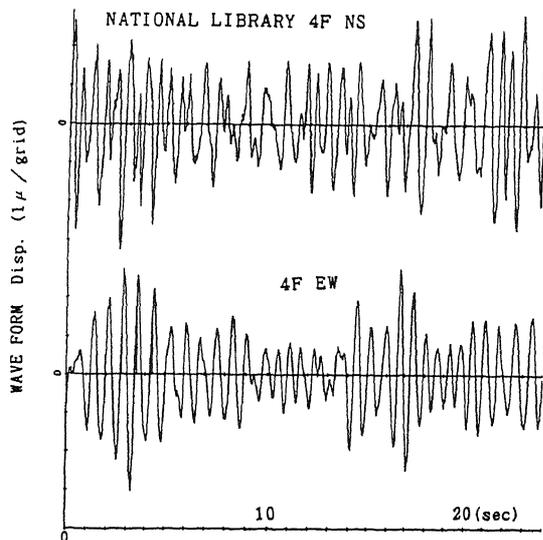
Figure 9. Microtremor records on the National Library in Nanira

Finally in Manila, we made measurements in the National Library. It had 4 stories and had mezzanine floors between each floor. Then it substantially had 8 floors and had height equal to standard 8 story buildings. At the earthquake it was damaged lightly on the core shear walls. The walls had made by concrete blocks were damaged in previous strong earthquake of 1968. And Then the

walls were replaced with reinforced concrete walls. Cracks were observed on the boundary portions between frames and repaired walls but not inspected at this time.
