Engineering analysis of earthquake damage in catalogue-like form: Case-study of Eastern Kazakh earthquakes of 1990

A.S.Taubaev & E.T.Kenjebaev
KazNIISA, Alma-Ata, Kazakhstan, GUS

E.Hampe, H.-G.Schmidt & J.Schwarz
College for Architecture and Civil Engineering, Weimar, Germany

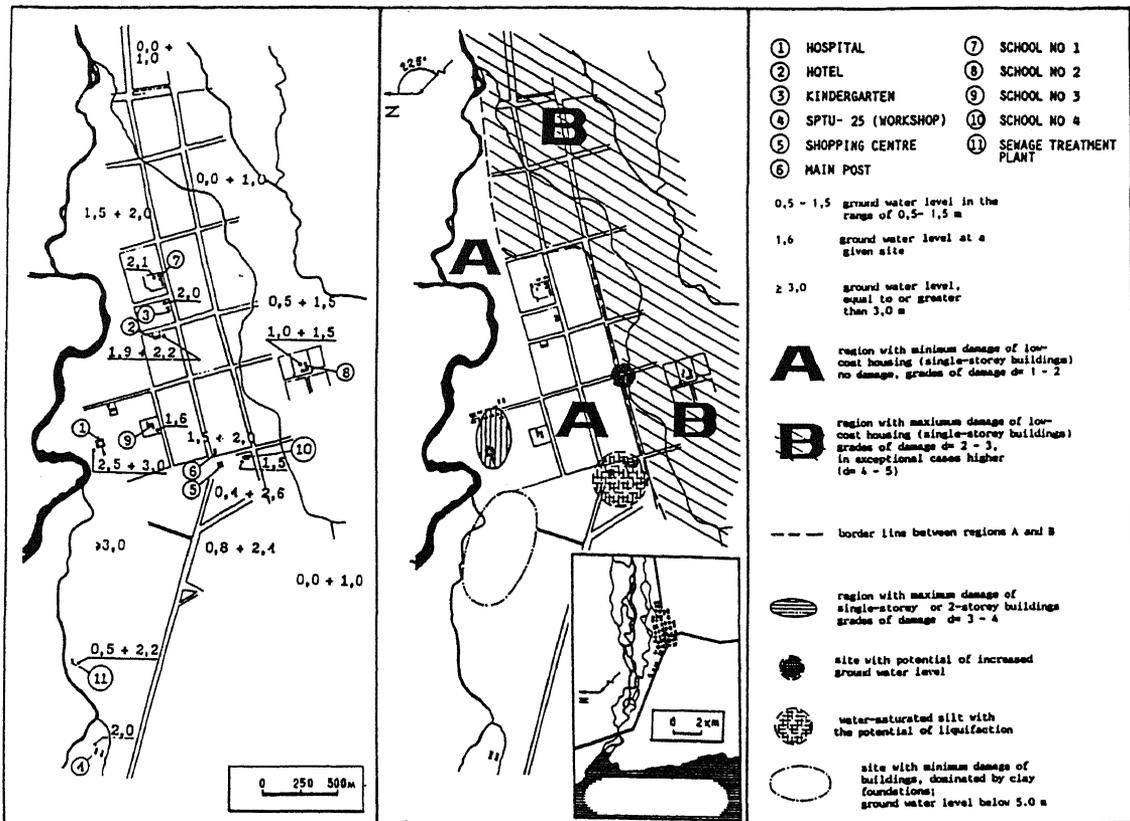
Figure 2. City map of town Kurchum including information on geohydrology, sites of inspected buildings and zones of different damage (vulnerability) of buildings

According to the analyzed structural damage the map of the town could be subdivided into two main zones which are nearly identical with the zones of qualitatively different levels of ground water table (Fig. 2):

- zone A: region with minimum damage of low-cost housing; typical grades of damage $d=1$ to 2 (according to MSK-81 intensity scale)
- zone B: region with maximum damage of low-cost housing; typical grades of damage $d=2$ to 3 and in exceptional cases also higher ($d=4$ to 5).

Additionally, smaller areas are circled on which special remarks to the subsoil conditions and the level of damage could be formulated. In the centre of the town a region of ground conditions is circled which is characterized by a thick layer of water-saturated silt with the potential of liquefaction. For the public buildings in this region (shopping centre, post office and school No 4; sites 5, 6 and 10 in Fig. 2) pile foundations were provided.

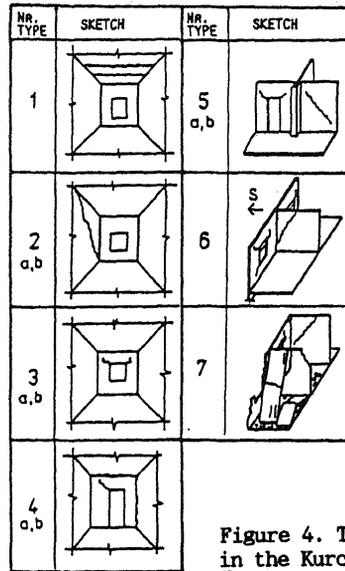
Figure 4. Types of damage in the Kurchum hospital

For the systematic description of damages seven types of damage patterns are distinguished, which are schematically shown in Fig. 4. (step 1). These types and their frequency of occurrence were elaborated for each block and within each storey (step 2). An extraction of summarized results is shown in Fig. 5.

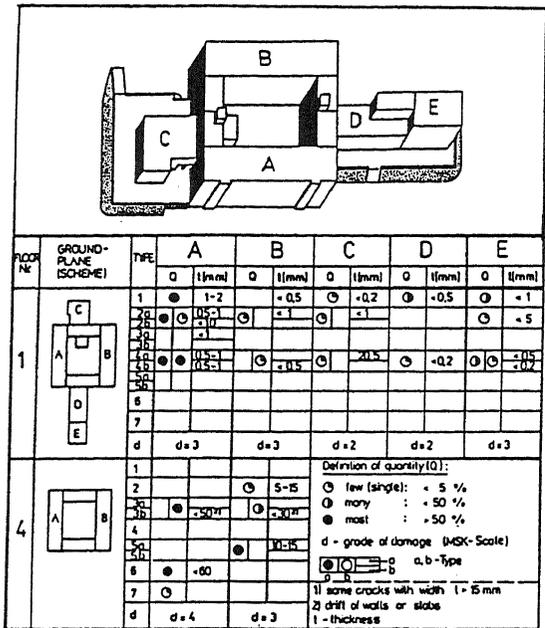
Figure 5. Results of the damage inspection of the hospital according to the reference types of damage pattern

During the earthquakes of June and August 1990 the hospital suffered damage of grades 2 to 4 (Fig. 5) according to MSK-81 intensity scale. Evidently the block A got major destruction and higher grades of damage.

The aftershock aggravated the conditions of the building. From the comparison of structural damage it can be concluded, that the aftershocks increased the average damage by one grade.

After the detailed inspection and analysis of the damaged hospital it was decided to dismantle the third and fourth storeys of the blocks A, B and E and to strengthen the basement and lower floors.

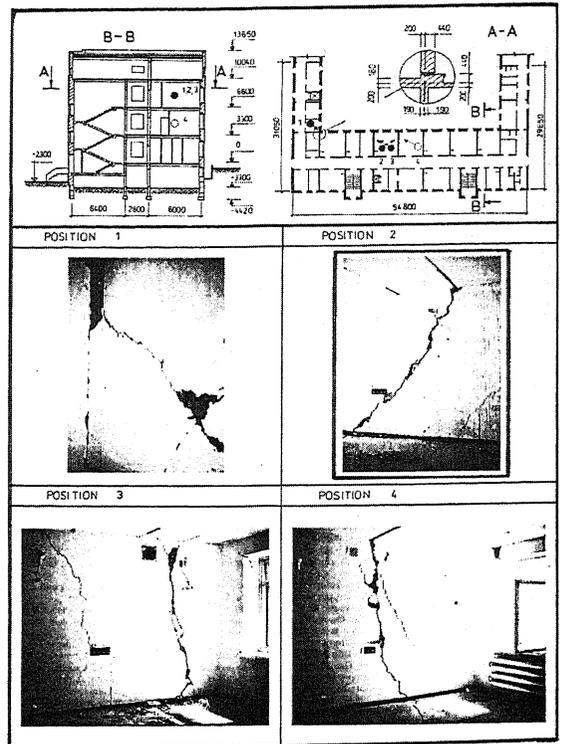
Figure 6.

- typical damage patterns of load-bearing and non-bearing walls (Fig. 6, Fig. 7)
- typical damage patterns of infills and piers between openings
- damage patterns, taken from both sides of walls and
- damage patterns, taken from the walls of storeys and the intermediate slabs.

(a) Typical damage patterns of load-bearing walls of the Hospital

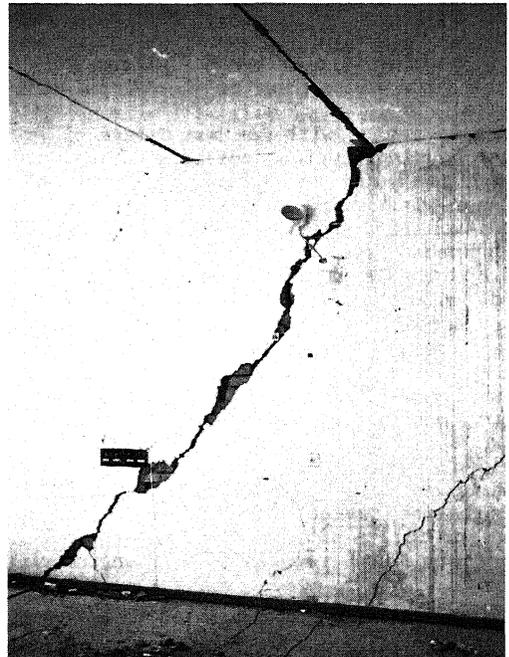
(b) Detail of catalogue sheet: Position 2 (Type of damage No 2 according to Fig. 4)

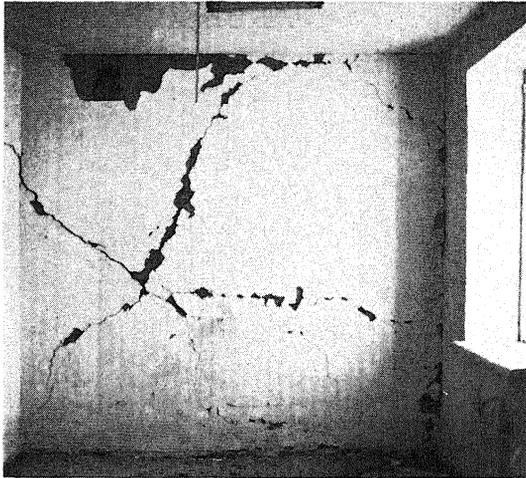
Figure 7. Typical damage patterns of non-bearing walls of the Hospital (3rd floor)

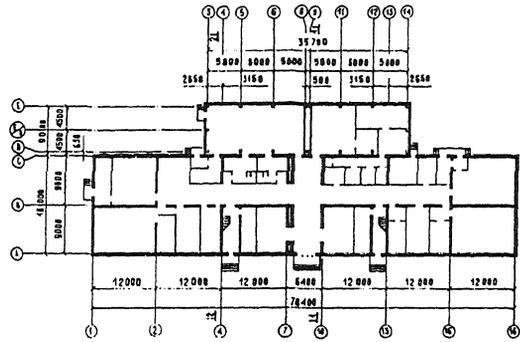
Figure 8. Regular plane of the school No 4

The good performance of school No 1 can be explained by the regular plane (Fig. 8) and the antiseismic design for a reference intensity of 7° (MSK) according to the previous zoning map OSR-1969 (see Fig. 1).

The following decisions were derived from the engineering analysis of structural damage - repair of school No. 4 (damage grade $d=1$) - repair and strengthening of school No. 3 ($d=2$ to 3) and school No 1 ($d=2$) and - demolition of school No 2 ($d=3$ to 4).
