Damage assessment for two Icelandic earthquakes

Hjörtur Thráinsson

Engineering Research Institute, University of Iceland, Reykjavík, Iceland

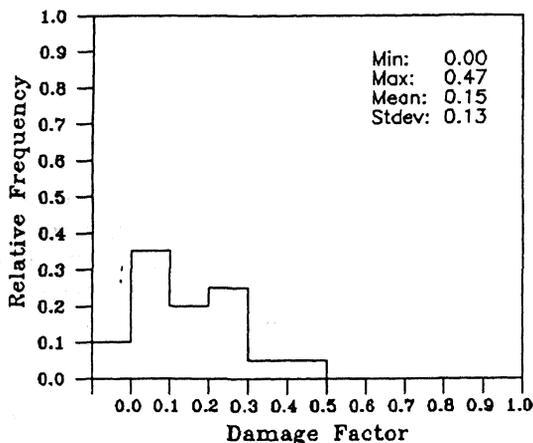
Figure 5. Damage in the 1934 Dalvík earthquake. Wood frame buildings. MMI = IX

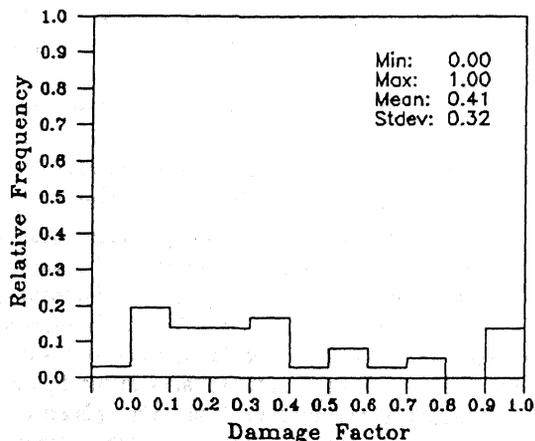
Figure 6. Damage in the 1934 Dalvík earthquake. Concrete shear wall buildings. MMI = IX

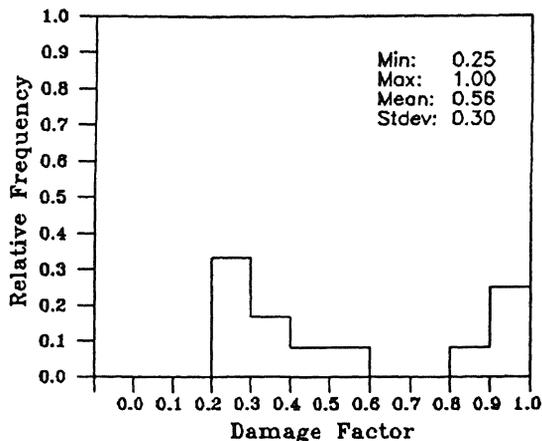
Figure 7. Damage in the 1934 Dalvík earthquake. Traditional Icelandic buildings. MMI = IX

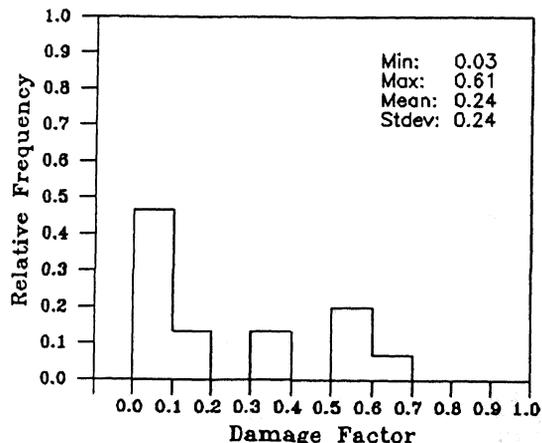
Figure 8. Damage in the 1934 Dalvík earthquake. Concrete shear wall buildings. MMI = VIII

Figures 8 and 10 show striking similarities, which indicates that the seismic resistant of concrete shear wall buildings was almost the same in 1976 as it was in 1934. This is, however, not very surprising because most of the houses struck by the 1976 earthquake were built before 1960 and had hardly any steel reinforcement in the walls. In the following, therefore, all the concrete shear wall buildings are grouped into one group.

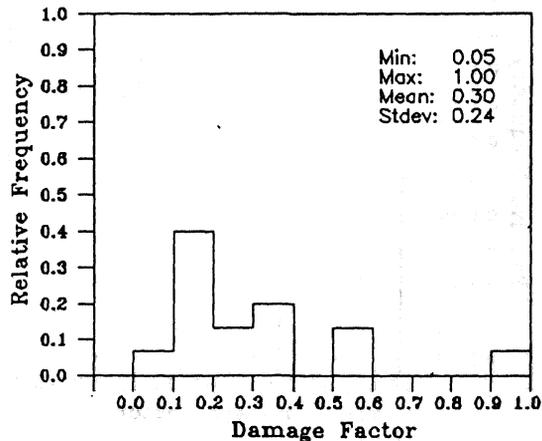
Figure 9. Damage in the 1934 Dalvík earthquake. Traditional Icelandic buildings. MMI = VIII

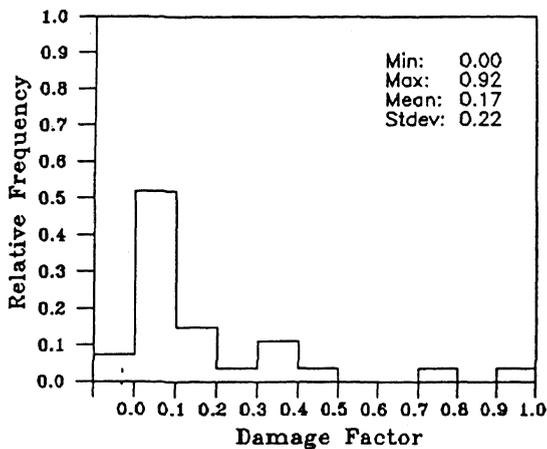
Figure 10. Damage in the 1976 Kópasker earthquake. Concrete shear wall buildings. MMI = VIII

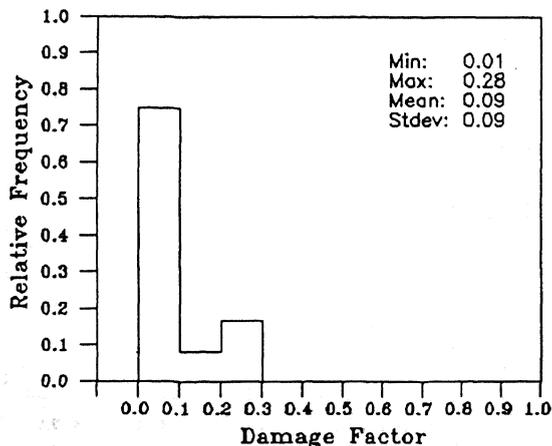
Figure 11. Damage in the 1976 Kópasker earthquake. Concrete shear wall buildings. MMI = VII

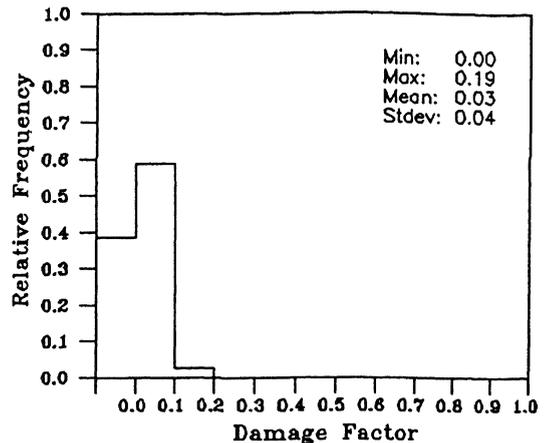
Figure 12. Damage in the 1976 Kópasker earthquake. Concrete shear wall buildings. MMI = VI

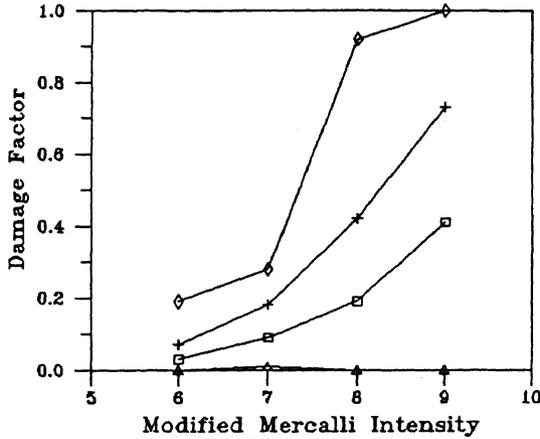
A summary of the findings for the concrete buildings is given in figure 13. The minimum, the mean, the mean plus one standard deviation, and the maximum damage factors are plotted against the ground motion intensity. It is worth noting, that for every level of ground motion intensity, some buildings exist which suffer hardly any or even no damage.

Figure 13. Damage of concrete shear wall buildings in the 1934 Dalvík and 1976 Kópasker earthquakes. Triangles: minimum; squares: mean; pluses: mean plus one standard deviation; diamonds: maximum

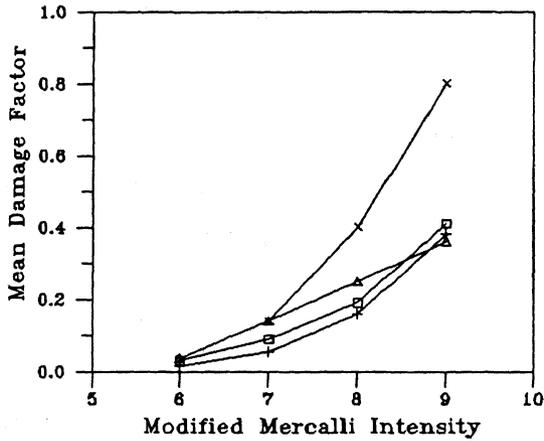
Compared to this study on Icelandic, unreinforced concrete buildings, the American damage factors would overestimate the damage for low intensities, and underestimate it for high intensities.

Figure 14. Comparison of mean damage factors obtained from different studies. Squares: concrete shear wall (this study); triangles: unreinforced masonry (Algermissen and Steinbrugge 1984); pluses: reinforced masonry (Sauter and Shah 1978); crosses: unreinforced masonry (S & S 1978)
