Earthquake damages and characteristics of microtremors at large-scale artificial housing sites

ABSTRACT: The detailed investigation by a house-to-house visit on the earthquake damages and the measurement of microtremors are carried out at two large-scale artificial housing sites. The extent of the earthquake damages corresponds to the soil condition of the fills at each housing site. The amplitudes of microtremors on the fill at damaged housing site are large compared to those at less damaged housing site. The largest cause for the serious damage of houses is insufficient compaction of the fill. Microtremor is worth using as the method of judgement for the damage potential in large-scale artificial housing sites.

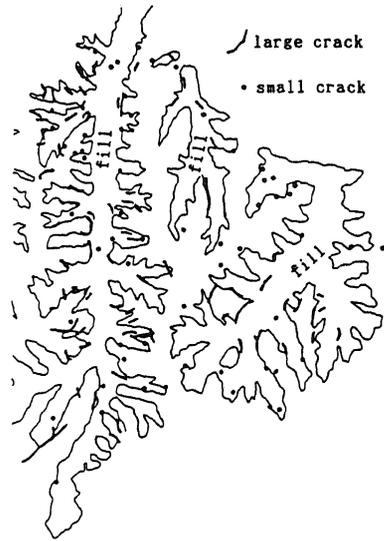
Fig. 3 Distribution of cracks (Nankohdai)

Fig.3 shows the locations of cracks at the

ground surface investigated in Nankohdai housing site. About ten years after since the earthquake occurred, this house-to-house visit investigation had been carried out. So it is possible that we overlooked some cracks. However, it is considered that the impressive cracks were not overlooked. The large cracks are located at the nearby boundaries between the earth cut and the fill, and are almost parallel to the boundary. It can be considered that these large cracks were caused by the slumping of the fill. The locations of heavy damages correspond nearly with the locations of large cracks. It is considered that the large majority of heavy damages were caused by these large cracks of ground.

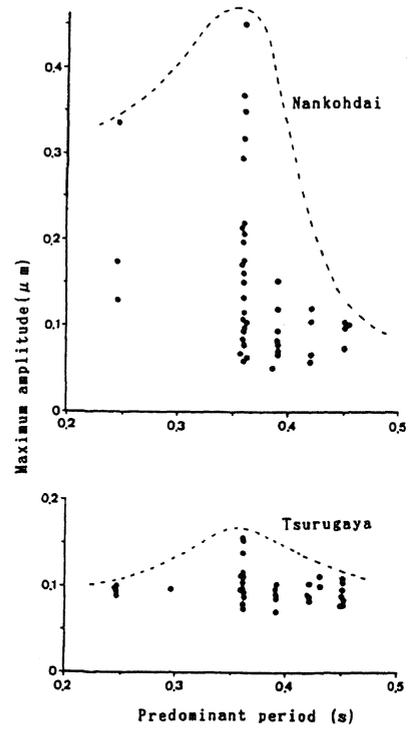
Fig. 7 Relation between the predominant period and the maximum amplitude

Fig.7 shows the relation between the predominant period and the maximum amplitude. The envelop curve has a peak at the period of about 0.36 second. Fig.8 shows the change of natural period of the building before and after the 1978 Miyagiken-oki Earthquake, and also shows the grade of the damage¹⁾. The building which natural period was about 0.36 second had been damaged severely. In Nankohdai too, the resonance phenomena might be occurred at the 1978 Miyagiken-oki Earthquake

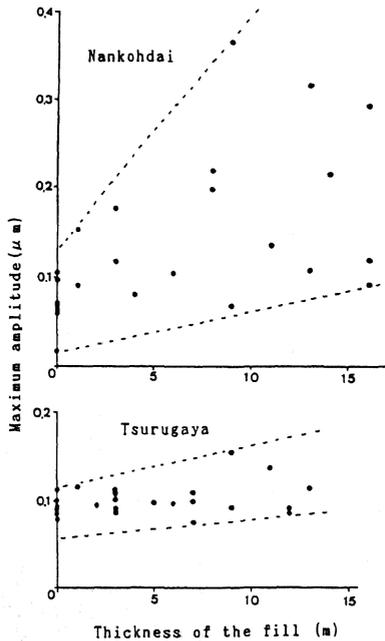
Fig. 6 Relation between the maximum amplitude of microtremors and the thickness of the fill

Microtremors were measured at midnight in both housing sites. Three components of displacement were measured simultaneously for six minutes using three transducers with a natural period of 1.0 second. The maximum amplitudes of horizontal component of microtremor in Nankohdai and Tsurugaya are plotted with the thickness of the fill in Fig.6. At the cut ground the majority of the maximum amplitudes are within the range of $0.06 \sim 0.11 \mu\text{m}$ and almost same in both housing sites. As shown in Fig.6, the maximum amplitudes in Nankohdai are scattered widely, but are more proportional to the thickness of the fill in comparison with Tsurugaya. It can be considered that there are large dif-

ferences in the shear modulus between the cut ground and the fill in Nankohdai.
