Behaviour of old historical buildings during August 21, 1988, Bihar-Nepal earthquake

S.K.Thakkar & D.K.Paul
University of Roorkee, India

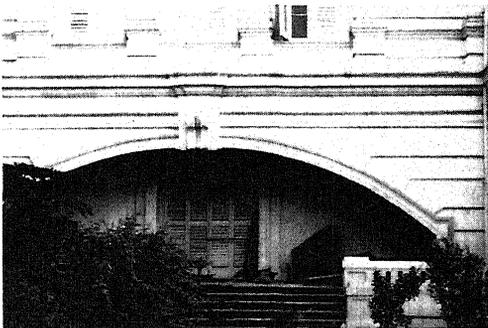
Governor's residence, Patna (Photo 1): The massive three storeyed structure used for residence was constructed during 1916-1918. It is a load bearing wall construction with massive brick floors. The walls contain several load bearing arches of small to large span. This structure was subjected to 1934 earthquake which had caused only minor damages. The earthquake of 1988 did not produce any cracks in N-S direction in masonry arches. Nearly, all verandah arches, about 10m span on all floors oriented in approximately E-W direction developed cracks near the crown. The 15m span arch on the western side of building developed a large horizontal shear crack on one side just above the crown. The cracks are fine in general. The cracks also occurred in roof slab and false ceiling at several locations. The damages were mostly repairable.

Photo 1 Governor's residence, Patna (Horizontal crack over the arch in right half)

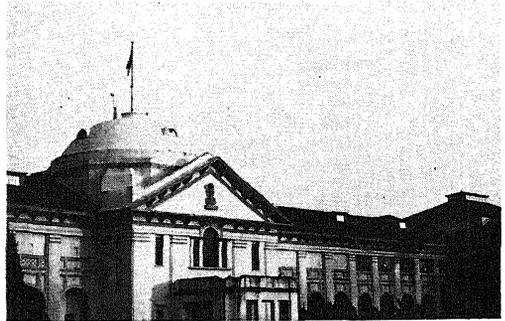
High court building, Patna (Photo 2): This is massive two storeyed structure constructed in 1917-18 having 50cm thick brick wall in lime mortar. The building has a large masonry dome on its top which developed cracks on its outer surface. The cracking also occurred on the outside walls. The damage was also observed in false roof all along the wall junction. The separation of walls at the corners and between the roof and the wall was observed. The cracks were observed on

several walls of the building. The building was also a heavy weight structure.

Photo 2 High court building, Patna. (Cracking of dome, walls, roof)

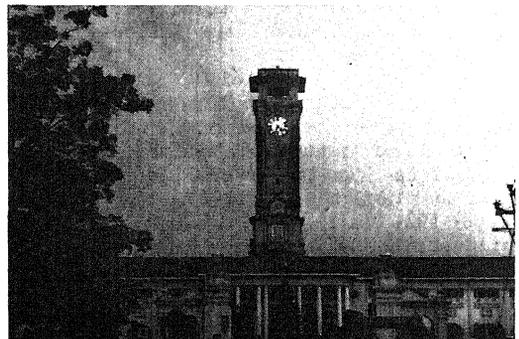
Old Secretariat, Patna (Photo 3): This is a massive two storeyed brick masonry structure in lime mortar constructed in 1916-18. The building consists of three main blocks connected with arch corridors. The building has a clock tower in the central block. The clock tower was damaged in 1934 earthquake, subsequently height of tower was reduced during reconstruction. The tie rods were used at the top in reconstruction. The clock tower did not show any damage as such during this earthquake but there was a slight crack in the wall where the girder was resting just above the clock at the top of the tower. The vertical cracks occurred near the crown of arches in both NS and EW direction.

Photo 3 Old secretariat, Patna (Walls and roof of left block cracked)

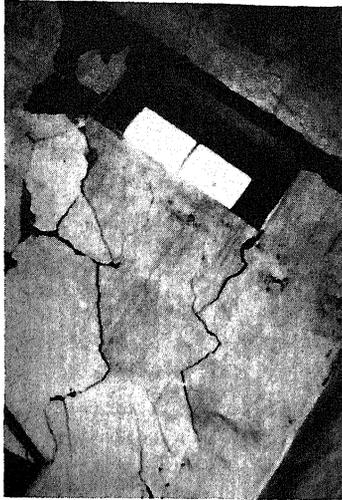
L.R. Girls High School, Darbhanga (Photo 4): This is a single storeyed

building in brick mortar approximately 70 to 80 years old. The school was damaged badly and was abandoned. The arches of the class room failed and there was extensive damage to the wall. The boundary wall was also badly damaged and collapsed at some portions.

Photo 4 L.R.Girls High School, Darbhanga (Cracking of walls and roof)

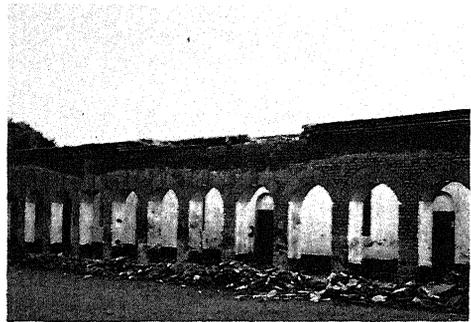
Madarsa Hamedia, Qila Ghat, Darbhanga (Photo 5): This was an old single storey brick masonry building in L shape constructed in 1937. The building consists of fourteen class rooms (height 4.5m with 60cm thick brick wall) on either wing of 6.5 x 6.5m size. The building structure was a typical load bearing wall type of construction in lime mortar. The front portion of class room has a verandah corridor consisting of brick masonry arches resting on brick pillars. The roof of the class room consist of four small brick jack arches resting over steel girders. The arches of span 3.0m of the verandah got completely damaged in one wing and the class rooms were damaged beyond repair. The ties came out from the arches and the cross and longitudinal walls got separated at the corners. There were loss of lives in the collapse of this school building. The main reason of damage was due to the failure of verandah arch at one end due to lateral thrust and torsion of building which triggered a sequential failure of arches.

Photo 5 Madarsa Hamedia, Qila Ghat, Darbhanga (Cracking of walls and roof)

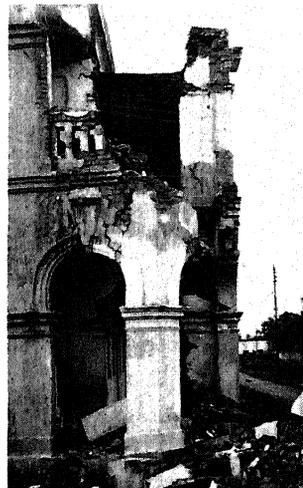
Medical College old hostel, Darbhanga (Photo 6): This is a two storeyed unsymmetrical brick masonry building built in 1927. There were 22 rooms on either side of staircase with jack arch roof. Front verandah consists of brick

masonry arches supported on brick pillars. The hostel was occupied by 180 students at the time of earthquake, only three students got injured. The first floor of the building was more severely damaged as compared to ground floor. One corner block of the building collapsed totally due to failure of corner arch. The damage to the other corner of building was also severe but did not collapse. The verandah arches had badly cracked near the crown.

Photo 6 Medical College old hostel, Darbhanga (failure of arches, partial collapse)

Most of the walls along transverse direction of building showed diagonal cracks and in most cases the roof fell down. In other places, there was wide separation of walls at roof level. The roof consists of three small arches of

2m span and 30cm high resting on steel girders. The ties were used in some spans. The verandah showed severe damage all along, specially at the crown of arches. The arches on ground floor cracked badly in transverse direction whereas some arches in longitudinal direction were not damaged at all. The building was declared unsafe after the earthquake. The main reason of damage was due to failure of corner arches and torsion of building.

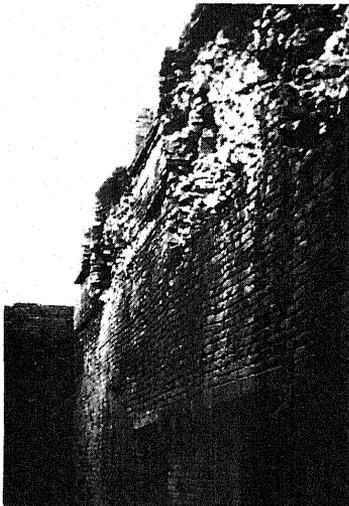
Nalanda Archaeological remain (Photo 7): The archaeological remain of Buddhist education centre, Nalanda University is in very bad shape which has developed cracks in the massive brick structure due to seepage of water. However, because of earthquake no damage was reported possibly due to its large distance from epicentre.

Photo 7 Nalanda Archaeological remain undamaged)

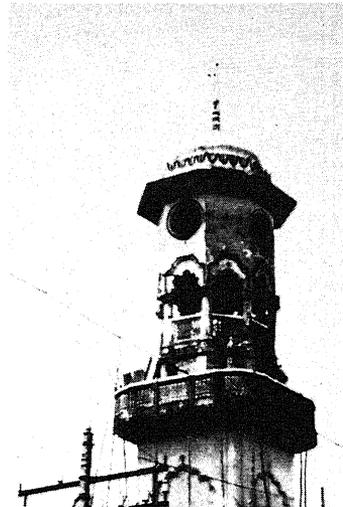
Jama Masjid, Darbhanga (Photo 8 & 9): This mosque was constructed in the year 1963. This was a brick masonry construction in cement mortar. The structure was severely damaged in this earthquake. One of the mehrab (domical portion) at the top was dislocated and hanging in a dangerous manner on eight 15cm size hexagonal columns. A horizontal shift of 7.5cm had taken place at the supporting level of dome on columns. The minarets of the structure were also badly damaged.

Photo 8 Jama Masjid, Darbhanga (top portion sheared, shifted to left)

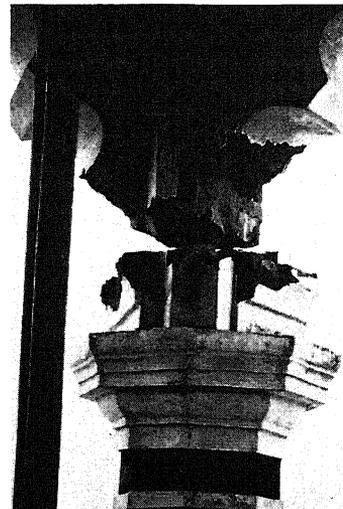
Photo 9 Jama Masjid, Darbhanga (cracking at top of column/arch junction)

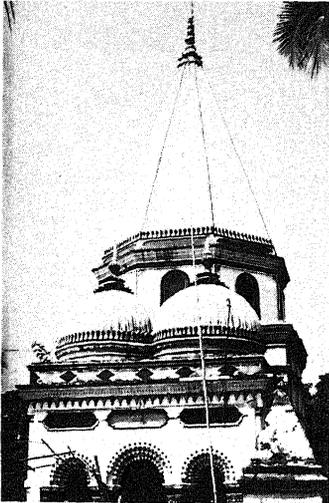
Shiva temple, Darbhanga (Photo 10): The arches of Shiva temple, a brick masonry structure (200 years old) developed cracks. The 20m diameter dome of the building was also cracked. The

separation was observed at the corner between verandah and temple walls. The vertical cracks at the corners were dominant. The temple was damaged in 1934 earthquake and subsequently repaired.

Photo 10 Shiva temple, Darbhanga (wide spread cracks in dome and arches)
