Post earthquake damage studies on the performance of buildings during Bihar (India)-Nepal earthquake on 21st August 1988

V.Thiruvengadam & J.C.Wason
 Central Public Works Department, New Delhi, India

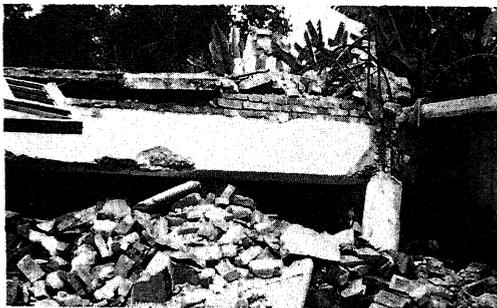
This totally collapsed building (Photo 1) was a two storeyed reinforced concrete structure with open bottom storey. The framing system adopted was rigid jointed one bay frames with brick filler walls only in the upper storey Fig.2. The upper storey had collapsed more like a rigid body without its member in an over stressed condition. The ground floor columns had buckling of the reinforcement and crushing failure of the concrete. The ground floor beams apparently were not in a over stressed condition. Observation of beam-column joints indicated inadequate anchorage of the beam bars inside the joints and no column ties were provided within the joint zone. Even in the body of the column, the ties were widely spaced and inadequate to restrain the column bars against buckling. It was seen that the structure had undergone a large sway deflection before collapse.

Photo 1. Collapsed building at ITI, Darbhanga

The building with stiff upper storey and flexible lower storey had undergone a heavy stress concentration due to the abrupt change in the storey stiffnesses. Large sway deflection has induced heavy moments and buckling of the columns due to P- Δ effects. The columns did not possess adequate ductility to withstand the large sway deflections and absorb the earthquake energy. This was evident from the absence of ductility detailing in the beams, columns and beam-column joints. Fig 3 indicates the code specified (2) ductility detailing of moment resisting frames.

While the main column reinforcement bars were adequate, closely spaced column ties were not provided to confine the concrete core and to prevent the buckling of the column bars. Due to the total absence of confining ties the vulnerable beam-column joints could not withstand the cyclic stresses induced by the earthquake. It was seen that the beam reinforcement had inadequate anchorage into the beam-column joints, with the result that the beams have not fully participated in resisting the earthquake forces and it could be seen that the beams have simply collapsed like rigid bodies.

The main lesson learnt from this building behaviour is the importance of ductility detailing. Also, the abrupt change in the storey stiffness has caused heavy stress concentration leading to the collapse of the building.

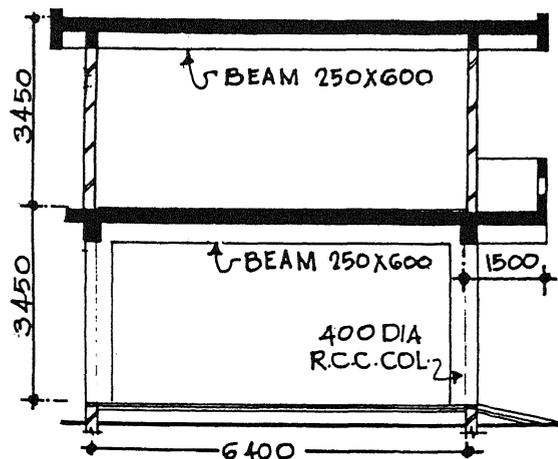
Figure 2. Sectional elevation of building at ITI Darbhanga

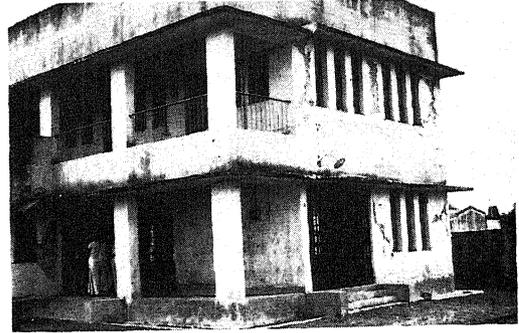
The brick piers between the window openings had developed extensive shear cracks and particularly the end walls were more damaged (photo 2) and the openings over the doors have developed diagonal cracks upto the RCC floors.

The building had partly tilted. There were no apparent damage to the RCC beams and slabs of the floors. The overall damage was extensive and building was vacated after the earthquake.

Photo 2. Cracking of brick walls between openings.

The observed behaviour indicate that the building had been subjected to heavy torsion due to unsymmetrical stiffening effect of the stiff staircase portion. Due to this, the end walls were severely cracked and building had tilted. Adoption of such open type of brick masonry structures without any cross walls is undesirable from the earthquake point of view. This structure with large halls and large number of window openings should have been made as R.C.C. framed structure. The low strength of the cement mortar, poor quality construction, improper planning of window openings and non-adoption of strengthening measures were also responsible for the poor performance of this building.

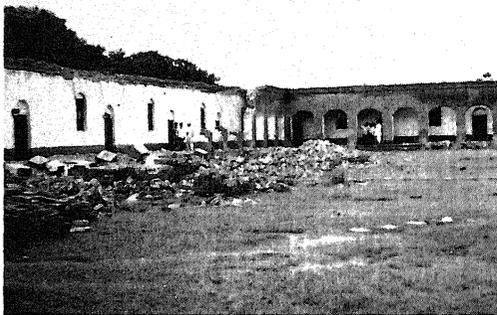
Photo 3. Madrasa building - collapse of brick arches.

The main reason for the damages of these buildings is their ageing with brick masonry losing their mortar strength due to prolonged weathering actions. The jack arch roofs collapsed as they could not withstand the tensile forces generated during earthquake. The masonry pillars supporting the corridor arches had collapsed due to shear failures. Heavy brick wall thicknesses and very thick lime concrete filling over the roofs had generated large inertial forces and the structure possessed no ductility and had very brittle failure. Another undesirable feature of the hostel building was its unduly long length causing large stresses under the conditions of differential ground vibrations. Similarly, the

Madrasa building might have also been subjected heavy torsional stresses due to its unsymmetric plan configuration.

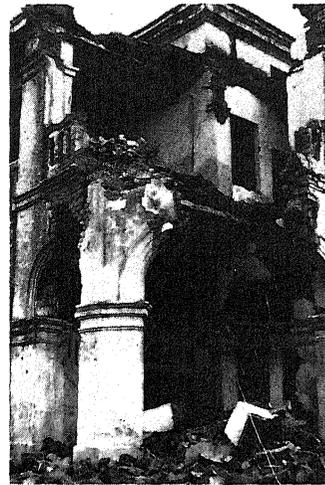
Photo 4. Old hostel at medical college - collapse of one end.

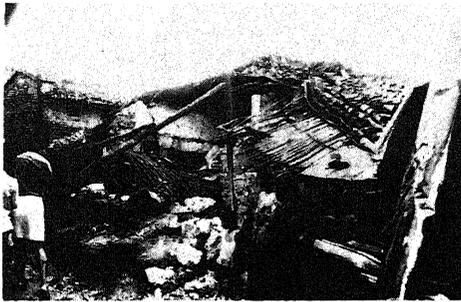
Majority of the loss of lives due to this earthquake was in villages due to the collapse of houses made of walls with mud constructions, sun-dried bricks or stone rubble masonry in mud mortar (adobe construction). The roofs of these houses were mostly clay tiles or stone slabs supported over wooden members, country wood ballies or bamboos. These roofs with no connections with the walls had collapsed, burying the people under the debris. The walls on account of their very brittle nature and heavy mass had cracked extensively and collapsed. However, in some areas

Photo 5. Collapse of a typical adobe house in a village.

It was observed that there is a total lack of awareness among the people on the earthquake resistance measures to be adopted in house constructions. It is necessary to evolve an appropriate low cost rural housing technique taking into consideration the availability of local material, living patterns, climatic and other socio-economic conditions and popularise these constructions among people in such high seismic zones through audio visual media and demonstration houses.
