Response of an unreinforced masonry building during the Loma Prieta earthquake

A.Tena Colunga & D.P.Abrams

University of Illinois at Urbana-Champaign, Ill., USA

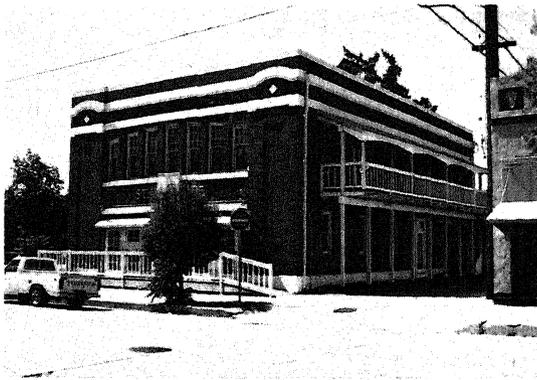
Gilroy California is approximately 15 km south east of Loma Prieta. A town hall in Gilroy constructed of masonry was severely damaged by the shaking. Two blocks north of the town hall stands another unreinforced masonry building that withstood the earthquake with little damage. The structure is a two-story historic building (Fig. 1) that

Figure 1. Southeast view of firehouse.

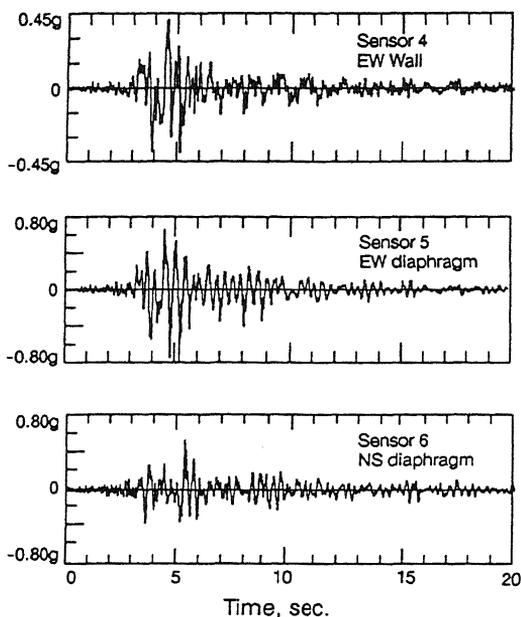
Figure 7. Recorded roof accelerations.

Peak acceleration response was 0.41g at the top of the interior east-west wall, and 0.79g at the center of the diaphragm resulting in amplification factors of ground motions equal to 1.4 and 2.7 respectively. Accelerations as large as 0.55g were measured in the north-south direction at the center of the diaphragm indicating an amplification factor of 1.9.

The sequence and frequency content of the east-west wall motion (sensor 4 in Fig. 7) was remarkably similar to that of the ground (third waveform in Fig. 5) suggesting that the wall acting parallel to its plane was quite stiff. The sequence and frequency content of the east-west diaphragm accelerations was also similar to that of the ground and the shear wall accelerations, with the exception that the long-period pulse at the 4.0 second point was not obvious. Apparently the diaphragm, once excited at its own natural frequency was not affected by this pulse.

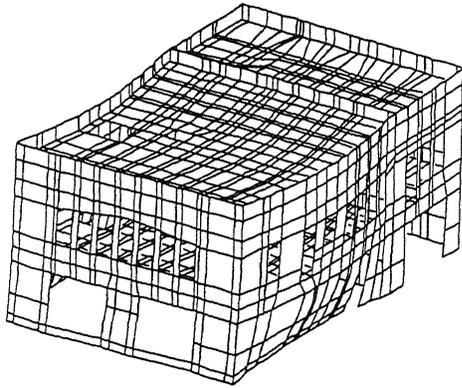
Because the discrete MDOF model was limited to two dimensions, and significant torsional motions were likely, the complete system was modeled with the finite element mesh shown in Fig. 10. The ABAQUS program was used with thick shell, isoparametric 8-node elements. Floor and roof diaphragms were modeled with an orthotropic formulation while masonry walls were modeled with an isotropic formulation. Linear behavior was assumed since the structure was observed to be essentially uncracked following the earthquake.

The first-mode shape (Fig. 10) depicts the deformation of the roof diaphragm in the east-west direction as it spans between the relatively stiff in-plane walls. Distortion of the east wall resulting from the diaphragm movement is also evident. It is clear from the system deflected shape that response cannot be represented with a simple lumped-mass, stick model as is commonly used for dynamic analysis of multistory steel or concrete buildings.

Figure 10. Finite element model.

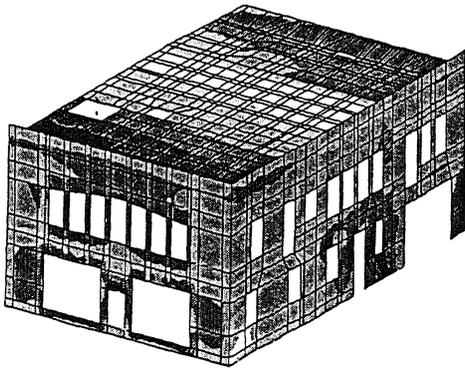
Shear stress contours are shown in Fig. 11 for the time of peak response from the time-step integration. Maximum wall shear stress was in the range of 0.38 to 0.56 MPa (55 to 81 psi) which is indicative of the range for allowable

stresses in masonry given by American codes. It is reasonable to assume with these stress levels that little or no cracking should have occurred.

Figure 11. Shear stress contours.
