Structural damage from Manjil-Iran earthquake of June 1990

M. Molavi

S. Eshghi

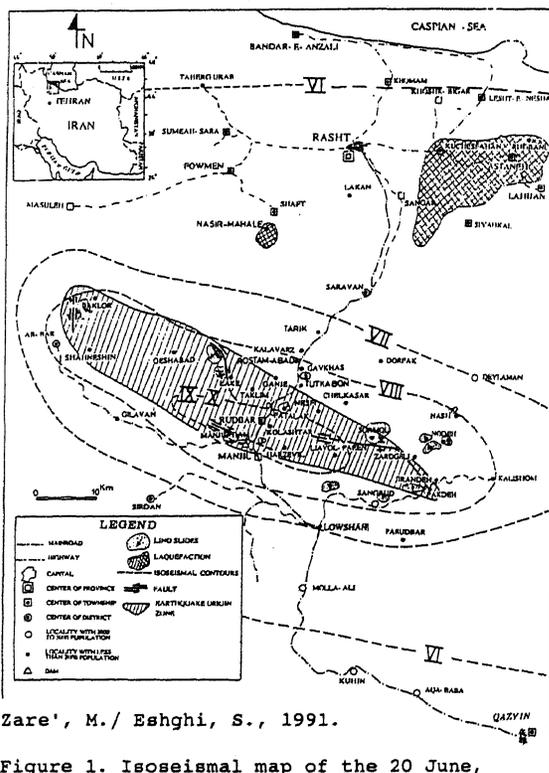
The main event, centered at near the city of Manjil (36:49:00N, 49:24:51E) with a focal depth of about 20 km, propagated along a number of previously unmapped faults that caused widespread ground failures. Numerous landslides as well as soil liquefaction occurred during this earthquake in a relatively vast area as shown in Figure 1.

The Isoseismal map of the 20 June, 1990 Manjil, Iran earthquake based on MSK scale, with the principal geotechnical failures and the earthquake origin zone for this event is shown in Fig. 1. Intensities ranging from VIII to X occurred in an about 200 km² of the imprinted area.

Figure 1. Isoseismal map of the 20 June, 1990 Manjil, Iran earthquake with the principal geotechnical failures and the earthquake origin zone.

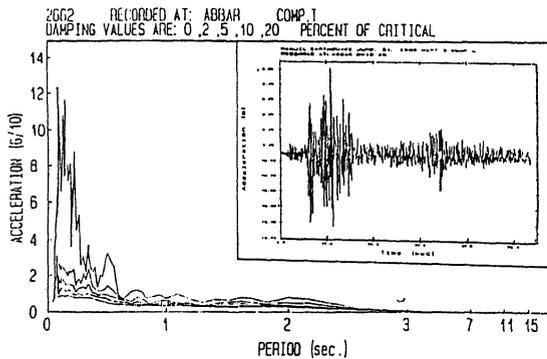
Ground motions were recorded at 20 sites during the earthquake. The main shock was followed by numerous strong aftershocks for several months. The maximum recorded Peak Ground Acceleration (PGA) was at 0.56g and 0.47g in horizontal and vertical directions, respectively, at Ab-bar station about 40 km far from the epicenter. Figure 2 illustrates the acceleration time history and response spectra of the main shock. The spectra have their peaks at the period around 0.2 to 0.3 seconds.

Figure 2. Acceleration time history and response spectra of the Manjil earthquake of June 20, 1990, recorded at Ab-bar station.

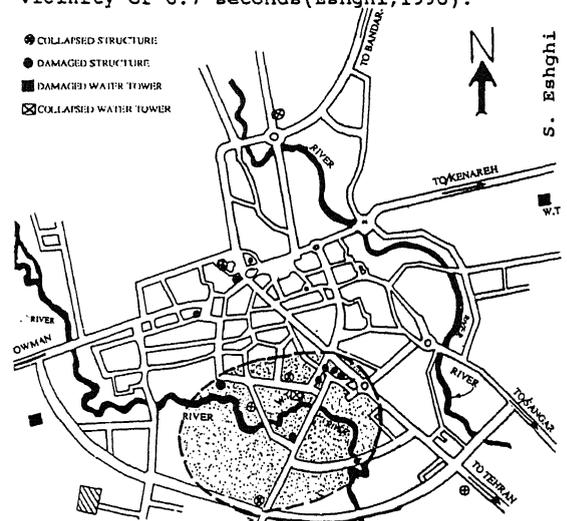
Rasht city, 60km from the epicenter, was hit by the far-field, long-period ground motions during the earthquake with a maximum acceleration of about 0.1g. Figure 3 shows a distribution of damage to residential buildings and three water towers in Rasht, demonstrating that most of the damaged buildings and the collapsed tower were concentrated around the estuary of a river, where soft soils were deeply deposited.

Figure 3. Damage distribution in Rasht.

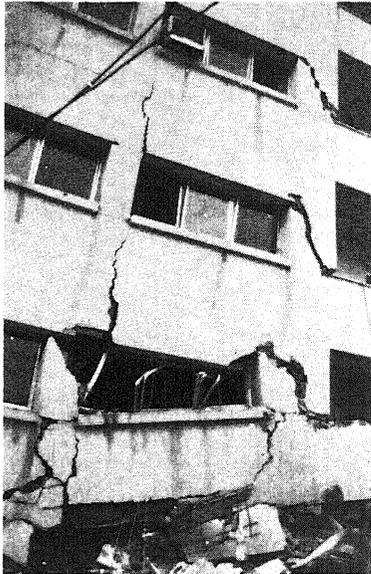
Generally, the damage rate was comparatively high for the buildings of 5 to 8 stories

made up of steel and reinforced concrete structures (Figs. 4, 5). The city was underlain by saturated alluvial deposits more than 60 m thick, consisting of alternating sand and clay layers. Predominate period of the ground was approximately 0.7 seconds (ISIRI, 1988). This fact suggests that a resonance of structures and soils may be a major cause of damage, considering that the natural periods of the mid-rise buildings in the city were in the vicinity of 0.7 seconds (Eshghi, 1990).

Fig. 4 Failure of an eight story steel structure in Rasht.

non-engineered steel and R/C structures with URM infilled walls were constructed without proper engineering design, based on the experience of local masons. In most cases, such constructions suffered many deficiencies (IAEE, 1986) resulted in total collapse of them in Rasht (Fig. 4). Collapse of infilled masonry walls was a common characteristic of structural failure. Modes of failure are summarized in sections 4.1, 4.2.

During the earthquake, extensive damage was experienced in many steel structures including several cases of total collapse (Figs. 4, 5) most of them due to the lack of lateral load resisting system, poor welded connections and poor performance of beam-column connections. Figs. 12, 13 show structural failures. Damages observed were dislocation and crushing of URM infilled walls, sideways of the entire building and pounding.

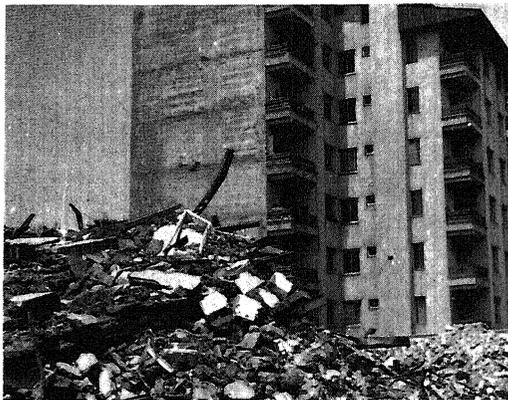
Fig. 5 Corner building collapse of a typified apartment building in Rasht.

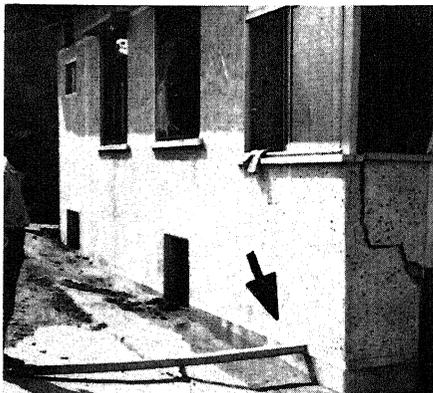
In the town of Astaneh, located about 50 km east of Rasht, soil liquefaction occurred during the quake and damaged several blocks of one-story buildings made up of steel skeleton with brick infilled panels. Many building settled up to 1.m in the liquefied soil and suffered major damage as a result of uneven settlements and also severe tilting. Most of these buildings only had shallow spread footing foundations (Fig. 6).

Fig. 6 Uneven settlement due to liquefaction

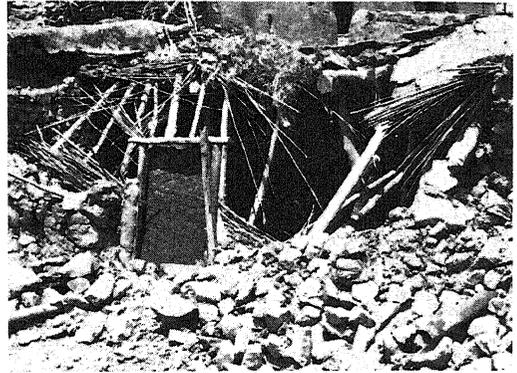
Non-engineered buildings including rural dwellings and urban buildings (houses, shops), experienced substantial structural damage and/or total collapse during this earthquake (shown in Fig. 7, 8, 9). The damage was particularly widespread in the earthquake origin zone (Fig. 1) and was responsible for the great majority of life loss associated with this event (Eshghi, 1990, Nateghi, 1991).

Fig. 7 Total collapse of a rural dwelling.

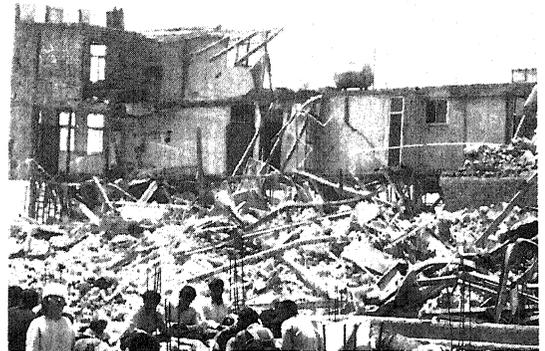
Fig. 8 Total collapse of urban buildings in Manjil.

Urban buildings were mostly built up to three stories and had three different load carrying systems: URM bearing walls, non-engineered steel and (R/C) reinforced concrete structures with URM infilled walls. They were not designed in accordance with building codes. These buildings generally performed unsatisfactory (Fig. 8).

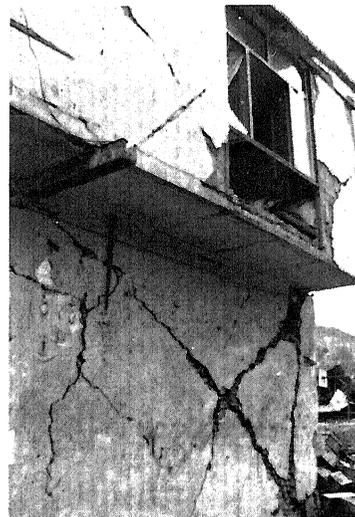
Fig. 9 X cracking in an URM wall.

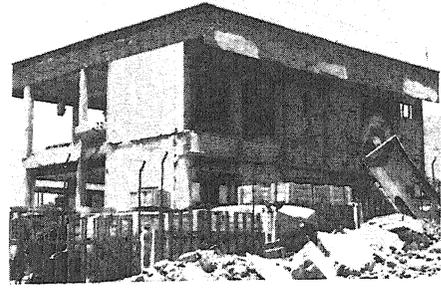
Reinforced concrete (R/C) structures performed unsatisfactory during this earthquake. A few number of reinforced concrete structures were totally collapsed, while others suffered severe structural damages (Figs. 14, 15). A large number of R/C structures had only a simple moment resisting frame for supporting gravity loads.

Lack of a proper ductile moment resisting frame, using plain reinforcing bars instead of deformed ones, not meeting the development and overlapping requirements, and low quality of concrete can be named as major contributing parameters in poor performance of these structures. Damages occurred were, crushing of column ends, short column effects (Fig. 14) diagonal cracking of beam-column joints.

Fig. 15 Damage to a R/C building (Manjil Telecom Center).

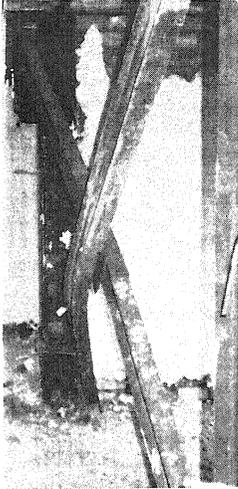
Fig. 12 Buckling of a bracing system.

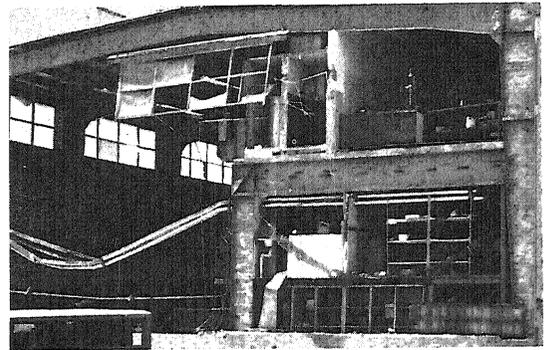
Fig. 16 Damage to industrial structures.

Special engineered structures such as industrial structures (Fig. 16), steel and concrete bridges, silos, steel water towers and also a large concert dam (Fig. 17) generally withstood the motions in the epicentral region with minor damage.

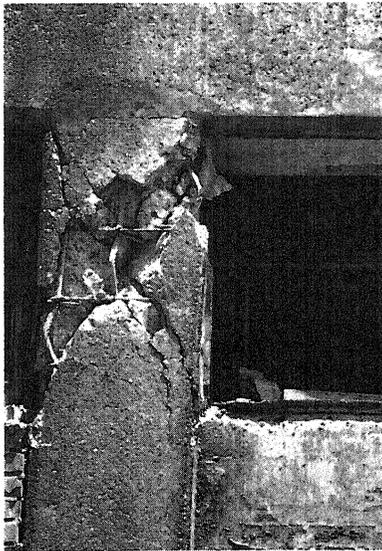
Fig. 14 Shear failure in a column which was shortened by interaction with the spandrel walls.

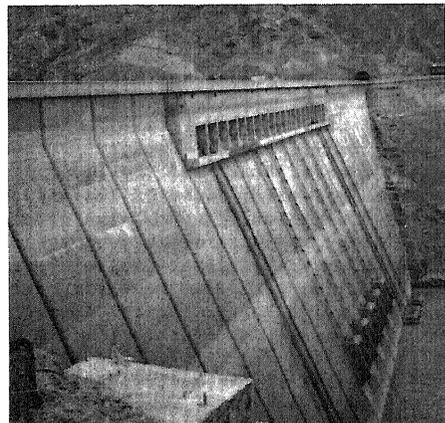
Fig. 17 Manjil large dam, which sustained only minor damage.

The only dam that suffered some structural damage was the Manjil Dam, located less than one km from the causative fault. The dam was the most important structure in the affected area. The dam was of the buttress type with a height of 106 m and crest length of 425 m. The reservoir was almost full at the time of earthquake. This dam experienced longitudinal crack at the interface of the crown and buttress tops, horizontal and diagonal cracks

at the top of some buttresses, but remained stable.

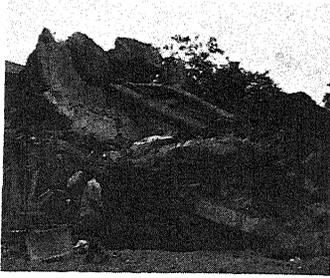
Fig. 18(a) Total collapse of R/C water tower in Rasht.

A R/C water tower with 1500 m³ capacity in Rasht collapsed (Fig. 18). Two more water towers with 2500 m³ in Rasht of the same type as the collapsed one, sustained cracks in the perimeter of the shaft near the base (Fig. 18). These towers did not collapse since they were empty at the time of the quake. The main factors contributed to the damage of these R/C water towers were as follows: high response amplification because of low natural frequency of the towers, local site effects in city of Rasht, and unsuitable structural form and detailing to withstand seismic loads.

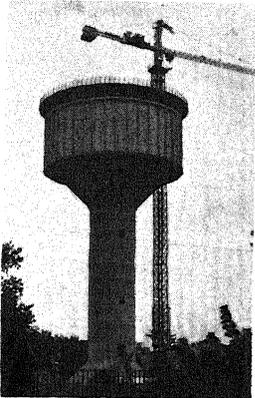
Fig. 18(b) Damage to an empty water tower also in Rasht.
