# Civil engineering features of damage on June 20, 1990 Manjil-Rudbar earthquake, Iran

F.Jafarzadeh

International Institute of Earthquake Engineering and Seismology, Iran

**ABSTRACT:** This paper reports a summary of the civil engineering features of the June 20, 1990 Manjil-Rudbar earthquake ( $M=7.6$ ), which left 37000 dead and caused widespread damage in the north of Iran. Seismological and geotechnical aspects of this earthquake and also damage to buildings and special structures in the affected area have been reviewed briefly.

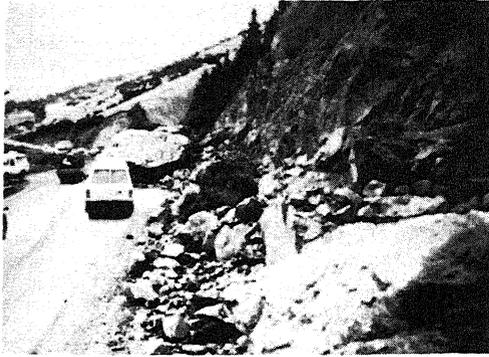
In several cases rockfalls caused damage of roads (Fig. 2), retaining walls and extended into villages which were built at the base of the mountains. A few villages completely or partially were buried by landslides. The dimensions of some landslides were more than one kilometer. Low resistance layers and high water content were two most important reasons for these slides. There were also a lot of slop failures in weathered parts of marl and clay slopes (Fig. 3). Foundation of many factories and buildings were collapsed by differential settlements. Liquefaction was reported in widespread silty sand areas (about 70 km. far from epicenter) that caused damage to roads, water towers, water canals and wells (Fig. 4). This phenomenon was also one of the main reasons for

Figure 2. One of the rockfalls along the main road.

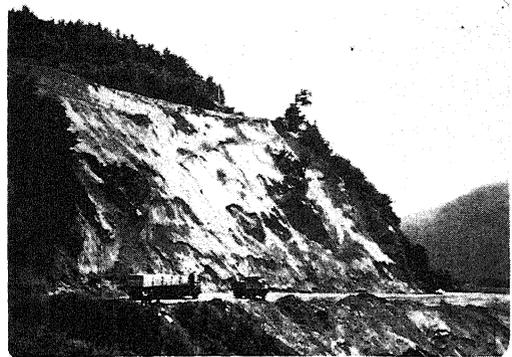
Figure 3. Failure in clay slopes.

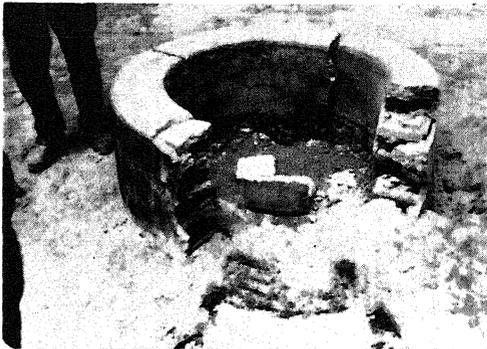
Figure 4. Filled water well with liquefied silty sand.

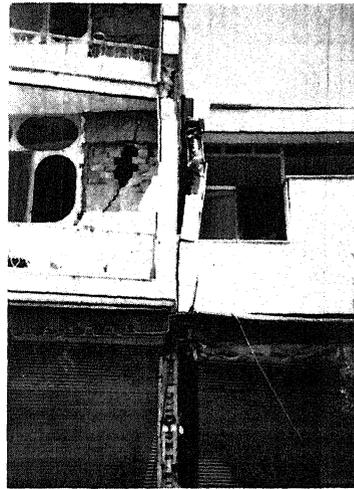
Figure 5. Structural pounding in masonry houses.

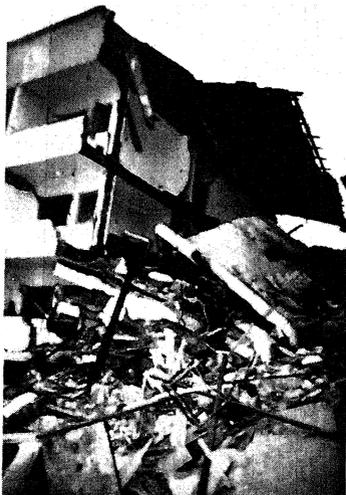
Type 1 is rural houses, built with adobe bricks and alluvial stones, having wooden roofs. Due to the heaviness of the walls and lacking of any connection between them, this kind of houses has no resistance even against the low intensity earthquakes. Type 2 is masonry houses, one to three stories high, made with unreinforced and unbraced brick walls. These walls transfer the vertical load of beams to the foundation. There is no frame or bracing systems in this type. Figure 5 shows two adjacent buildings of this type. Also in this figure structural pounding effect is evident. Type 3 is high buildings from three to eight stories high, made with reinforced concrete or steel frames. In figures 6 and 7 two examples of this type have been shown. Generally the stability of braced steel frame buildings (Fig. 7), comparing with reinforced concrete structures, was good, although some welded connections of braces have been destroyed (Fig. 8). The action of infilled frames in reduction of the intensity of damages were evident. Weakness or lack of any special bracing system or shear wall, free and soft ground story (Fig.6&9) and poor constructions quality were the main reasons of the collapse in this type.

Figure 6. Destroyed 7 story residential apartment in Rasht.

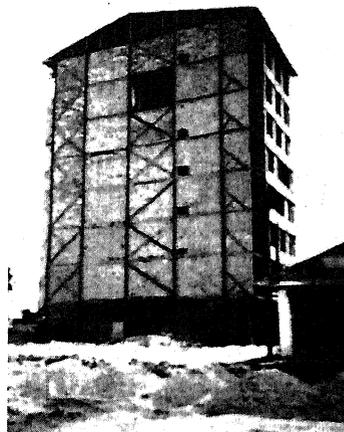
Figure 7. 8 story steel frame building in Rasht.

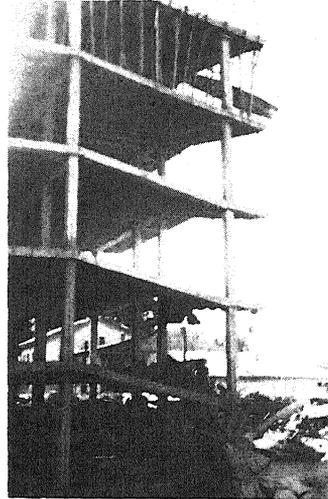
Figure 9.  
Destroyed 5 story  
reinforced concrete  
building in Rasht.

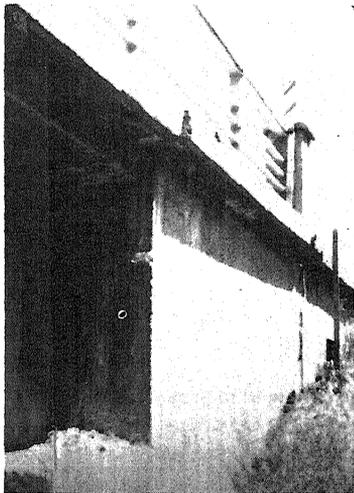
In this disaster, transportation systems like roads, bridges and tunnels; water supply systems such as water towers, pipelines and agricultural canals; electrical power distribution and communication systems suffered many damages. Horizontal and vertical displacements (more than 10 cm.) are shown in one of the bridges in shaken area in figure 10. Figure 11 shows completely damaged water tower in Rasht. The main reason for collapse of this tower was unsuitable connection between prestressed tank and R.C. shaft. Generally, geotechnical features of the earthquake such as rockfalls, landslides and liquefaction were the main reasons for damages done to lifeline systems.

Figure 10. Horizontal and vertical displacements in a  
concrete bridge.

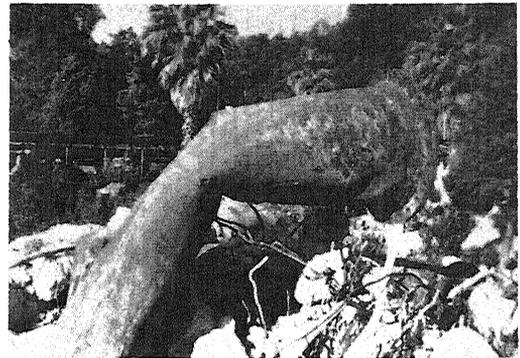
Figure 11. Destroyed water tower in Rasht.

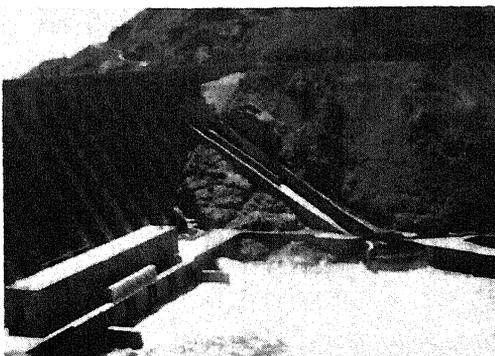
Figure 12. Sefidrud storage dam located in the epicentral  
area.

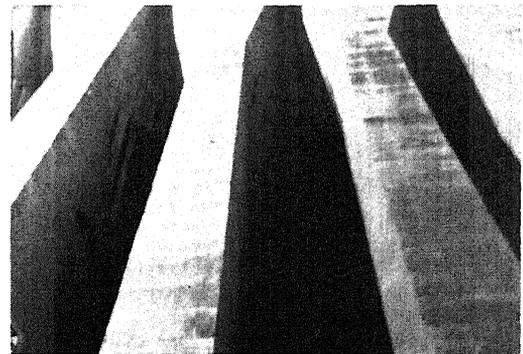
The region affected by earthquake is a well developed agricultural and industrial area. There were more than 68 industrial factories and workshops, like two cement factory, thermal power plant, shoe factory and spinning and weaving factory, which were severely damaged or collapsed in some part. Also Sefidrud storage dam, buttress dam with 106 m. height (Fig. 12), Tarik and Sangar diversion dams are three important hydraulic structures that suffered light damages. Sefidrud dam was located almost in epicenter. Figure 13 shows leakage of the water from the longitudinal cracks, which concentrated around horizontal construction joints. There were some damages in parapet of crest and instabilities in the abutments, however, the general stability of the dam was good. Fortunately, repairing operations of the dam were completed after less than one year.

Figure 13. Leakage of the water from the horizontal  
cracks of the sefidrud dam.
