Liquefaction at Moss Landing during the 1989 Loma Prieta earthquake

Lelio H. Mejia, David K. Hughes & Joseph I. Sun
Woodward-Clyde Consultants, Oakland, Calif., USA

ABSTRACT: The October 17, 1989 Loma Prieta earthquake caused extensive liquefaction in the coastal area of Moss Landing, California. The Moss Landing Marine Laboratory (MLML) was damaged beyond repair by liquefaction of the natural subsurface soils and lateral spreading and differential settlement of the site. In contrast, permanent ground displacements at the site of the new Monterey Bay Aquarium Research Institute (MBARI) technology building and pier were small and these facilities were undamaged. This paper describes some of the liquefaction effects in the Moss Landing area including the liquefaction failure of the MLML and the absence of liquefaction damage at the MBARI facilities.

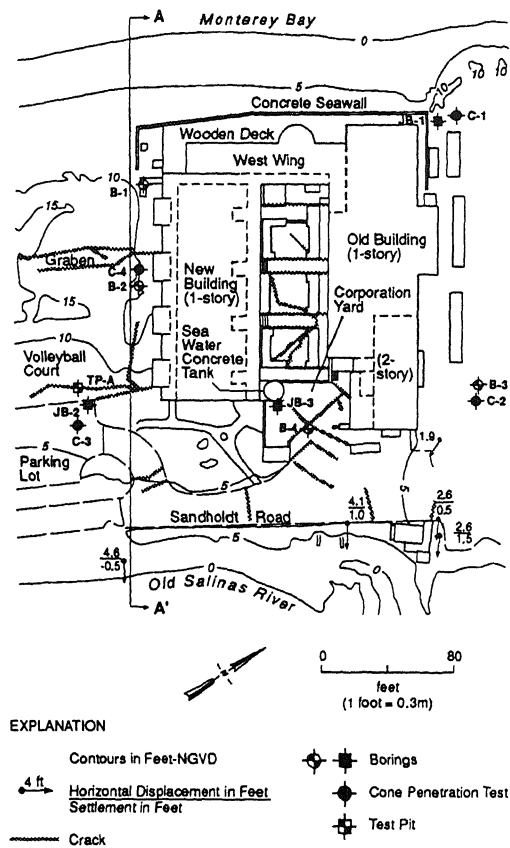
Figure 3. Site plan of Moss Landing Marine Laboratory.

As shown in Figure 3, lateral spreading resulted in extensive cracking throughout the site. The southern building suffered severe cracking in the foundation and slab floor. Cracks up to 15 cms wide developed in the slab and separations of up to 25 cms occurred between building floors and walls. The northern building also suffered severe cracking at the roof and foundation levels with separations in excess of 45 cms at some locations.

upwelling of muddy water through cracks in the corporation yard pavement shown in Figure 3.

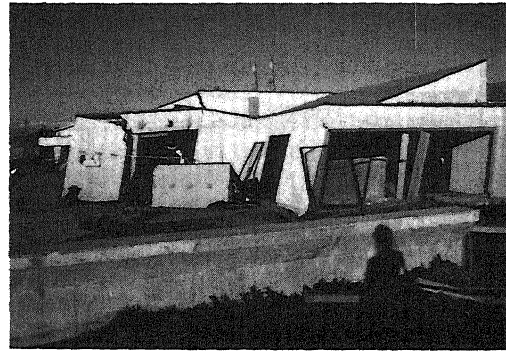
Figure 4. Racking of director's office at south west corner of MLML.

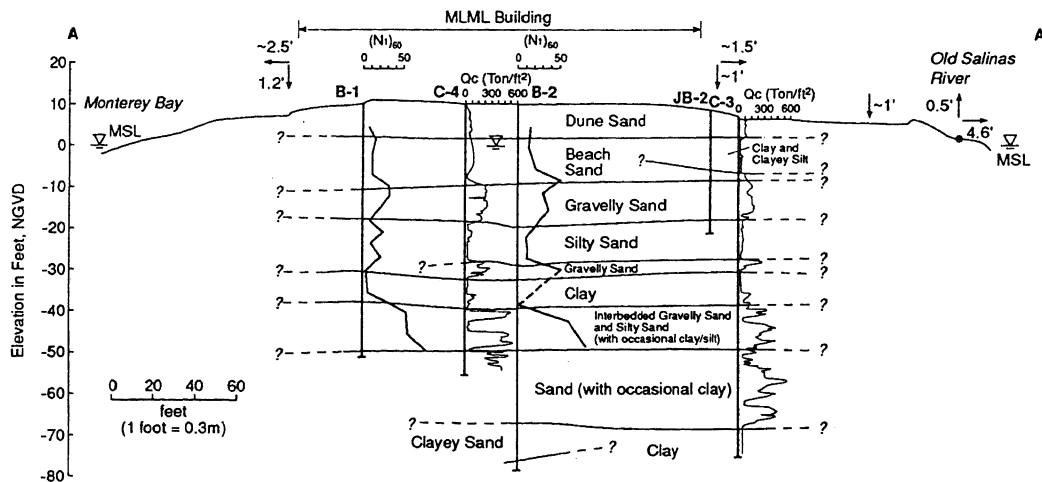
Figure 5. Subsurface conditions at Moss Landing Marine Laboratory.

As shown in Figure 5, the MLML site is underlain by dune, beach, marshland, and alluvial deposits. Ground failure at the site was the result of liquefaction of the loose to medium dense beach sand below the water table including the beach sand below the clayey silt underlying the east side of the site. The soil boil ejecta at the volleyball court indicate that the clayey silt underlying the dune sand in this area also appears to have liquefied (Mejia, 1992).

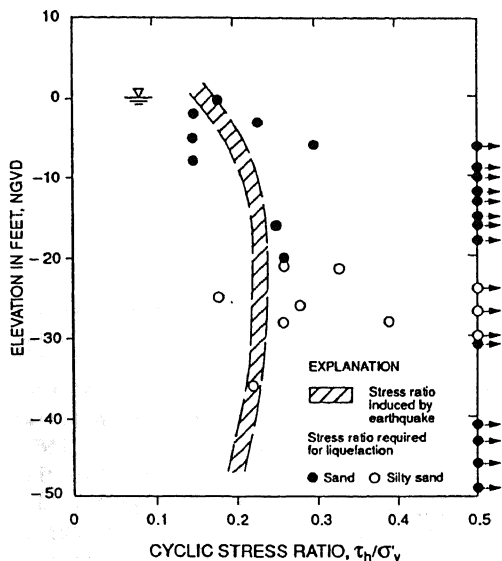
Figure 6. Comparison between cyclic stress ratio induced by earthquake and stress ratio required for liquefaction based on SPT data at MLML.

Liquefaction of the beach sand would be anticipated based on the SPT blow count data from borings at the site and currently available empirical correlations between normalized blow count $(N_1)_{60}$ and liquefaction resistance. Figure 6 shows a comparison between the cyclic stress ratio induced by the earthquake and the stress ratio required for liquefaction calculated using the procedures outlined by Seed and others (1985). The figure shows that liquefaction would be expected in the beach sands. The figure also indicates that the dense gravelly sands probably did not liquefy and that limited liquefaction may have occurred in the silty sand below.

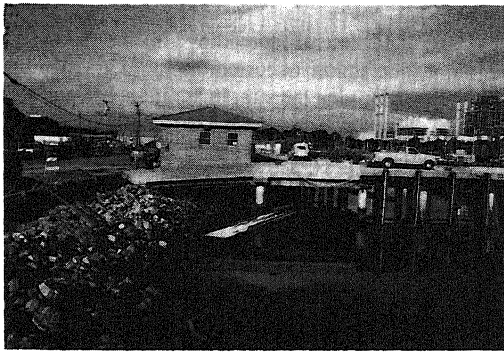
Figure 8. Appearance of MBARI pier three days after the earthquake.

The MBARI pier was essentially undamaged by the earthquake. Figure 8 shows a view of the south side of the pier. Evidence of small movements in the form of minor concrete spalling could be observed at the joints between some of the piles and the deck. Lateral displacements of the edge of the road towards the

harbor were about 25 cms and 8 cms just north and south of the pier, respectively. However, the pier appears to have displaced laterally less than about 3 cms towards the harbor.

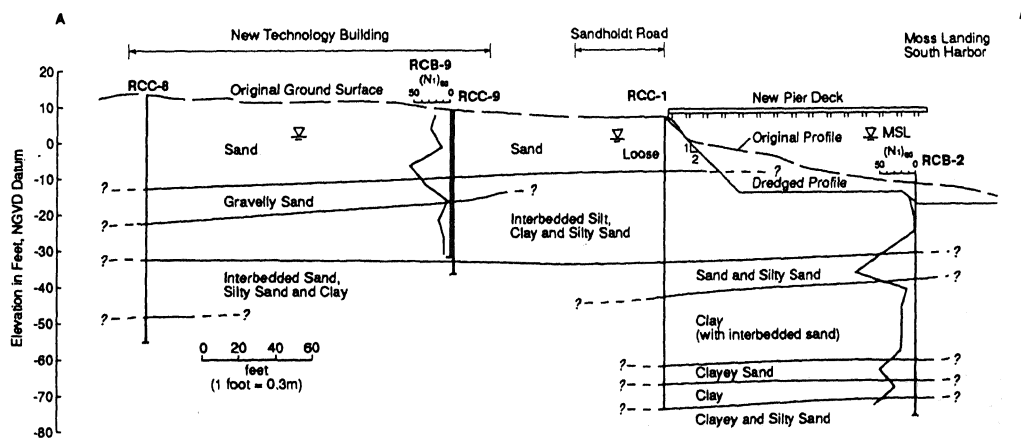
Figure 9. Subsurface conditions at Monterey Bay Aquarium Research Institute facilities.

The soil conditions in the area are shown in Figure 9. Based on the observed lack of damage, it is clear that widespread liquefaction, such as that observed at the MLML site, did not occur at the site of the technology building. The small deformations observed around the building suggest that localized liquefaction may have occurred in the medium dense to dense sand underlying the site. The marked difference in observed performance between the MLML and the MBARI technology building sites appears to be due to the apparently higher density of the near surface sands at the MBARI site.

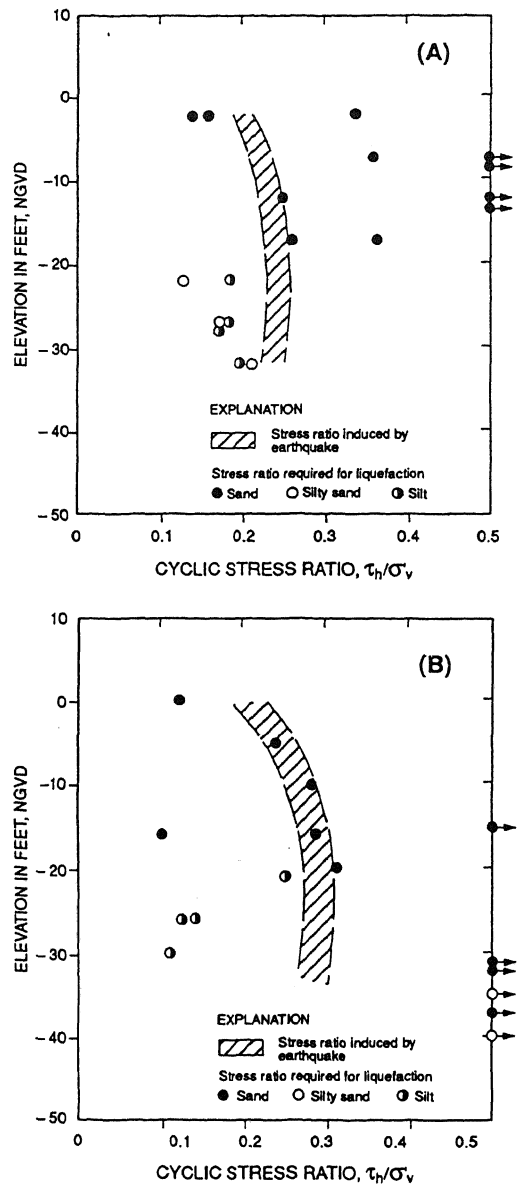
Figure 10. Comparison between cyclic stress ratio induced by earthquake and stress ratio required for liquefaction based on SPT data. A. MBARI technology building. B. MBARI pier.

The apparent distribution of liquefaction at the site of the MBARI facilities is consistent with SPT blow count data at the site and the empirical correlations between $(N_1)_{60}$ blow count and liquefaction resistance proposed by Seed and others (1985). Figure 10 shows a comparison between the cyclic stress ratio induced by the earthquake and the stress ratio required for liquefaction calculated from the $(N_1)_{60}$ blow counts at the site. Based on the SPT data, limited liquefaction would be expected in the sands underlying the technology building. More widespread liquefaction would be expected in the sands in the pier area in good agreement with the observed surface evidence.
