Performance of R/C buildings in the 1985 Chile earthquake

R. Riddell

ABSTRACT: One of the most important features of the March 3, 1985 earthquake in central Chile was the performance of moderate-rise reinforced concrete buildings in the coastal city of Viña del Mar. Most of the buildings were designed with structural walls to resist both gravity and seismic loads. Strong ground motion occurred in Viña del Mar, but only a few buildings sustained serious structural damage. In this paper the general characteristics of the building inventory in the city are described, and the results and conclusions of detailed analyses of the three most severely damaged buildings -Acapulco, El Faro, and Hanga Roa- and two undamaged buildings -Torres del Sol and Torres de Miramar- are presented.

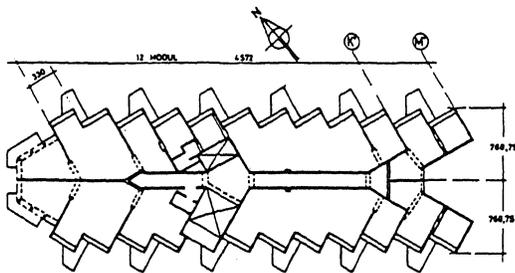
Figure 5. Acapulco building floor plan. Levels 2 to 6.

herring-bone pattern as shown in Figure 5. Walls are not connected by beams, except by shallow ones in a few locations. Properties of the materials specified for construction were: concrete cubic strength of 225 kg/cm^2 (equivalent to 190 kg/cm^2 cylinder strength) and steel yield stress of 2800 kg/cm^2 . Earthquake inspection revealed that twisted bars with yield stress of 5100 kg/cm^2 had been also used, but there was no evidence of the extent it substituted or supplemented the original reinforcement; therefore the analysis of the building was based on the original structural drawings. Walls and slab-wall connections sustained extensive cracking during the earthquake. Wall M' was badly damaged: crushing of the concrete, yielding and buckling of the main reinforcement, and slippage along the construction joints was observed between the ground and fourth levels; wall K' also showed crushed concrete

at the ground level. The analysis revealed that these walls, as well as several other structural elements, were underdesigned according to both allowable stress and ultimate strength methods. The results of modal superposition and response history analyses correlate well with observed damage; the latter method is particularly effective in this case in identifying a more critical condition of the building at $1/3$ and $1/2$ of its height in the transverse and longitudinal directions respectively.

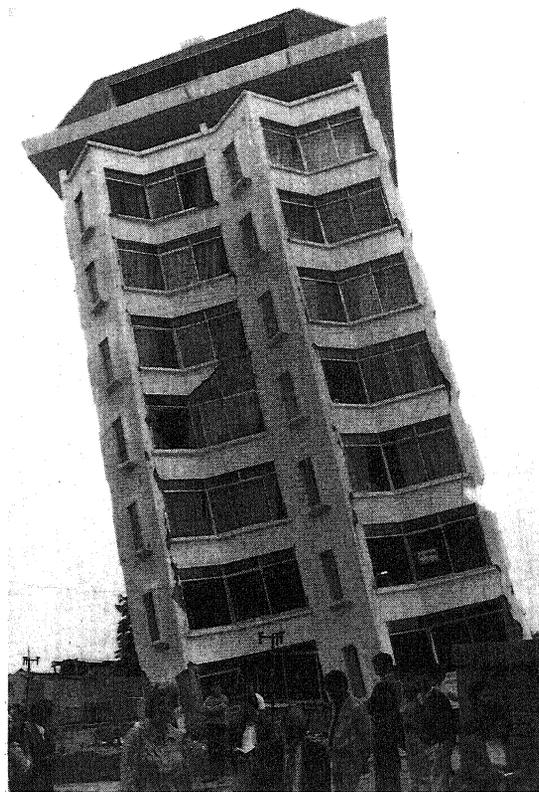
Figure 7. El Faro building. South-west elevation.

This was an eight-story one-basement building built in 1981. Materials specified for construction were: concrete cubic strength of 225 kg/cm^2 and steel yield stress of 4200 kg/cm^2 . The unsymmetrical arrangement of walls resulted in great eccentricity and significant torsional response. The typical floor plan is shown in Figure 6, where dashed lines delineate the basement plan. The building was severely damaged during the earthquake. There was no failure of the soil or the foundations. Damage concentrated in the first story: the wall along

axis M and its adjacent wall in axis D collapsed and the building leaned sharply as seen in Figure 7. Since collapse was imminent, the building was dynamited a few days after the earthquake.

Evaluation of individual members shows a lack of flexural reinforcement in several walls of the first story, including walls M and D, while concrete compression and shear are moderate. Results of the analysis and observed damage correlate well. Wood et al. (1991) investigated the behavior of this building and concluded that the building collapsed after the longitudinal reinforcement fractured in wall M in the first story; the brittle failure was related to underreinforcement, condition that was aggravated by the torsional response.

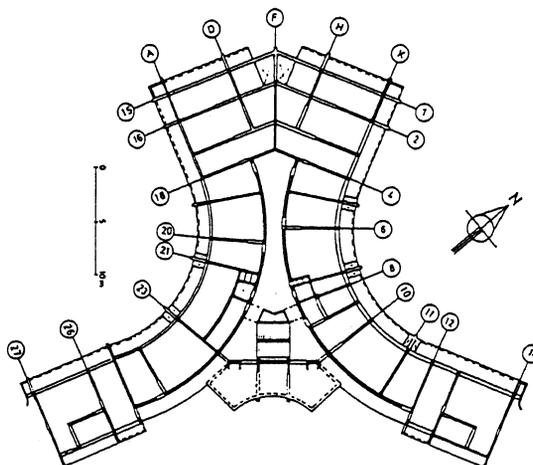
Figure 8. Hanga Roa building. First story plan.

It is a 15-story two-basement building constructed in 1970-1971 with unusually shaped plan as shown in Figure 8. The curved walls along the central corridor have doorway openings staggered in the vertical direction. The resulting one-story-deep lintels suffered severe damage featuring cracks up to 50 cm wide. Reportedly, there had been damage in these elements in a previous earthquake -occurred just after construction was completed in 1971- and had not been repaired but cosmetically. There was also significant cracking of the slab. The building was extensively repaired and retrofitted after the 1985 earthquake.

The analysis indicated that the nominal shear capacity of the lintels varied between 40% to 80% of the required code strength. The lintels also presented insufficient flexural capacity. Again, the results of the analysis correlated well with the observed damage.

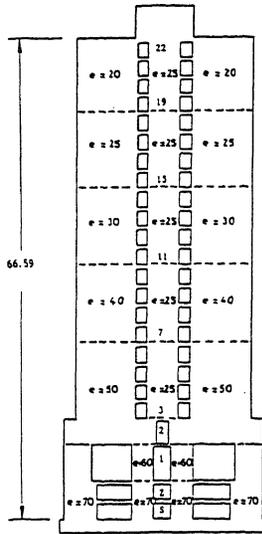
Figure 12. Torres del Sol building. Elevation of axes F and G.

The analysis shows that the reinforcing steel in the exterior walls in axes F-G at the basement and 1st-story levels exceed the allowable stress; these walls are subjected to flexure combined with axial tension for lateral earthquake loading. However, no damage could be seen in these walls even though they must have been driven within the inelastic range. Compression and shear stresses in concrete were in general quite low. Similar proportions to the Torres de Miramar buildings suggest that this building may have also experienced favorable soil-structure interaction effects. This condition, the low concrete stresses, and the symmetric configuration, may be possibly considered as beneficial factors justifying the good behavior of the building.
