# The repair and strengthening of the historic Stanford Memorial Church

C. D. Poland & E. M. Reis

*H.J. Degenkolb Associates, Engineers, San Francisco, Calif., USA*

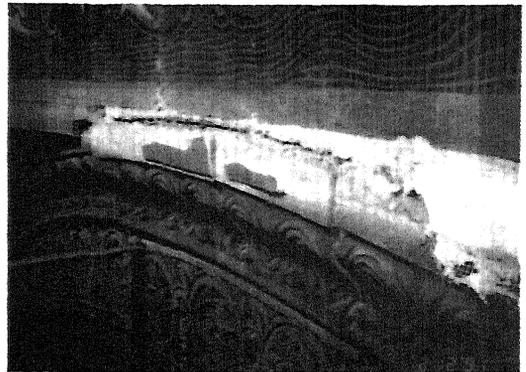
Figure 5: Damage to crossing arches (Loma Prieta earthquake).

therefore, completely unbraced against out-of-plane movement. In the recent earthquake, the arches suffered damage due to perpendicular movement. In the north and west arches, movement was so severe that the bedding and pointing mortar of the voussoir stones was loosened, causing several of the stones to crack and slip down as much as two inches as shown in Figure 5. Many of the unanchored ashlar stones on the face of the arches popped over an inch out from the brick, and some crumbled to the floor.

The most obvious deficiency in the church is the lack of sufficient in-plane and out-of-plane strength in the crossing arches and columns. The lack of any elements to brace and tie one arch to another makes the box very flimsy so that the arches can flex independently of each other and substantially speed up their deterioration under strong shaking. The existing steel frame within the arches was determined to be too weak, too flexible and not well anchored. It is expected that the arch structure would suffer substantial damage or partial collapse in the major earthquake under consideration.

The major thrust of the strengthening occurred in the crossing. The four large arches needed to be braced against out-of-plane movement and substantially connected to the perimeter concrete shear walls. The resulting details are shown in Figure 10. During exploration of the existing construction, a 20-inch void space was discovered within the five-foot thick arches containing the steel frame which had originally supported the clock tower above. This void space around the full perimeter of the crossing provided an excellent opportunity to strengthen the arches from

within. By removing a selected amount of brick from the interior wall of each arch, a complete, reinforced concrete wall was designed within the void space to interconnect the arch structure, provide the needed out-of-plane strength for the perpendicular loads, and substantially enhance the in-plane strength. To complete the perpendicular bracing of the arches, a concrete and steel bracing structure was added to the top of the arches that would work with the existing steel framing to transfer the seismic loads to the available shear walls.

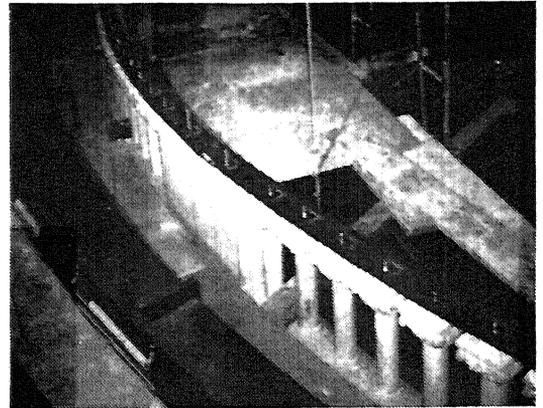
Figure 9: Bracing of balustrade railing at organ loft.

The other deficiencies in the main church relate to various elements of the building. The church lacks sufficient diaphragms to interconnect the tops of the lateral resisting systems and to deliver the loads generated in the heavy roofs to the walls. None of the stone railings have sufficient strength to avoid toppling. Bracing is virtually non-existent in the original Murray-Harris organ, although it is adequate in the newer Fiske organ.

The railings in the galleries and the organ loft were braced by adding reinforcing within each baluster and the stone cap. The railings were carefully dismantled and cored to permit the installation of dowels and steel cap channel or plate as required. The dowels were epoxied into the concrete walls beneath the railing. A typical detail of this strengthening is shown in Figures 9 and 11.
