Observed effectiveness of minimal seismic strengthening of unreinforced masonry buildings

D. R. Bonneville & D. W. Cocks
H. J. Degenkolb Associates, Engineers, San Francisco, Calif., USA

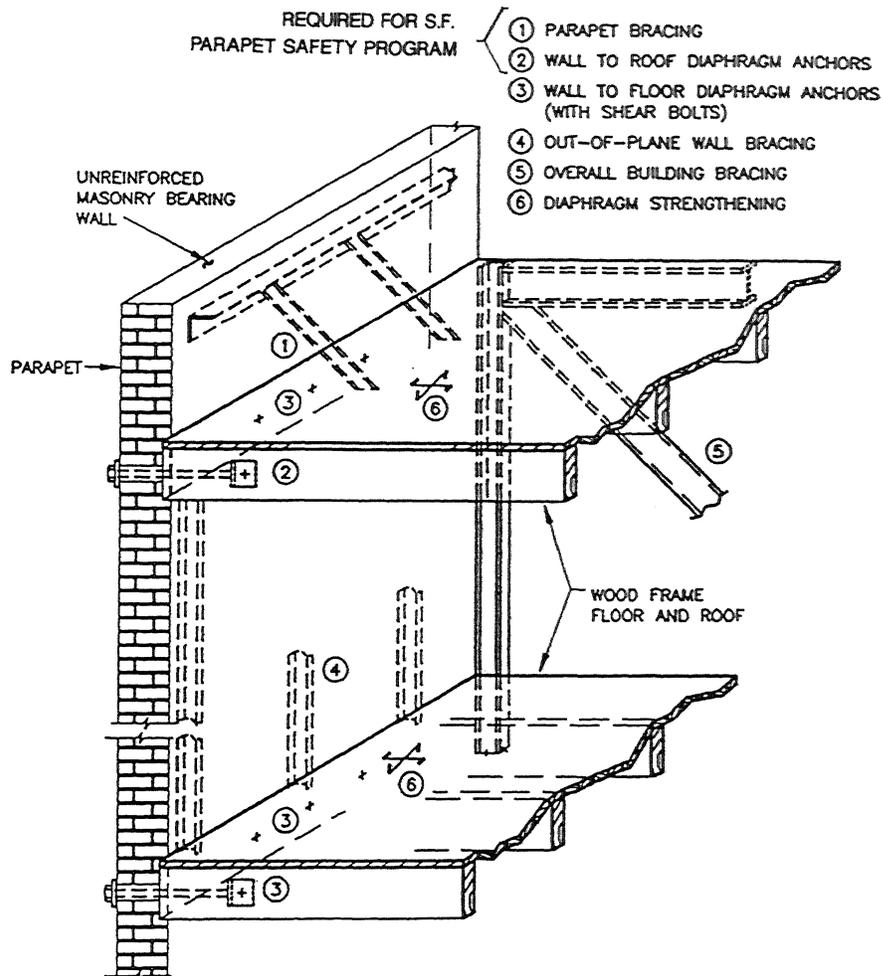
FIGURE 2

SEISMIC STRENGTHENING ELEMENTS FOR UMB'S.

diaphragm anchorage and may include out-of-plane wall bracing, diaphragm bracing, and building bracing, such as shear walls or braced frames. These items are also shown in Figure 2.

Based on observations of past seismic performance of UMBs, the strengthening elements shown in Figure 2 may be prioritized in terms of effectiveness. Generally, the priorities are listed in the following order:

- 1 Parapet Bracing (including wall to roof diaphragm anchorage)
- 2 Out-of-plane wall to floor diaphragm anchorage (including shear bolts)
- 3 Out-of-plane wall bracing
- 4 Shear wall strengthening (in-plane)
