Interpretation of high pressure pipeline damage by liquefaction-induced ground movements

ABSTRACT: During the 1971 San Fernando earthquake, large ground deformations occurred at the Joseph Johnson Filtration Plant along the west side of the Upper Van Norman Reservoir. Recent analyses of aerial photographs taken before and after the earthquake have provided a comprehensive view of lateral and vertical ground movements at the site. Most pipelines in the utility corridor at the site were not damaged, but some pipelines were damaged by the ground movements. The object of this study is to show by numerical analyses why some of the pipelines were damaged while others were not. The analyses showed that for in-situ stress and frictional resistance pertaining to medium dense sand, almost the same magnitudes of stress as that of the yield stress were estimated at a location where tensile failure occurred for Grade-B steel pipelines. But lower stress levels were estimated for x-52 steel pipelines, which sustained the ground movements.

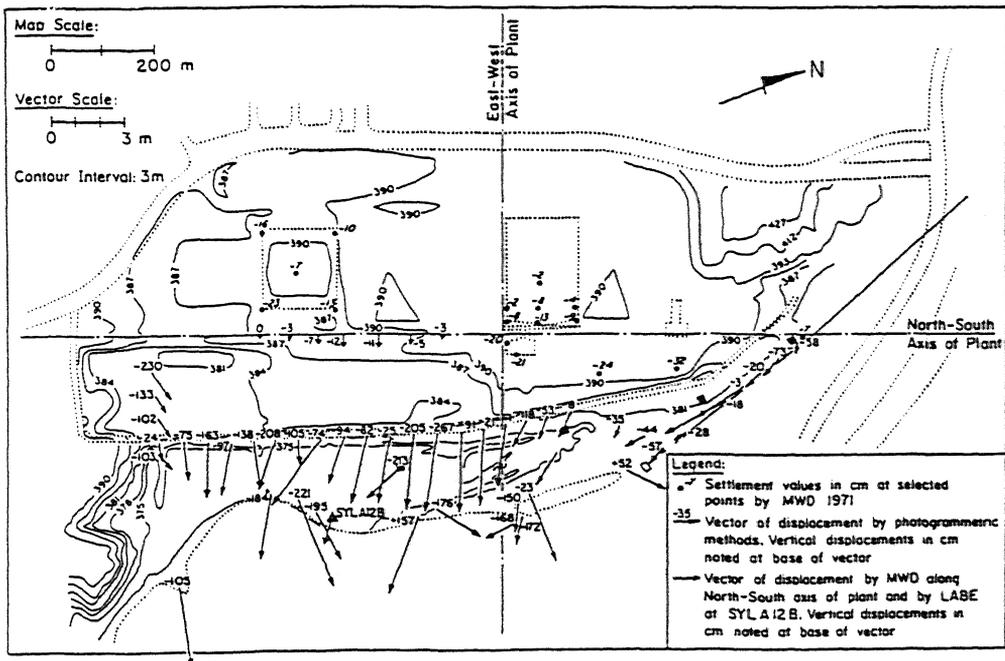
Figure 1. Displacements determined from air photo analyses and optical surveys.

(e.g. Hamada et al. 1985). The results of these analyses are shown in Figure 1 as vectors of horizontal movement and measurements of settlement and heave. Measurement accuracy is approximately 10 to 20 mm for lateral movement and settlement. Optical survey measurements performed by the Metropolitan Water District of Southern California (MWD) are also shown at various locations. For example, lateral offsets surveyed along the north-south plant axis and settlements at several key structures are included in the figure.

The air photo analyses show lateral ground movements along the utility corridor, typically 2 to 3 m, in an easterly direction toward the reservoir. At the eastern terminus of the Outlet Conduit, air photo measurements show lateral soil movements of 1.3 to 2.2 m, which agree reasonably well with the total cumulative movement measured on the ground at this location.

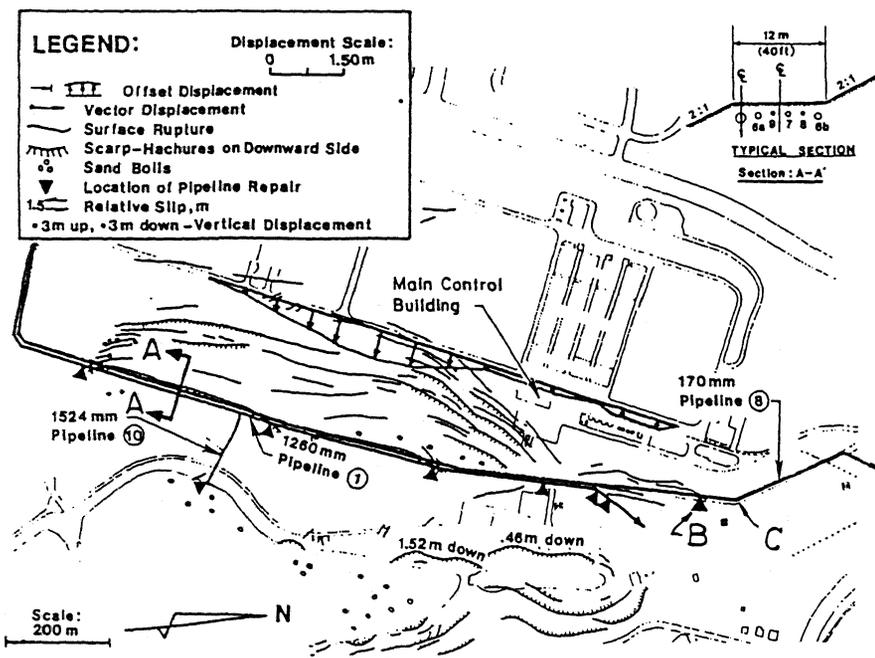
Figure 2 shows a plan view of the area west of the Upper Van Norman Reservoir on which are superimposed ground ruptures associated with liquefaction-induced ground failures in this locality. The locations of pipeline damage were determined from repair records provided through the courtesy of the Los Angeles Department of Water and Power (LAD-

WP) and the Getty Oil Company. The information in the repair records was supplemented by discussions with utility personnel. The locations of pipeline repairs are designated by solid triangles in the figure. Table 1 summarizes information about the pipelines and includes dimensions, installation date, composition, joint type, coating, depth of soil cover, and nominal operating pressure at the time of the earthquake. The outside diameter (O.D.) and wall thickness for each pipe are listed in the column headed dimension. Each pipeline is numbered for the purpose of referencing and corresponds to the numbers used in the Typical Section in Figure 2. In general, the pipelines were buried in medium dense and silty sands above the water table. Transmission pipelines for natural gas, liquid fuel, and water were involved, representing different dimensions, joint design, operating pressures, welding practices, and age. Pipelines operated by the Los Angeles Department of Water and Power and the Southern California Gas Company are prefaced by DWP and SCG, respectively.

Figure 2. Locations of pipeline repairs, west side of the Upper Van Norman Reservoir.

Oil Company, failed in tension across a weld at the northern boundary of the landslide area (Point B in Figure 2). The analyses for pipeline 8 are discussed in the following chapter. Detailed discussion of the damage at other points is given by O'Rourke et al. (1990).

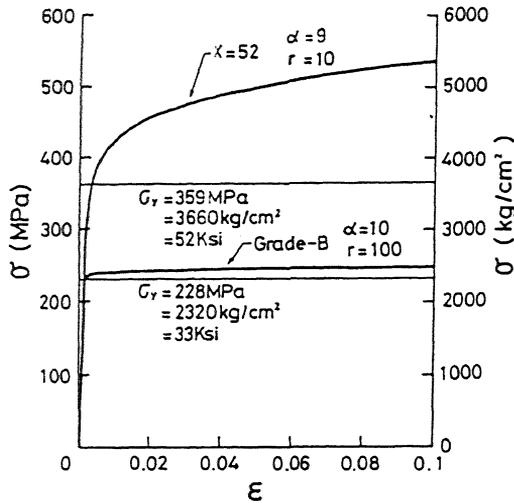
Figure 5. The stress-strain curves for analyzed pipes.

It is necessary to determine the parameters α and r for the analyzed pipes, Grade-B and X-52 steels. The stress-strain curves shown in Figure 5 were used for these pipes. The parameters were $\alpha = 10$ and $r = 100$ for the Grade-B steel and $\alpha = 9$ and $r = 10$ for the X-52 steel.

The yield stresses of the Grade-B and the X-52 steels are 228 Mpa (2320 kg/cm², 33 ksi) and 359 Mpa (3660 kg/cm², 52 ksi), respectively. After yielding, the Grade-B steel has a very flat slope, but the X-52 steel has a steep slope.

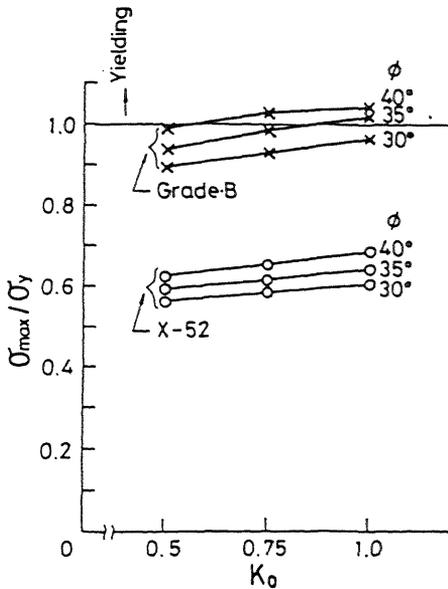
The maximum tensile stresses normalized by the yield stress, σ_{max}/σ_y , obtained from Equation (6) are shown in Figure 6. This figure shows that the stress ratios for the Grade-B steel are almost 1, but much smaller than 1 for the X-52 steel. This means that these stresses are nominally sufficient to yield the Grade-B steel but not the X-52 steel. If the Grade-B steel in pipeline 8 had a relatively flat slope in the post yield portion of its stress-strain curve, as shown in Figure 5, then such stress would be sufficient to rupture the line. In contrast, the X-52 steel in pipelines 6a, 6b, 7 and 9 had both sufficient reserve against yield and ductility to sustain the ground deformation imposed on them. This means that the post-yield slope in the stress-strain curve, as well as the magnitude of the yield stress is very important, when a buried pipeline is subjected to large ground deformation.

Figure 6. The normalized maximum stresses induced in the analyzed pipes.
