# Dynamic behaviors of an earthquake-damaged viaduct before and after being mended

**ABSTRACT:** In Japan, Mizufuka first railway bridge, which is consisted of six single-story Gerber-type RC rigid frame viaducts, was heavily damaged by the Chibaken-Toho-Oki Earthquake having a magnitude of 6.7. The site, where this bridge is located, is steeply varied in the depth of bearing layer, and situated about 80 km away from the epicenter. A major damage to the viaducts was diagonal cracks that occurred in the upper part of the columns. The damaged viaducts were retrofitted by injection of epoxy resin into small cracks and making shear walls between columns transversely. Microtremor and earthquake observation were carried out in the states before and after the mend. The predominant frequency of the mended viaducts is higher than that of the damaged ones, and besides the response of the predominant frequency becomes dull. It is found that the shear strengths of the mended viaducts have increased.

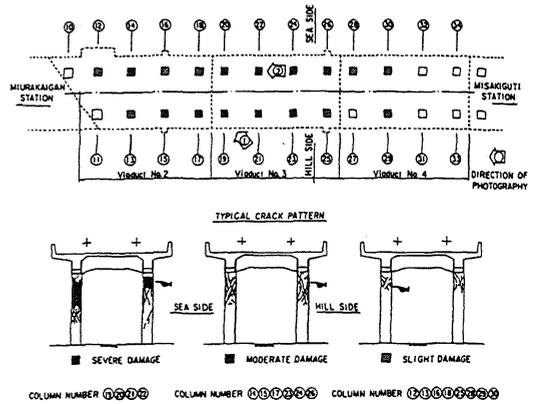
Figure 4. Structural damage distribution of viaducts No. 2, No. 3 and No. 4.

Figure 4 shows a distribution of the typical structural damaged viaducts No. 2, No. 3 and No. 4. These three viaducts suffered severe, moderate and slight damage to the upper part of each column. Moreover, categories of three typical damage patterns are classified as shown in Fig. 4. Photographs 1 and 2 show detail of damage to the columns for viaducts No. 2 and No. 3. The major damage was diagonal cracks in the column of the upper part of viaducts No. 2 and No. 3. Diagonal cracks in the upper part of columns No. 19 and No. 22 are

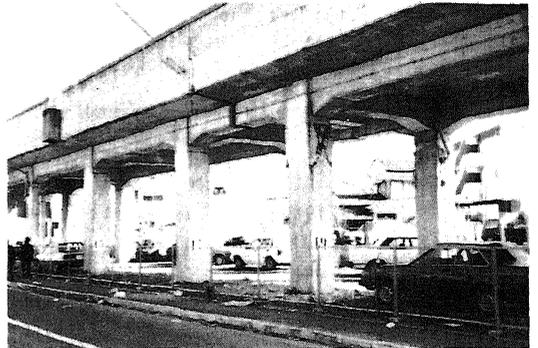
very clearly shown in Photos. 1 and 2. Many small cracks occurred in columns.

Photograph 1. Side View of damaged viaducts No. 2 and No. 3.

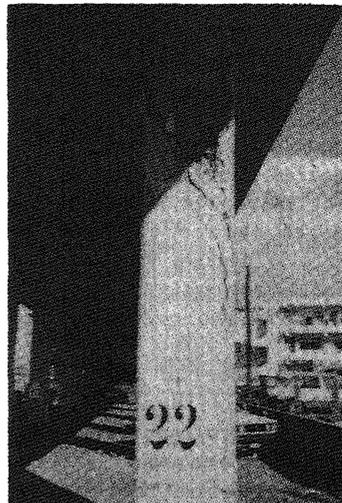
Photograph 2. Shear crack in the column No. 22.

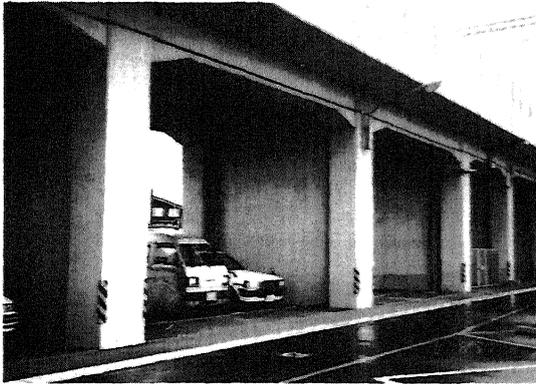
Photograph 3. Side View of mended viaduct No.3.

First of all, Epoxy resin was injected into small cracks in columns. Then, the viaduct was strengthened by newly shear walls. Photograph 3 shows the newly constructed shear walls to the viaduct No.3 of the Mizufuka railway bridge.

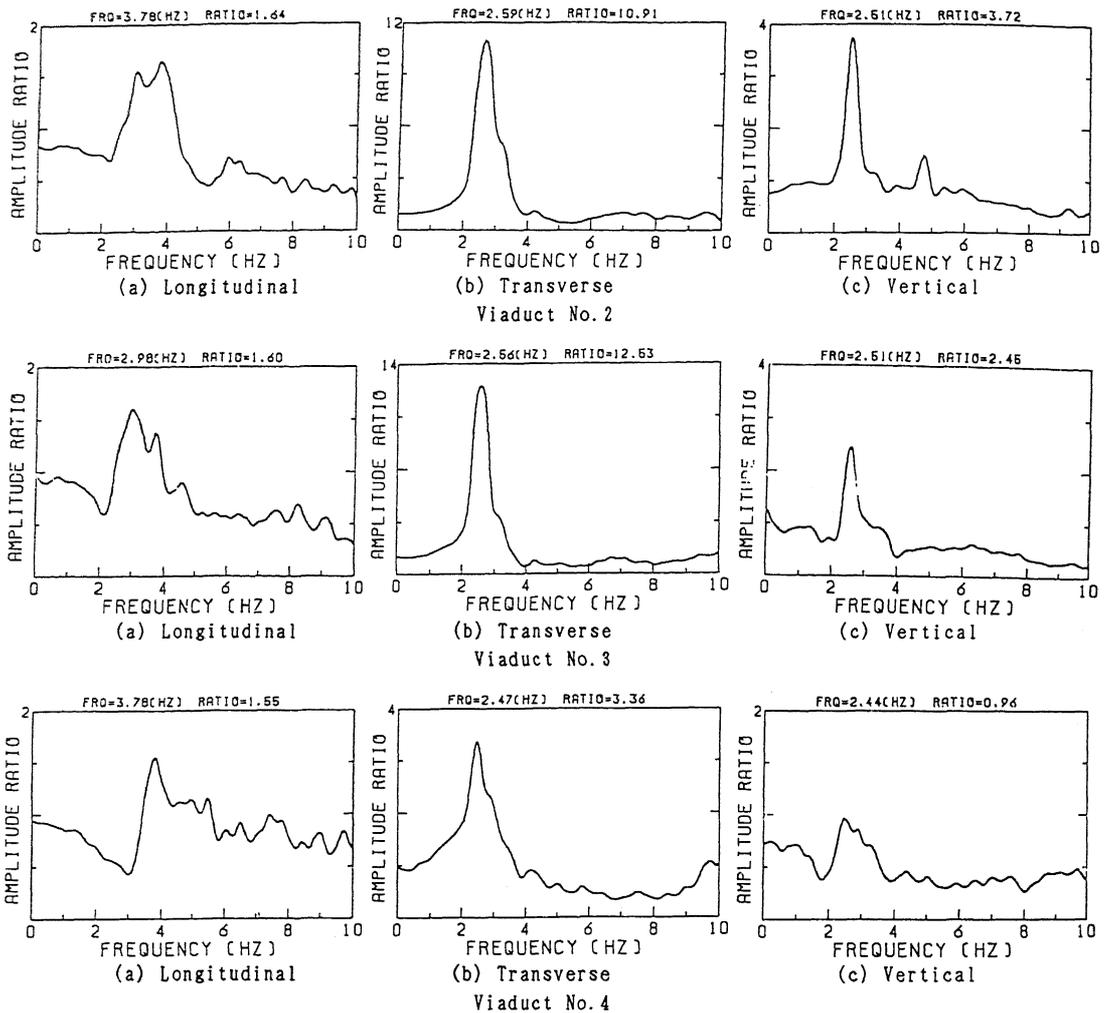
Figure 6. Transfer functions between viaduct and ground in the longitudinal, transverse and vertical directions of damaged viaducts No. 2, No. 3 and No. 4.

Figure 6 shows a transfer function of the velocity time histories between the ground

and the viaduct in the longitudinal, transverse and vertical directions to viaducts No. 2, No. 3 and No. 4. It is clearly seen that the predominant frequencies of the transfer functions of the three viaducts in the transverse and vertical directions are approximately 2.5 Hz and that the predominant frequency in the longitudinal direction is approximately 3 Hz. The amplitude ratio of viaducts No. 2 and No. 3 are greater than that of the viaduct No. 4. This is because the upper part of the columns of the viaducts No. 2 and No. 3 are severely damaged than those of the Viaduct No. 4 (see Fig. 4). A common feature of the response of the damaged viaduct in the vertical direction is predominant.

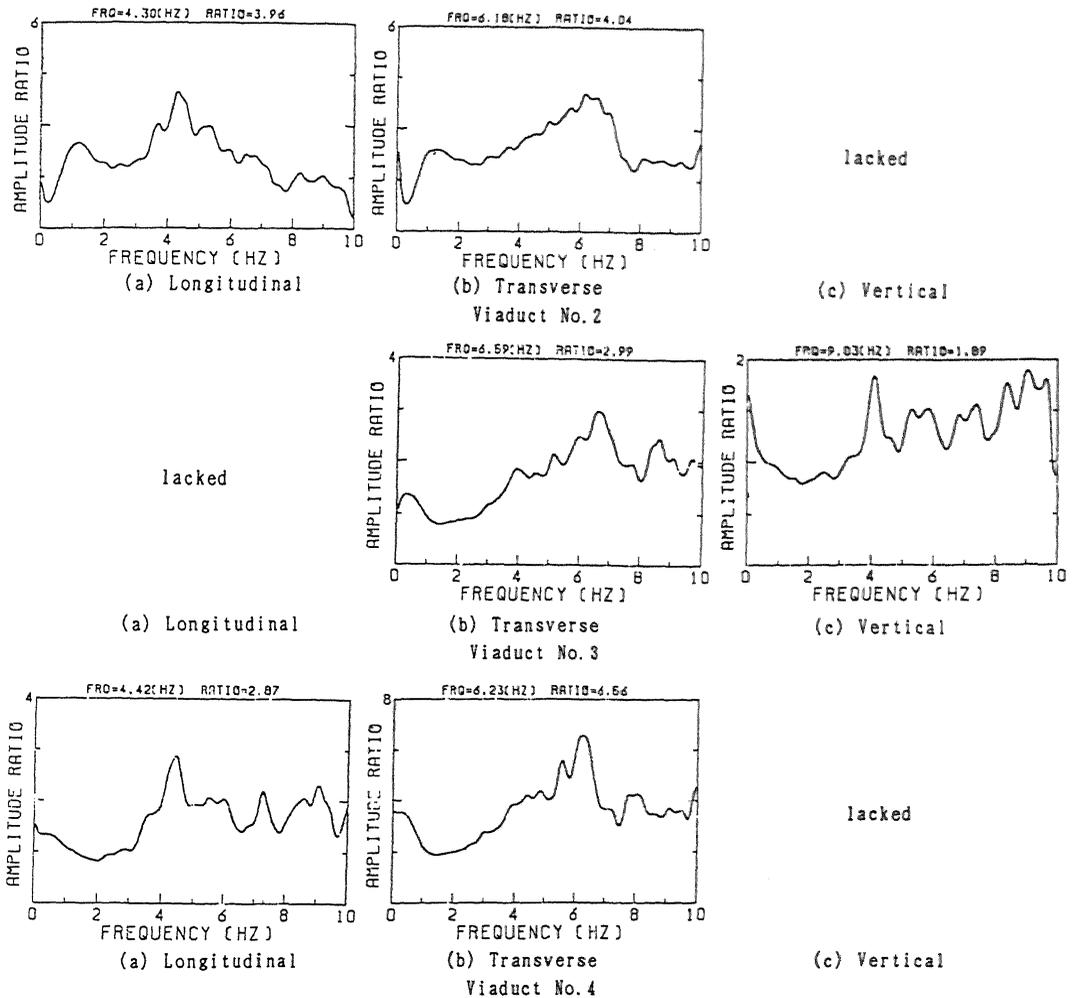
Figure 7. Transfer functions between viaduct and ground in the longitudinal, transverse and vertical directions of mended viaducts No.2, No.3 and No.4.

Figure 7 shows transfer functions of the velocity time histories between the ground and the viaduct in the longitudinal, transverse and vertical directions to viaducts No.2, No.3 and No.4. The transfer function of the vertical direction of viaducts No.2 and No.4 and the longitudinal of the viaduct No.3 are lacked. Predominant frequencies of all three directions are not so clear. The predominant frequencies of all three directions are different; 4.0 Hz in longitudinal direction, 6.0 Hz in transverse

one and 7.0 Hz in vertical one. The amplitude ratio is not so large compared with the damaged viaducts. Moreover, the amplitude ratio of the transfer function in the vertical direction is unity.
