Behavior of lifeline systems during Manjil-Iran earthquake of June 20, 1990

S. Eshghi

Civil Engineering Department, K.N. Toossi University & IIEES, Tehran, Iran

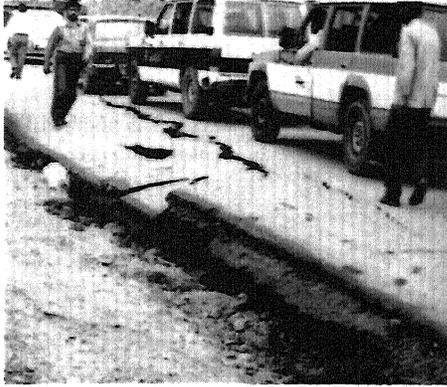
The extent and types of damages of roads due to the main shock and aftershocks of Manjil earthquake were primarily different and dependent on the position of the road section. Namely, road sections passing through wide and flat areas mainly damaged due to the ground settlements as a result of liquefaction or other types of seismically induced ground failures (Fig.3). Contrary, the road sections passing through steep hilly and mountainous regions were much severely damaged due to the local and global soil and rock slope instabilities. In total, more than 1200 km rural roads were needed improvement or reconstruction (Eshghi, 1991a).

Fig. 3 Damage to Rasht-Qazvin highway.

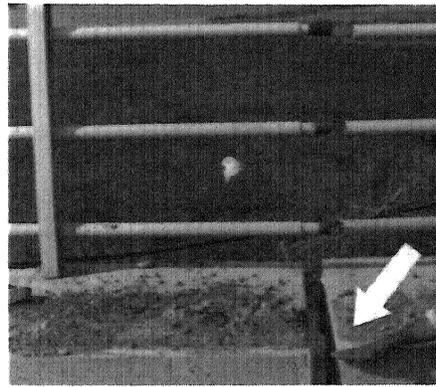
Damage to super-structures, those to bearings supports e.g. failures of shoes, breakage of pins, protrusion of rollers, expansion devices and also pounding of longitudinal girders against each other or against abutments, were most prominent. Some shear cracks occurred at the edges of the bridge seats near the shoes. Differential movements damaged sidewalks, service conduits and guard/hand rails (Fig. 4) (Eshghi, 1991b).

Fig. 4 Displacement of a R/C bridge deck.

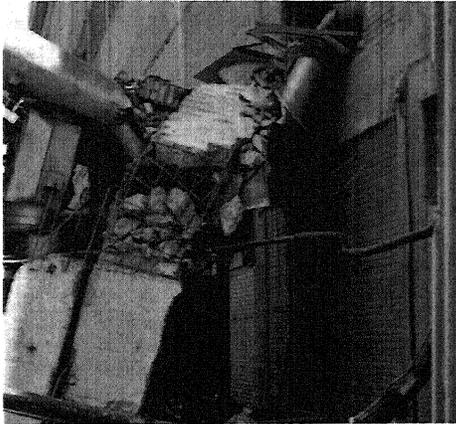
Lowshan power plant (built 1971), was forced to go off the line immediately because of internal station damage. It was located 7 km from Lowshan, equipped with 2x120 MW steam units and 2x60 MW gas turbine units and provided with a 230 kv transformer station. Based on the Ab-bar record which had a peak horizontal acceleration of 0.56g, the resulting PGA for the station was estimated about 0.2g in horizontal direction (Tavakoli, 1991). The bus-duct destroyed due to falling of the non-structural elements (Fig. 5). The foundations of turbo-generator suffered differential settlement and caused misalignment of the turbine shafts. Extensive structural damage also occurred in the plant during the earthquake. Manjil hydro-power plant (built 1963), was located near the earthquake's main fault break. The capacity of HPP was 5x17.5 MW. The framed foundations of the turbines were damaged and one of the steel entrance gates of the penstock was severely deformed by the earthquake. The control room was a reinforced concrete structure which suffered damage due to the collapse of URM infilled walls and other non-structural elements.

Fig. 5 Damage to bus-duct of Lowshan power plant due to non-structural elements.

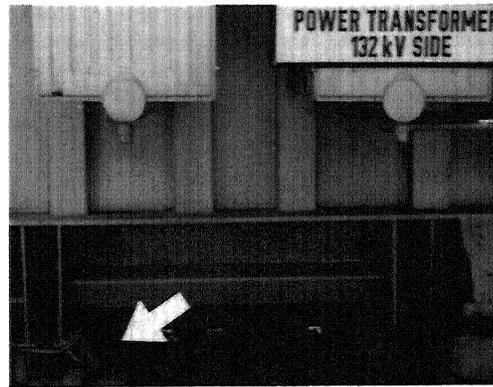
Three electrical substations were failed due to the structural and equipment damage. The equipment damage was attributed to the failure of ceramic components which were primary structural members in many of them. Transformers were not anchored, thus rolled, slid and bounced off their rails or foundation pads (Fig. 6). Temporary restoration allowing basic operation of substations were achieved in a matter of weeks.

Fig. 6 Damage to the transformer support.

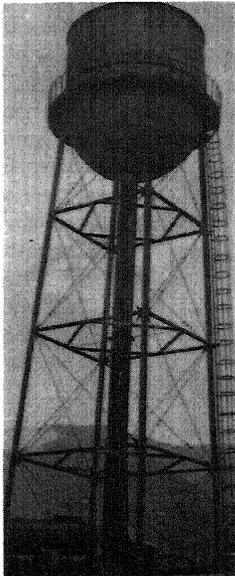
There were many steel and R/C water towers in the flatted areas of the region. Steel water towers performed well during the earthquake, Fig. 7 shows a steel water tower in Manjil, despite of rupturing steel rod-bracing, the structure performed well and remained stable.

Fig. 7 Steel water tank in Manjil, survived the earthquake.

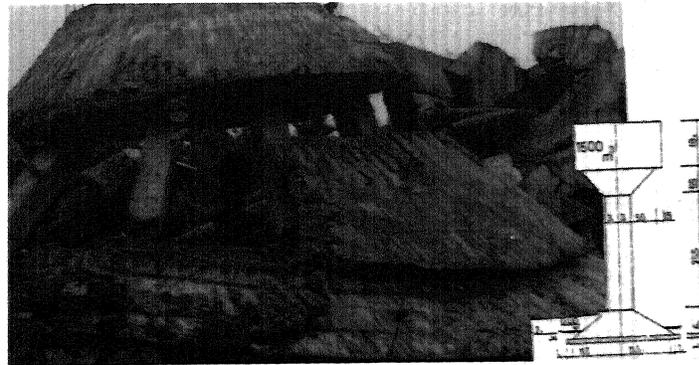
A 1500 m³, 46.5 meter high water tower constructed 25 years ago and supplying the city of Rasht was overturned and totally collapsed after the main shock in Rasht (Fig. 8). The structure consisted of a R/C shaft and a prestressed concrete tank which was about two-third full of water during the quake. Two similar 2500 m³, 46.5 meter high water towers in this city were under final stages of construction when the earthquake occurred, and were thus empty. They sustained horizontal cracks at the perimeter of lower part of the shaft. These water towers behaved like an inverted pendulum during the earthquake and lacked suitable structural form and detailing to withstand seismic loads, hence collapsed (Eshghi, 1991b).

Fig. 8 Collapsed water tower of Rasht.
