THE AMPLITUDE DEPENDENT DYNAMIC CHARACTERISTICS OF AN EXISTING BUILDING BEFORE AND AFTER SEISMIC RETROFIT

Masato MOTOSAKA¹, Takeshi SATO², Yuu YAMAMOTO³

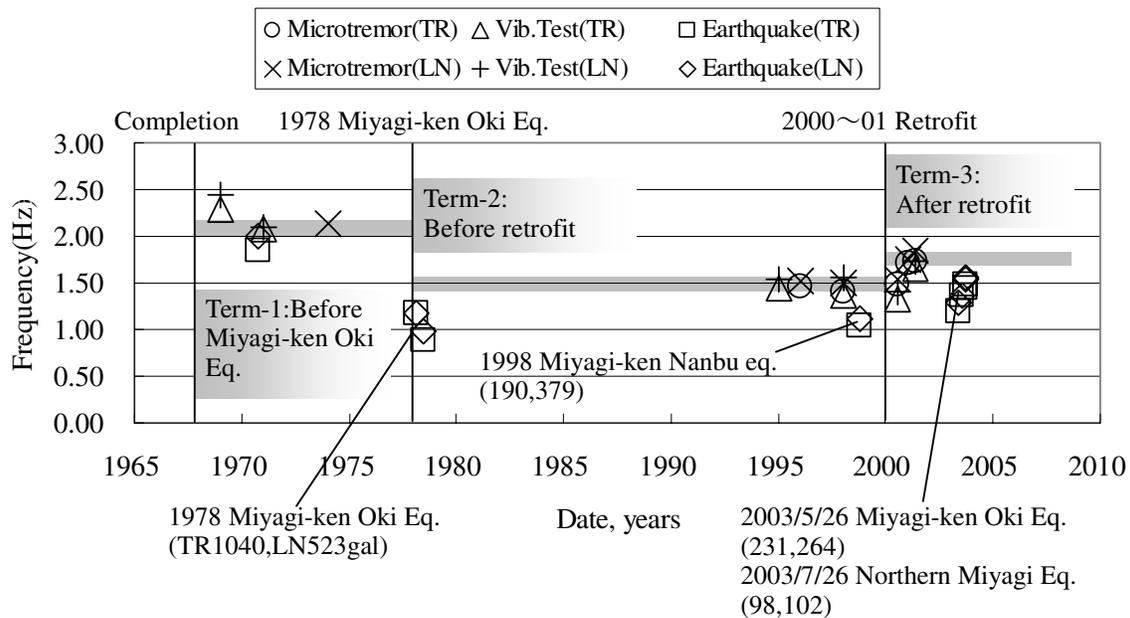
Fig.1 Historical change of fundamental dominant frequencies

The dynamic characteristics of RC buildings changes depending on the amplitude of the deflection of the structure. Different types of observations and vibration tests have been performed to an existing 9-story RC building for 35 years after its completion in 1969 up to date, as shown in Table 1. The building was severely damaged during the 1978 Miyagi-ken Oki earthquake (Shiga et al., 1981) [1]. During this earthquake, the maximum acceleration recorded at 9th floor exceeded 1G, 1040 cm/s², but the repair work in 2001 [2] was the first large scaled retrofit. On this building, some forced vibration tests were performed after the completion times (Shiga et al.,1973) [3]. Continuous earthquake observation and also microtremor observations have been performed. Vibration tests by applying impulsive loads to the ground were also performed using the Air Gun Impactor (Ali and Motosaka, 2001)[4]. These observations made it possible to investigate the change of vibration characteristics of the building for these 35 years.

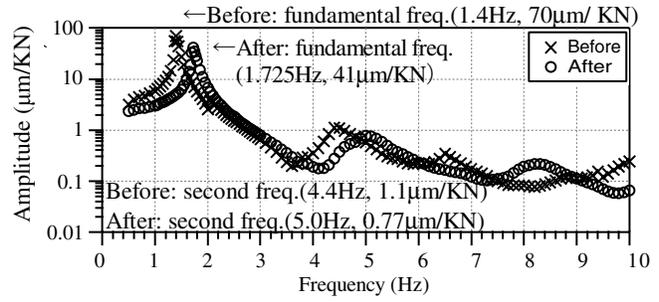
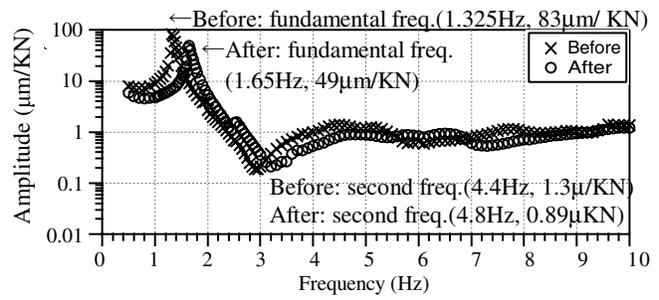
Fig.8 Comparison of resonance curves at center of roof floor for the two tests

Fig.7 shows the resonance and the phase lag curves at the center of 4 floors for TR excitation of the test before the retrofit work. Fig.8 shows the comparison of the resonance curves for the tests before and after the retrofit work. Fig.8(a) is the resonance curves at the center of the roof slab for LN direction and Fig.8(b) is for the TR direction. The vertical axis shows the amplitudes for the unit excitation force, 1tonf. It is recognized that the resonant frequency becomes higher and the amplitude become smaller due to the strengthening in the both excitation directions. In the LN excitation, fundamental frequency changed from 1.40 Hz to 1.725Hz. The corresponding resonance modes are shown in Figs.9 (a) and (b) for the two tests. It is recognized that the torsional component is relatively large as shown in Fig.9(a) but becomes fairly small in Fig.9(b) due to the retrofit, installing the steel braces to depress the torsional motion. In the TR excitation the fundamental frequency changed from 1.325 Hz to 1.65 Hz. Note that the fundamental frequency for the LN excitation was 2.1 Hz just after the completion of the building, and 2.0 Hz for the TR excitation.

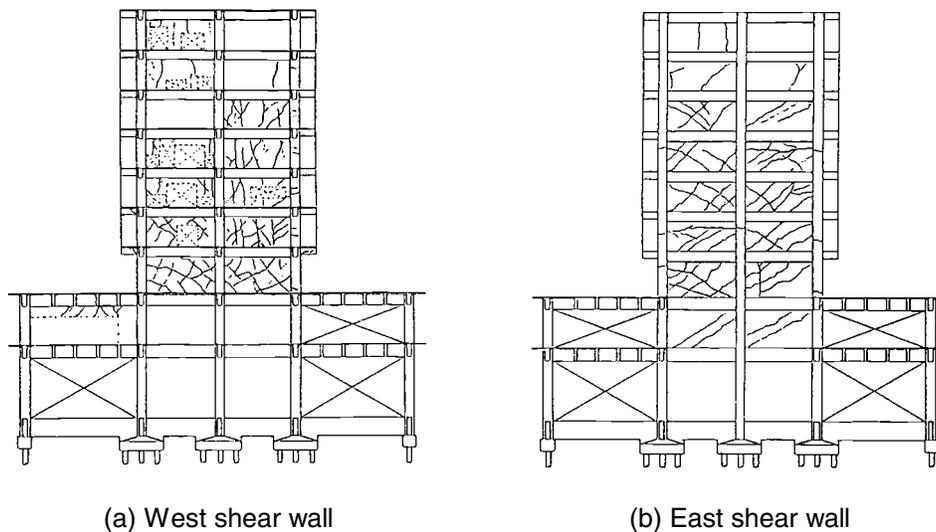
Fig.12 Shear crack distribution due to the 1978 Miyagi-ken Oki earthquake

The results of the system identification are shown in Table 6. The calculated resonance and phase lag curves are compared with the corresponding test results for the case of TR excitation as shown in Fig.13(a). It is found that the remaining stiffness is smallest at the block of 3rd to 6th floor meaning that the portion is damaged more than the other portions. The damage of columns and beams at the higher portion (3rd to 9th floor) in the TR direction seems to be larger compared to the LN direction. This may be explained by the fact that deflection level was larger in the TR direction compared to LN direction during the 1978 Miyagi-ken Oki earthquake. It is also found that damage of west side shear wall is larger compared to the east wall. This is consistent with the damage extent judging from the state of shear cracks as shown in Fig.12.

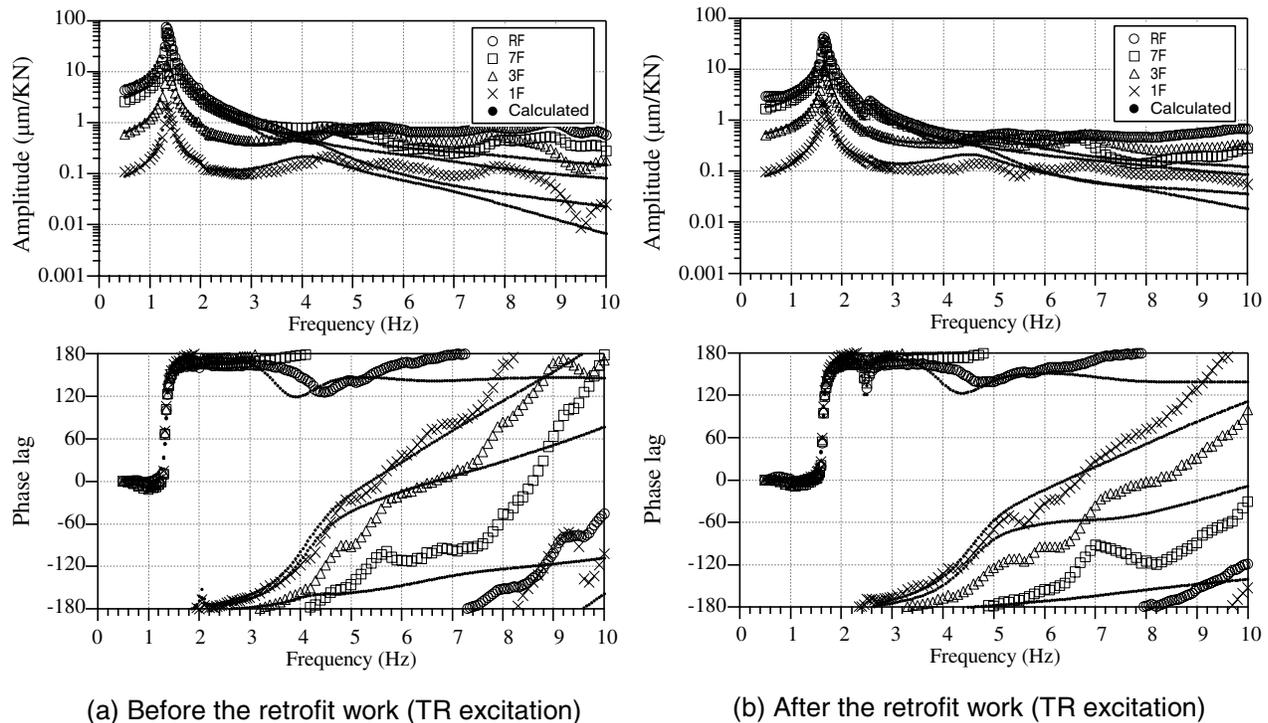
Fig.13 Comparison of calculated and tested resonance and phase lag curves

The results of the system identification are shown in Table 7. The calculated resonance and phase lag curves are compared with the corresponding test results for the Transverse direction in Fig.13.

It is confirmed that the remaining coefficients at the reinforced portions become higher. The stiffness recovery of the side shear walls is remarkable, and the coefficients are now almost the same among them.

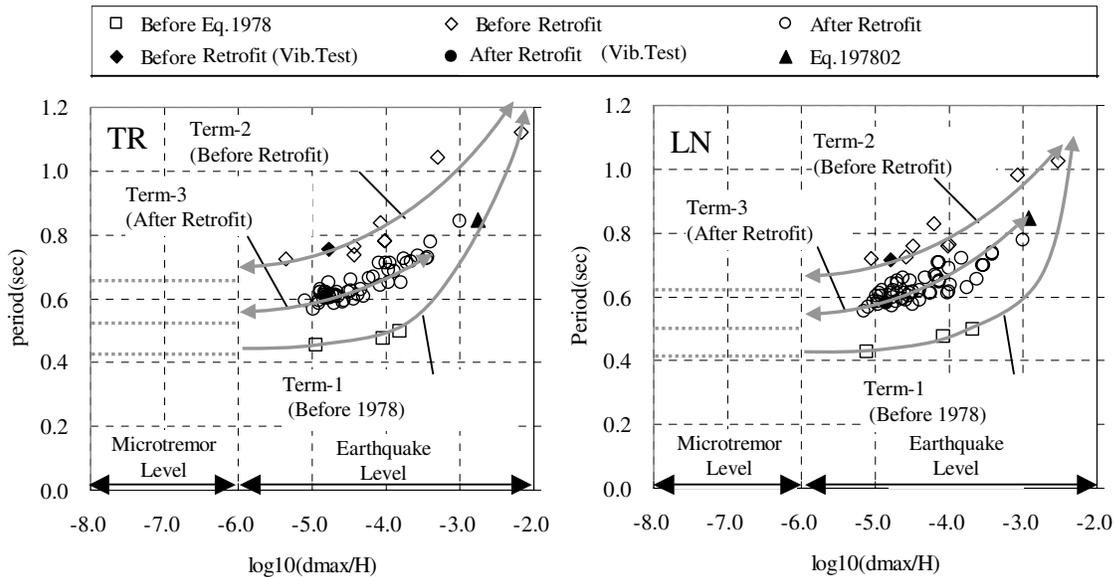
Fig.15 The relation between the dominant period and average deflection angle

In order to discuss the amplitude dependency of dynamic characteristics of the building, the relation between the dominant period and average deflection angle was investigated using the earthquake observation records at 9th floor. The results are shown in Fig.15 for TR and LN directions. The deflection angle was calculated as the apparent value by dividing the maximum displacement by the height from ground to the seismometer. To calculate the dominant period, the Parzen Widow with 0.2 Hz was applied to the Fourier spectral of the record. In this figure, the fundamental periods obtained from forced vibration tests before and after the retrofit work are plotted for the corresponding deflection angles (the symbol \blacklozenge for before and the symbol \bullet for after the retrofit). For each Period, the approximated curve is determined and plotted in the figures. The fundamental periods for the microtremor observations are also plotted in the figure. It is noted that the deflection angle order is about 10^{-2} radian during the 1978 Miyagi-ken Oki earthquake.

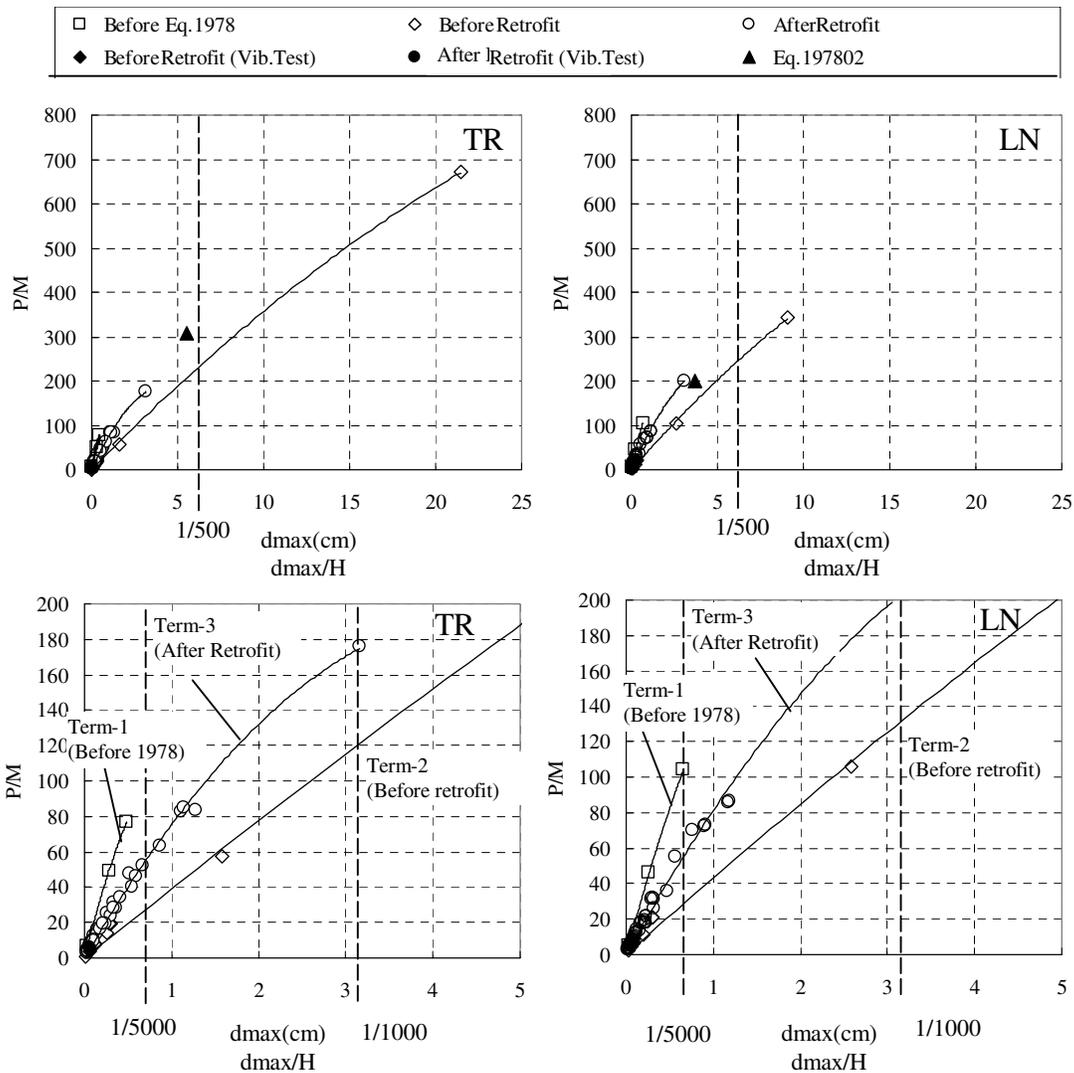
Fig.16 The relation between the force normalized by mass and maximum displacement (d_{max}), average deflection angle (d_{max}/H) (Bottom figures are expansion figures of top figures)

Fig.16 shows the force-deflection relations for the large amplitude range and the small amplitude range. It is found from these figures that the global stiffness in the small amplitude range shows highest values in Term-1 and are reduced by 60% (the remaining stiffness is 40%) in Term-2 due to the severe damage caused by the 1978 Miyagi-ken Oki earthquake. Then, the stiffness is increased 1.5 times after the retrofit work (Term-3) in the deflection angle order of 10^{-3} radian. This is noticed from the earthquake observation records of Term-3 compared to those in Term-2. Namely, stiffness is recovered up to 60% compared to that in Term-1. It is also that the slope of the approximated curves of the relation between the fundamental period and deflection is steeper before the retrofit work compared to the curve after the retrofit work, especially in the TR direction. This means that the amplitude dependency in stiffness is larger before the retrofit.
