**AN EXPERIMENTAL STUDY ON THE COLLAPSING PROCESS OF
WOOD CONVENTIONAL HOUSES
-SHAKING TABLE TESTS OF REAL-SIZE MODELS-**

Mikio KOSHIHARA¹, Hiroshi ISODA², Chikahiro MINOWA³ and Isao SAKAMOTO⁴

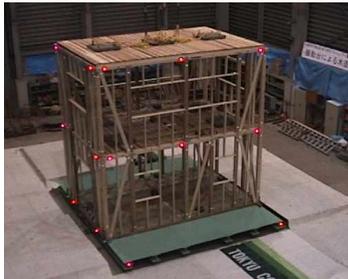
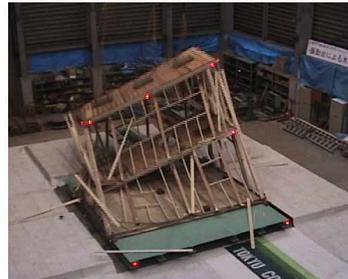
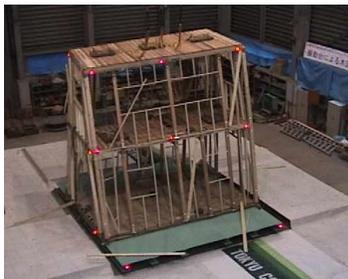
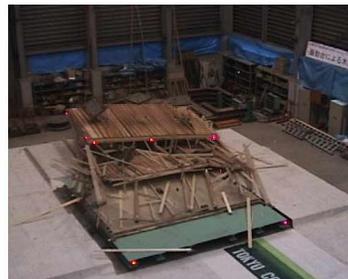
Photo.1 Collapse Process (No.3)

When input motions of JR Takatori records were applied to the houses, No. 1 and No. 3 collapsed at both the first and the second story simultaneously [Photo 1]. In the meanwhile, the house No. 4 to which three-dimensional motions (X, Y and Z) were applied did not collapse, though large residual displacement of 356.5 mm (1/7.4 rad.) at the first story and 314.9 mm (1/9.1 rad.) at the second story were measured (Photo 2).

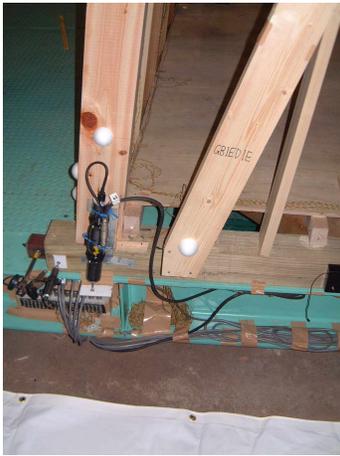
(1) Breaking of Bracing

These houses were damaged and collapsed in the order of (1) falling off bracings [Photo.3(1)], (2) buckling of them, (3) bending failure of upper portion of columns [Photo.3(2)] and (4) splitting failure of ground sills [Photo.3(3)].

The mark X in Fig. 2 (2) shows the time at which buckling and falling off occurred on three bracings (at the first story) located in the X direction. Eventually, all bracings of test houses lost its function because of falling or buckling. The figure shows that damages of all the bracings at the first story occurred near the first peak displacement (2.7 to 4.0 sec.) of input motion.

The collapse started at 10sec. or later, and all bracings lost its function at the time of the maximum (positive and negative) acceleration of input motion. It is considered that the resistance after the breakage of bracings was provided by the moment resisting frame effect of intermediate frame on the frame 4 in Fig.1.

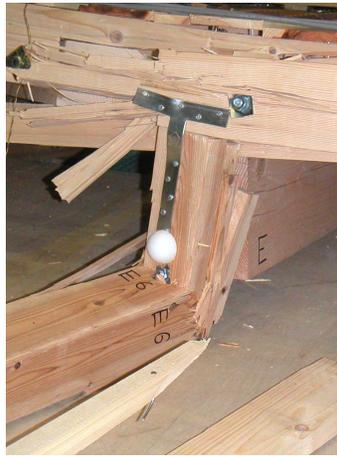
(2) Bending Failure of Column

The mark, black triangle (▲), in Fig. 2 (2) shows the time at which the bending failure of intermediate column occurred at the upper portion, i.e., at the level of the bottom of the beam. It is considered that the bending failure of column head occurred near the time when the relative story displacement at the first story shown in Fig.2(3) exceeded 500mm (1/5.9 rad.). The through columns at the four corners did not break until collapse occurred.

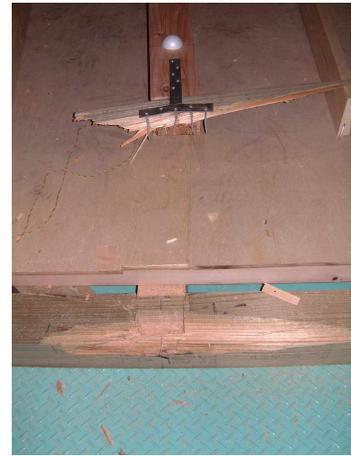
(3) Splitting Failure of Ground Sill

When collapse occurred, the ground sill was splitted at the row of nails of T-shaped plate.
