SEISMIC VULNERABILITY OF SCHOOL BUILDINGS IN LIMA, PERU

Jorge MENESES-LOJA¹ and Zenón AGUILAR²

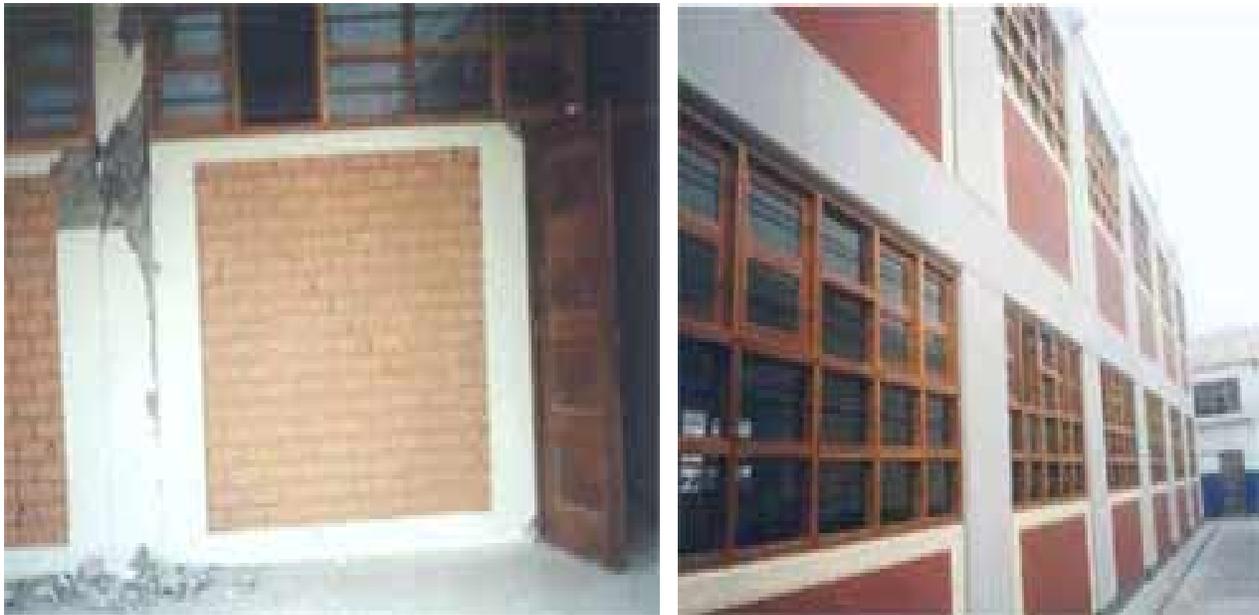
Recent earthquakes in Peru have revealed a high vulnerability of buildings and infrastructure, including school buildings. During the 1996 Nazca earthquake, even new school buildings were seriously damaged. As a result of this experience, a new earthquake-resistant design code was issued in 1997, which is more demanding than the former 1977 code. The seismic performance of school buildings compliant with the new code, made of concrete frames with unreinforced masonry infill walls (quite popular in urban areas of Peru), was successfully tested during the 2001 Arequipa earthquake. In this event, these structures did not present damage at all even though they were located in cities such as Moquegua, where the observed maximum seismic intensity was VIII on the Modified Mercalli scale, and where other similar structures designed and built with the 1977 code were severely damaged (Fig. 2).

Fig. 2 Different seismic performances of two school buildings during the 2001 Arequipa Earthquake. Left: School designed with the 1977 Code (see damage). Right: School designed with the 1997 code (no damage), Bariola [3]

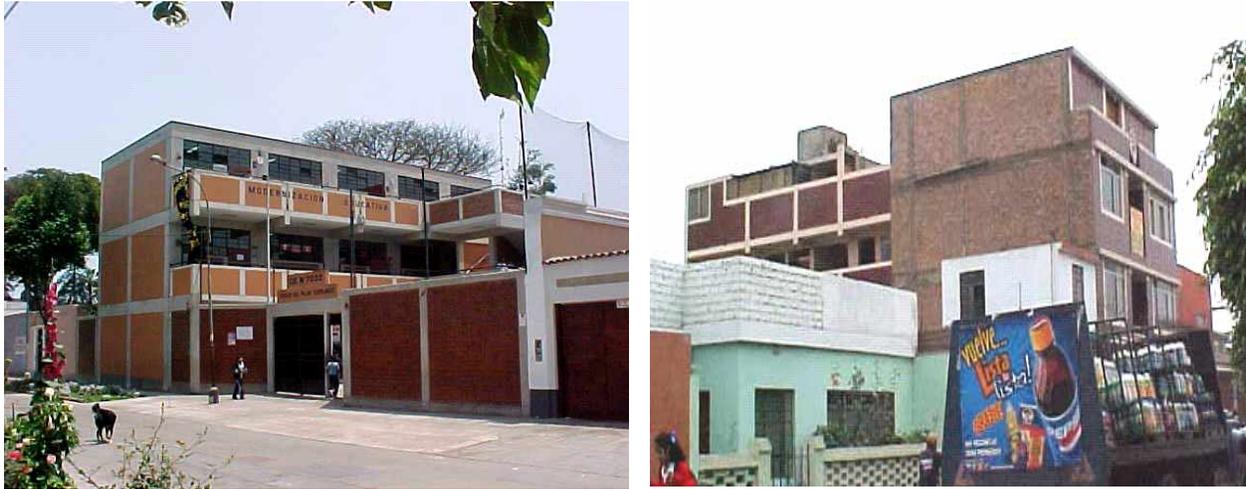
Fig. 6 “Virgen del Pilar” School (C3), and “Mi Peru” School (CM)

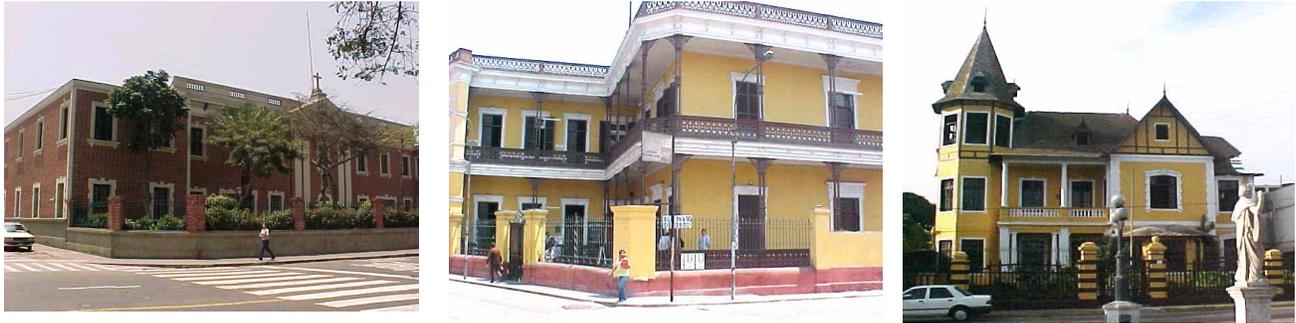
Adobe and wood structures were constructed at the beginning of the last century; as seen in Fig. 7, it is apparent their deterioration due to aging and lack of maintenance. Some of these buildings have changed their use from classrooms into administrative office, reducing drastically the level of occupancy, and therefore their vulnerability.

Fig. 7 From left to right: “San Luis” School (URM); “San Fernando” School (ADB); and “San Julian” School (W)

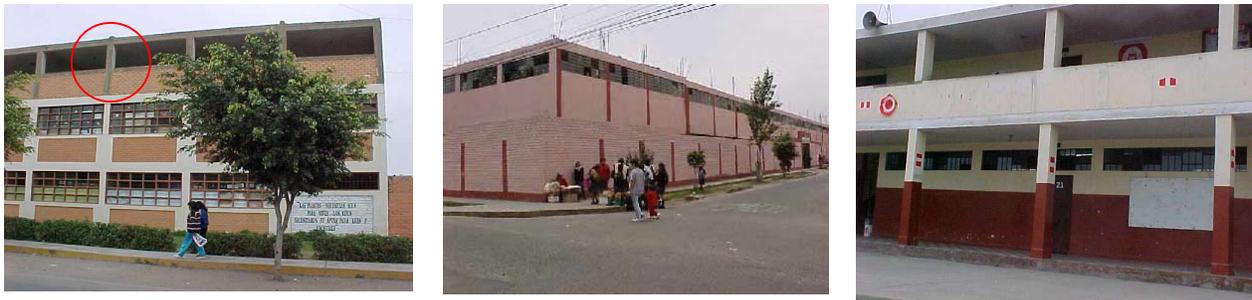
Short column is the major problem in these buildings (Fig. 12), this is true not only for existing structures but for new buildings being constructed without technical assistance. Figure 12 (left) shows a school under construction and encircled a short column.

Fig. 12 Short Columns in several C3 Buildings
