## **HOUSING RECONSTRUCTION AND RETROFITTING AFTER THE 2001 KACHCHH, GUJARAT EARTHQUAKE**

**Elizabeth A. HAUSLER, Ph.D.<sup>1</sup>**

### **SUMMARY**

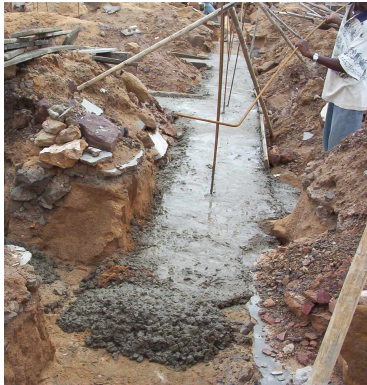
Fig. 2. Unreinforced concrete base layer for strip footing, with vertical steel bars

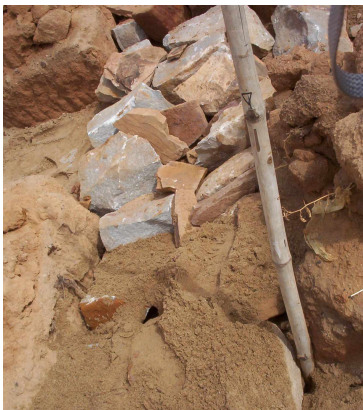
Both foundation approaches allowed by the guidelines were commonly used (see Figs 2-5). In the latter option, the cobbles are laid out, covered with loose sand (Fig. 4), and flooded with water so as to slurry

the sand into the voids between the cobbles. In practice, this procedure rarely fills the voids completely. The support matrix consists simply of the cobbles themselves, which are often rounded and in poor contact with each other and the base of the excavation. Thus a competent support matrix is not formed, leaving the foundation vulnerable to differential settlement under the static load of the walls, which is especially problematic for brittle masonry and earth construction. A tenet of foundation construction in seismic regions is that the foundation should be able to span soft spots so that settlement occurs uniformly; yet this approach *creates* soft spots. Plus, foundations should be connected horizontally to reduce shear forces induced in the structural elements resting upon the foundation. Further, differential settlement due to static and seismic loads is unlikely to be restricted by the unreinforced concrete layer.

Fig. 4. Random cobble foundation covered with loose sand

Further research is required to illustrate the potential for and impact of differential settlement under static and seismic conditions for the foundation approach using cobbles flooded with loose sand. This foundation practice is prevalent throughout India (INTERTECT [20]), and a low-cost alternative should be identified and tested, such as manually crushed, angular hardcore. The level of energy dissipation provided by the common and proposed approaches should be quantified so that the benefits of a reduction in energy transfer can be weighed against the consequences of settlement.

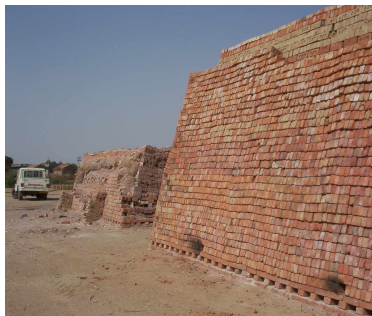
made in coal-fired outdoor kilns as shown in Fig. 7. This process does not burn the brick uniformly. Crushing strength of country-fired bricks varies from 0.3-6 MPa (3-60 kg/cm<sup>2</sup>).

Fig. 7. Kiln for country-fired brick production

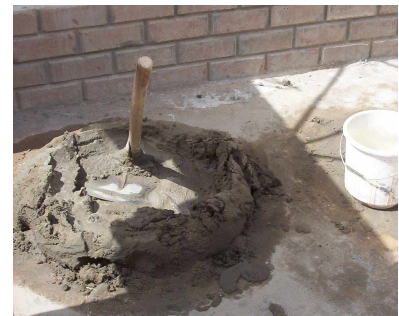
The potential lack of compatibility between the mortar and masonry units may be offset by the quality of the mortar as put in the wall. Mechanical mixers are non-existent in rural Kachchh for low-rise housing construction; instead, mortar is mixed on the ground by hand (Fig. 9). Dry materials are mixed together in a pile that is formed into a circular berm with a hollowed out center portion where water is added. Mixing takes place by gradually pulling in material from the sides. In this process, some of the material on the sides is hydrated for a longer time, producing variations in strengths and consistency.

Fig. 9. Typical mortar mixing

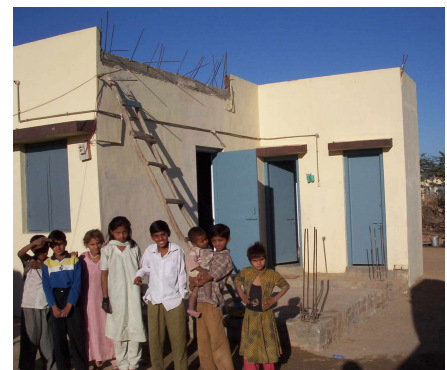
Houses should be structurally capable of supporting extensions, additions, and modifications with inexpensive and locally available skills and materials. If a structure is built with a flat roof, it is likely that a second story will be added as the family expands (Fig. 13). Many foundations for one-story structures with flat roofs were not designed with the possibility of a second story in mind.

Fig. 13. Flat roofed house with preparations for second story

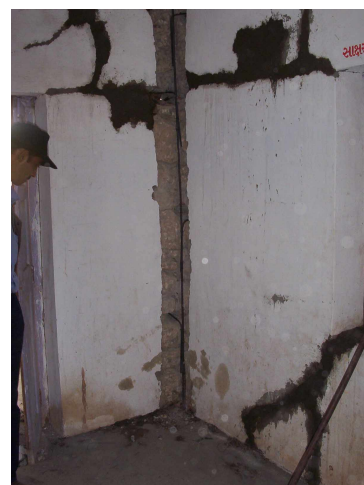
Fig. 15. Vertical bar with shear connectors

In practice, the holes that were made for the shear hooks were very large. Also, in order for this technique to be effective, the concrete should be placed under pressure, or a non-shrink grout used. Neither technique was observed in the field.
