## **THE RECONSTRUCTION OF SAN GIULIANO DI PUGLIA AFTER THE OCTOBER 31<sup>ST</sup> 2002 EARTHQUAKE**

### **SUMMARY**

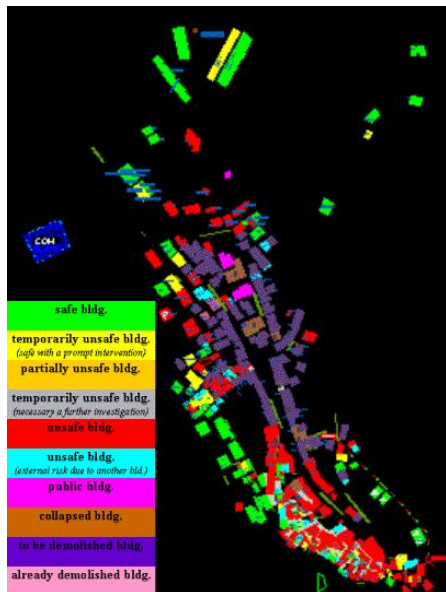
**Fig. 10a. Safe (green), unsafe (red) and demolished (violet) houses**

emergency phase, when the ENEA researchers, in the framework of the SG-TSG activities, carried out a detailed analysis of all the structures. These were classified in (Fig. 10a): severely damaged buildings to be demolished (violet); damaged buildings, which could be repaired and seismically improved (red); buildings that could be used immediately (green). On the basis of this analysis, SG-TSG drafted the demolition plan, approved together with experts of Molise Region, Cultural Heritage Office, Province of Campobasso, National Fire Brigade and San Giuliano Technical Office (in the framework of subsequent and collective investigations). Then, a dedicated team of Firemen performed the work (about 120 structures, Fig. 10b), in presence and in agreement with the owners. Thanks to these and other interventions, it was possible to eliminate the danger and make accessible the principal streets (Fig. 10c), in order to allow the residents to safely re-enter their non-damaged houses (about 10% of the 1200 inhabitants of the village). Recovering, if possible, of personal effects and valuable architectural elements (above all stone portals and balconies, see Fig. 11) was also performed.

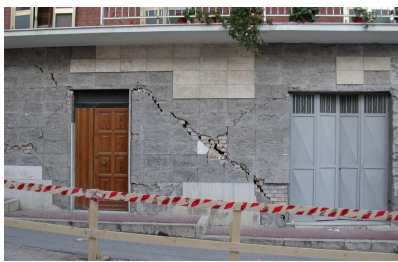
**a) in-plane shear actions**

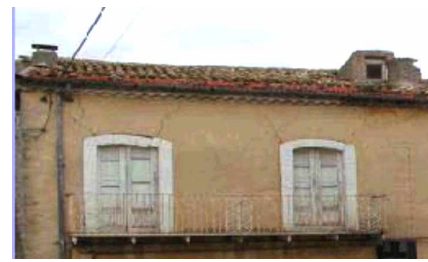
**m) Yielding of architraves**

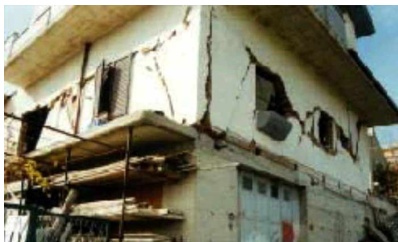
**b) in-plane shear actions in the higher wall belt**

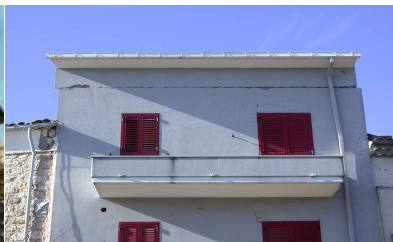
**g) horizontal floor sliding**

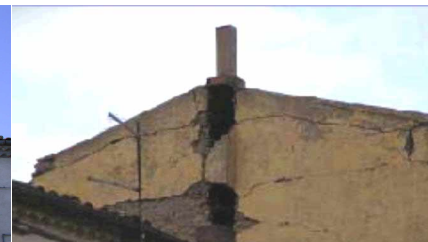
**n) material irregularity, local weakness, etc.**

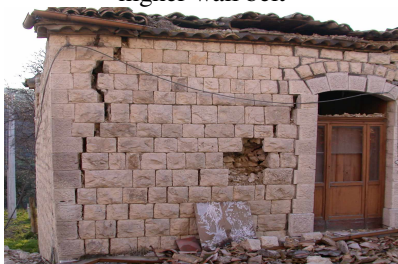
**c) global wall overturning**

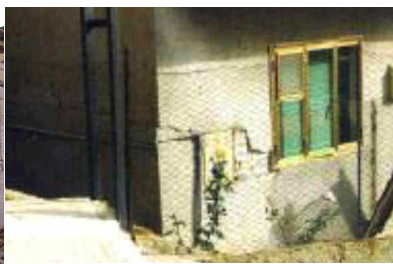
**h) foundation settlement**

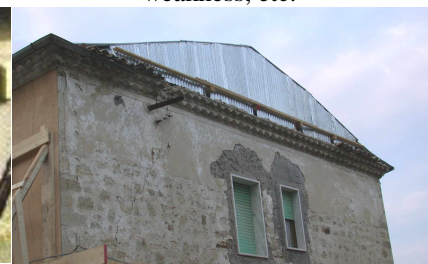
**o) out-of-plane tympanum overturning**

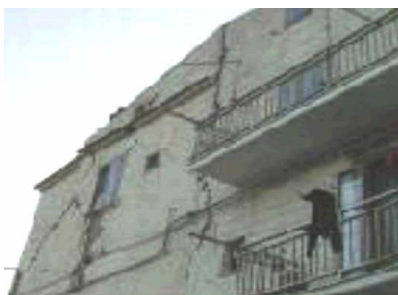
**d) partial wall overturning**

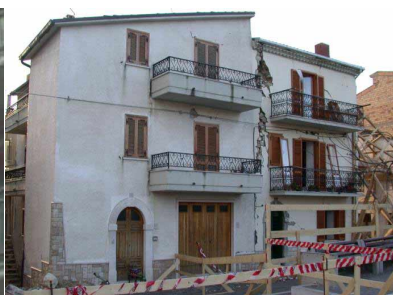
**i) irregularity between adjacent bodies**

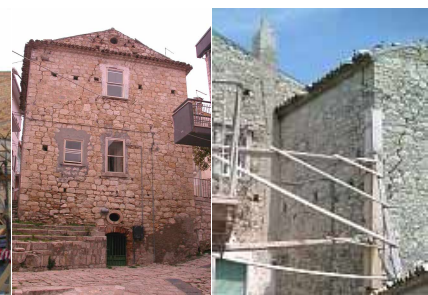
**p) out-of-plane overturning of the superior angle wall**

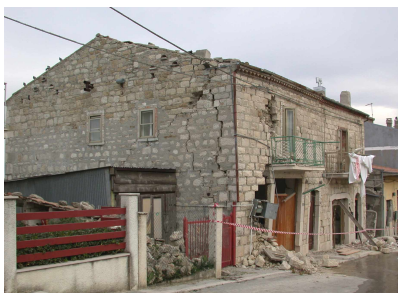
**e) wall vertical instability**

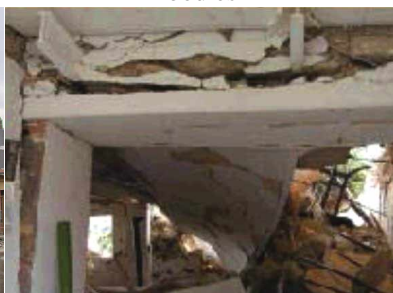
**l) floor beams pulling out from the vertical wall**

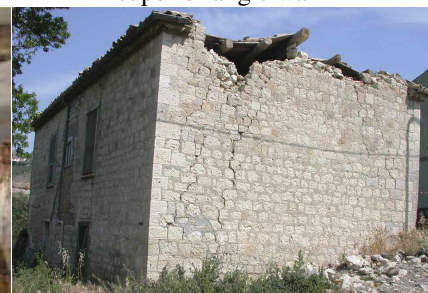
**q) roof wall belt out-of plane overturning**

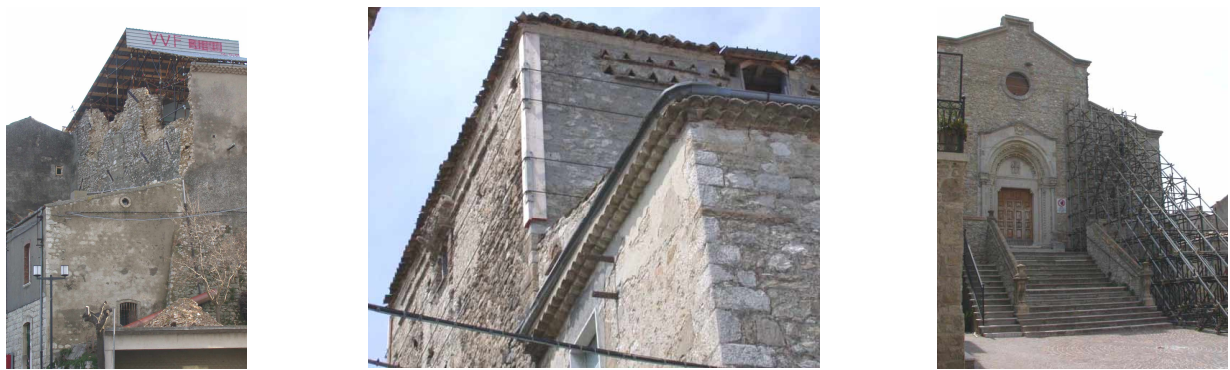
**Fig. 16. Damages to Marchesale Castle and Tower and to San Giuliano Martyr Church**

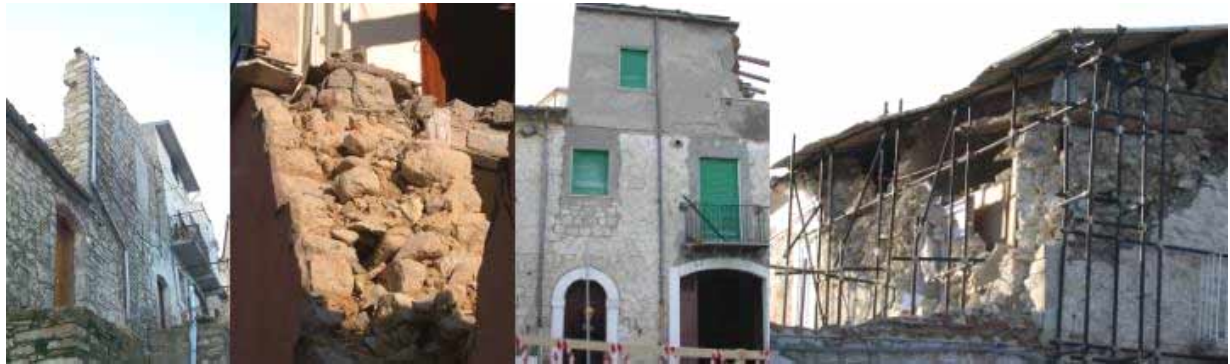
The most usual collapse mechanisms were the wall inflexion with the typical cross cracks. In some cases, recent storey additions and restoration works, made without improving the masonry mechanical properties, caused collapse or heavy damage (Fig. 19). Sometimes the pull out of beams and steel ties from the walls was observed (Fig. 20). Most of the horizontal structures (Figs. 21-22) were steel or timber floors (75%), while only 10% vaults (Fig. 23) and 10% concrete. The vaults supported the seismic action well enough when suitable supports were at the springings; in other cases, they fell down (Fig. 24), when not suitable interventions modified geometry and loads. Masonry foundations often lay directly on the rock, and not at the same level. Moreover, the seismic behavior of many Italian historical centers is also influenced by their structural organization. Often composed by a reciprocally dependent chaotic system of bodies (with height and size in plan very different, without respecting the joints criteria and the maximum suggested building size), they resulted in very irregular stiffness. This situation makes quite complex the interpretation of the structural behavior and almost impossible any numerical modelling. The develop of the saddle zone started in the first half of the twentieth century with masonry constructions and continued in the second half with concrete buildings. The saddle area was characterized by two alignments at the sides of the “Corso”, each of them called “stecca”, composed by different constructions close together (Fig. 25). About 50% of the constructions were poor masonry buildings, 25% good masonry buildings and 25% concrete or mixed (masonry-concrete) buildings. The horizontal structures were steel or timber and the other 50% concrete floors.

**Fig. 17. Building collapse**

**Fig. 18. “A sacco” wall with heavy fill**

**Fig. 19. Storey addition**

**Fig. 20. Pulling out of a steel tie in unreinforced stone masonry**

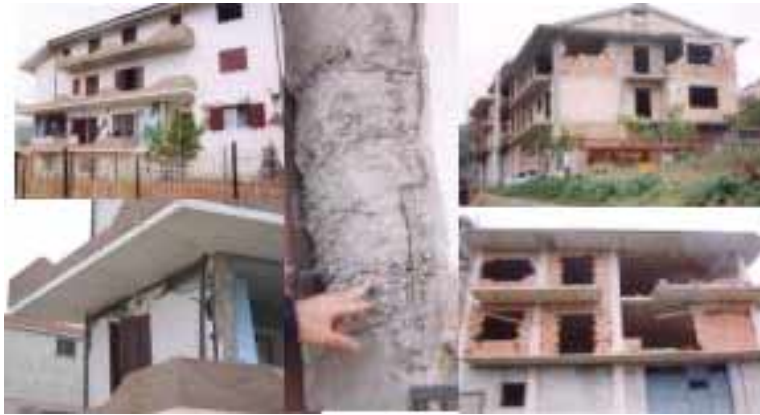
The most impressive feature was that lots of houses were made of stone or perforated bricks, certainly suitable to absorb neither vertical nor seismic actions, especially in presence of subsequent storey additions. The most usual collapse mechanism was due to shear actions (see Fig. 12). In fact, typical cross cracks in the walls could be observed, due to their very low strength, related both to very thin thickness and to the presence of many openings (external and internal, see Fig. 12). Recent restoration interventions often increased the vulnerability, because they introduced heavy concrete elements not well connected to the masonry. In this zone, also concrete buildings showed serious damages (Fig. 26).

**Fig. 26. Damages to concrete buildings in the saddle area**

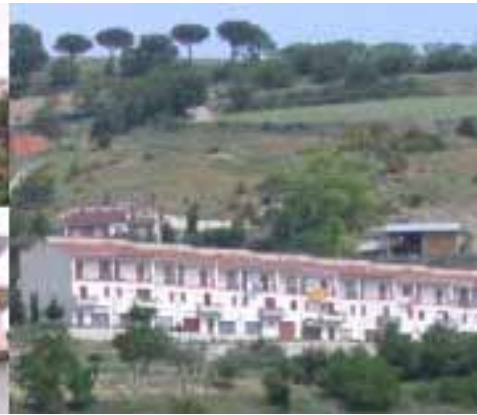
The Northern area had grown in the 50s and modern concrete buildings were built, containing more than one apartment. In general, damages were very low. It is worth noting that buildings almost undamaged have defects (as the absence of seismic joints, see Fig. 27), requiring an anti-seismic improvement.

**Fig. 27. Absence of joints**
