HOW PERUVIAN SEISMIC CODE GREATLY IMPROVED BUILDING RESPONSE TO REAL EARTHQUAKES

Javier PIQUE¹, Peter MARTEL²

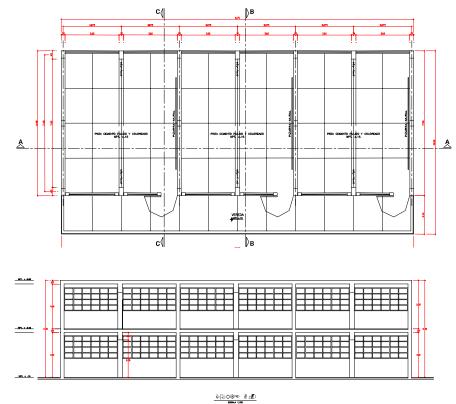
Figure 8 Elevation and first floor plan of school buildings

Structures shown in Figure 8 (1977 Standard) are built with reinforced concrete frames in the longitudinal direction, although, as can be seen in the plan view, columns are oriented with the strong axes in the transverse direction, because of gravity load framing. This is a flexible direction.

In the transverse direction seismic resistance is provided by solid confined masonry, being this a very stiff system.

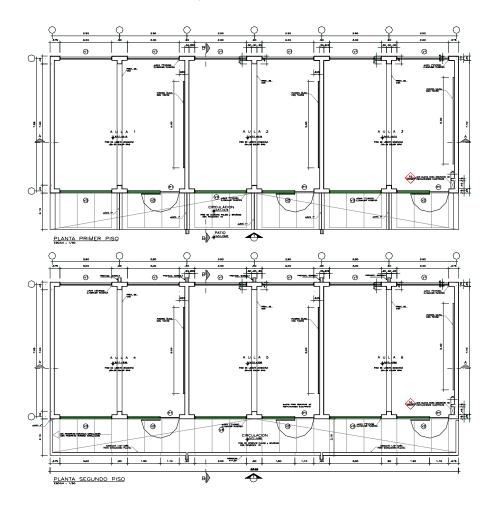
Figure 9 First and second floor plan of school buildings designed with 1997 Standard. Note T shape columns which provide larger stiffness in longitudinal direction

Schools shown in Figure 9 were designed with 1997 Standard and columns have now small flanges in the longitudinal direction giving the structure a higher stiffness. In the transverse direction the seismic resistance system is the same based on masonry walls.
