## Lessons From Jan, 26, 2001 Gujrat (India) Earthquake

P.B.BOKEY<sup>1</sup>, P.S.PAJGADE<sup>2</sup>

Authors have done extensive post earthquake survey of Jan 26, 2001, Bhuj earthquake. Based on the post earthquake survey, important points are highlighted.

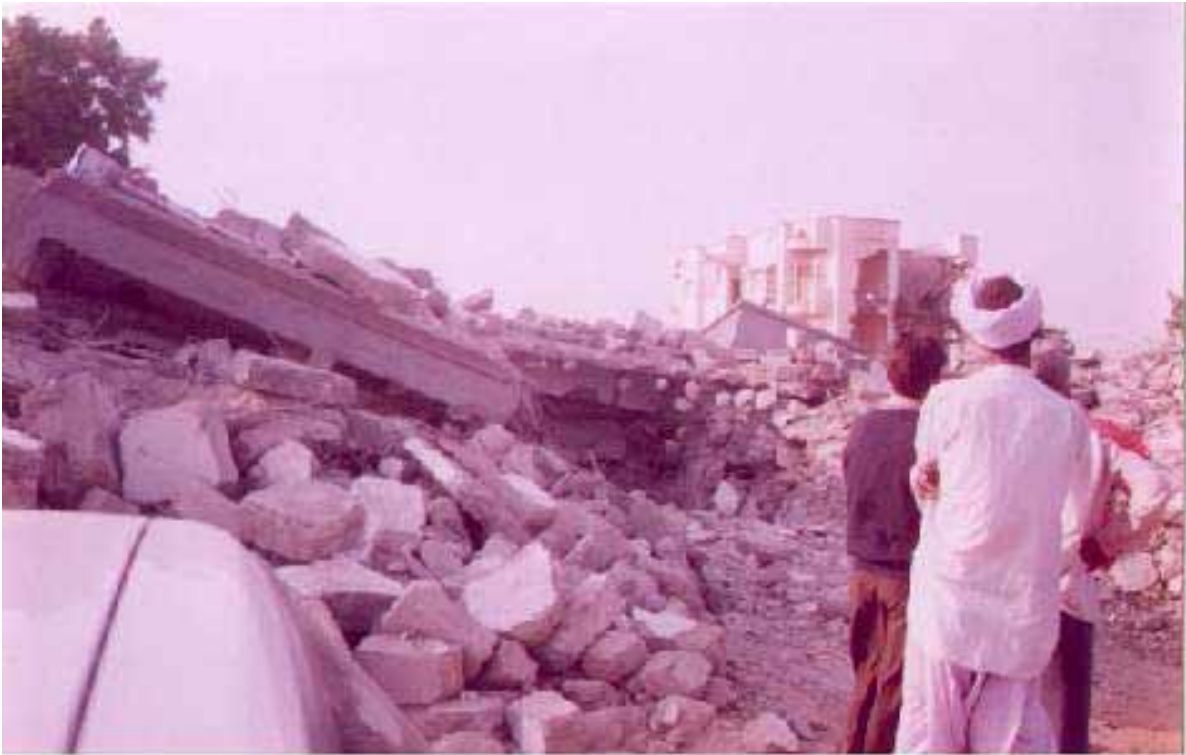
Photo No. 1 : Total Collapse at Bachau 18 Km. From Epicenter.

- a) The masonry wall, mainly in mud mortar.
- b) Absence of connecting band.
- c) No through stone were provided.
- d) Heavy mass concentration at roof level.
- e) Buildings were close to each other.
- f) Unsymmetric buildings, due to full opening at its front resulting into torsional moment on the buildings

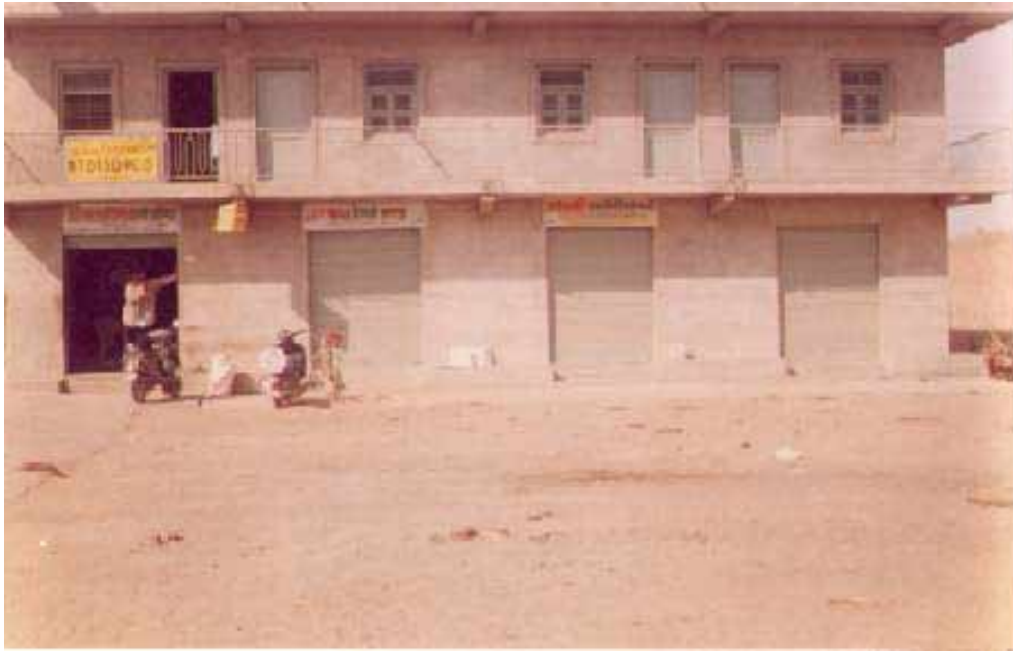
Photo No. 2 : Intact Two Storied Load Bearing Structure At Madhapur.

Above buildings are perfectly alright without any damage. The reasons are listed as follows –

- a) Symmetric building.
- b) Structure with bands at sill level, lintel level.
- c) Appropriate size and location of the openings.
- d) Quality workmanship

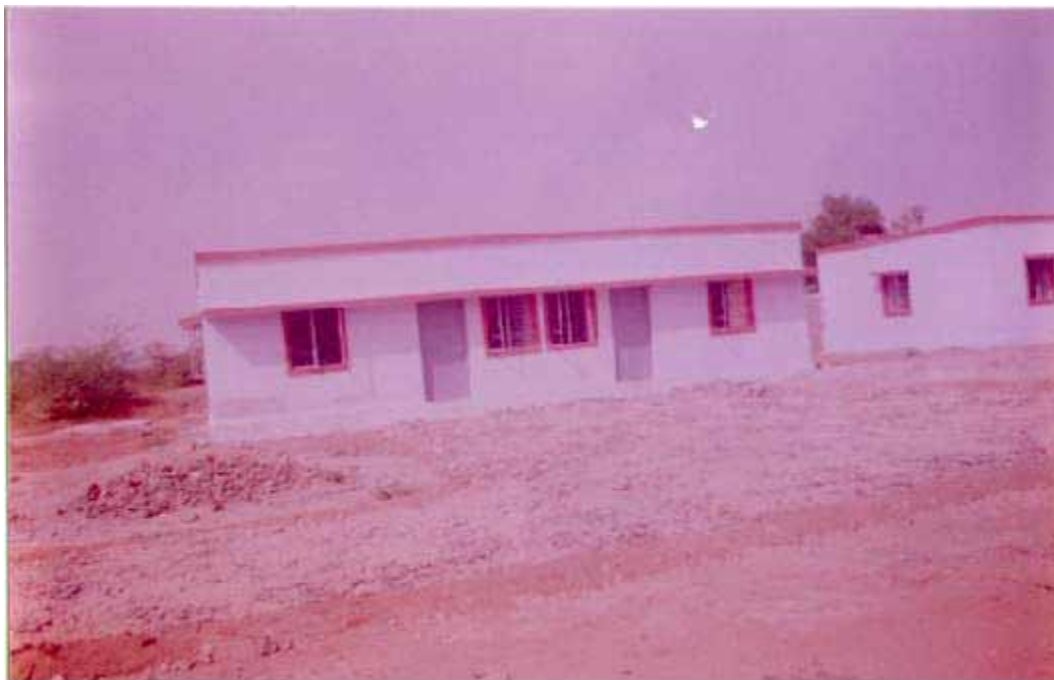
Photo no.3: Intact Single Storied Load Bearing Structure of Railway quarters At Aundh, 20 km from epicenter

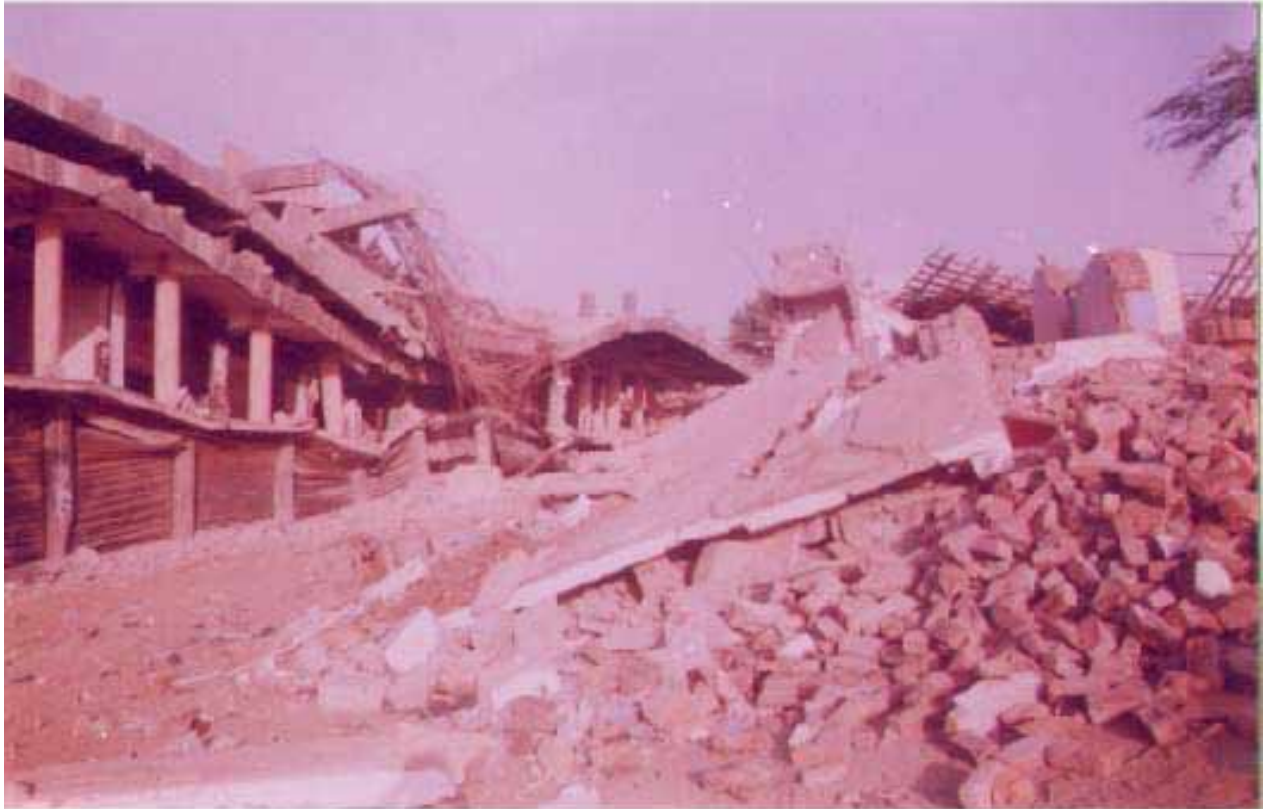
Photo No. 4 : Total Collapse Of Framed Structure At Bachau

In case of shopping complex, large corridor is always provided .To some extent this converts the corridor portion in soft storey. In this structure, front beams are provided at 2.4 meter height.(Floor height. is 3.60 meter). The column is converted in to a short column, thereby attracting large earthquake forces. Due to unsymmetrical distribution of partition walls, torsional moments are developed. Combined effects as mentioned above result into a total collapse as seen in photo no.4.

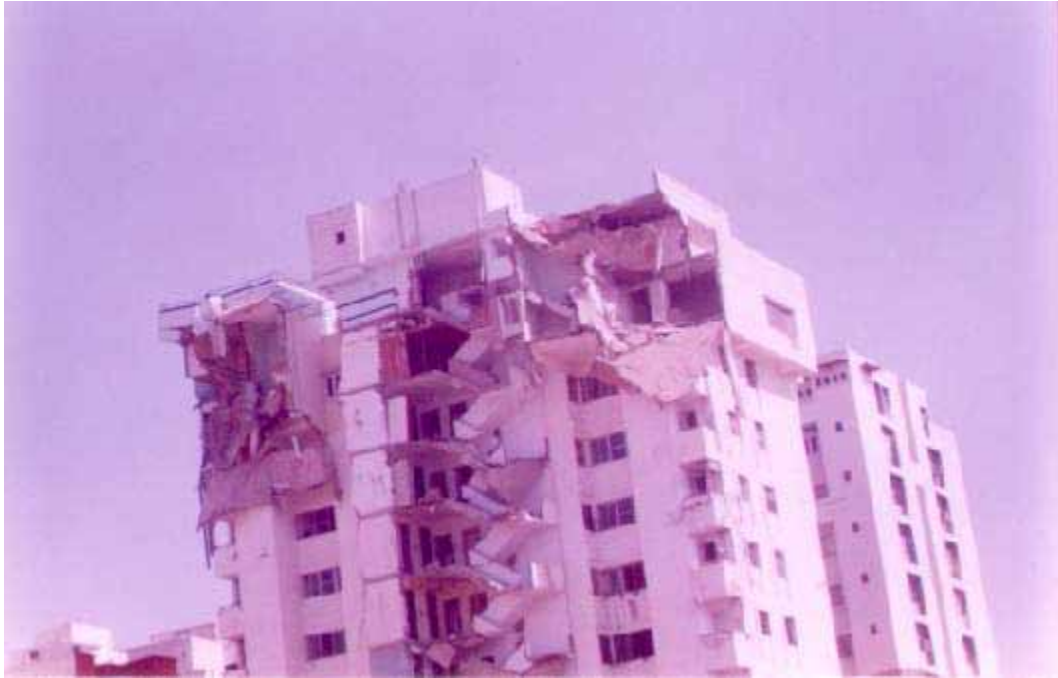
Photo No. 5 : Total Collapse Of Framed Structure At Ahmedabad (Mansi Tower)

Ahmedabad is located at 250 km away from the epicentre. Photograph shows Mansi tower which consist of four blocks and one of the block is totally collapsed. It is seen that on this block a swimming pool was constructed at its top, which resulted into unsymmetry and heavy mass concentration at the top of the structure. Large mass at the top means large inertia forces developed at the top level. This resulted into the failure of particular block of Mansi tower.

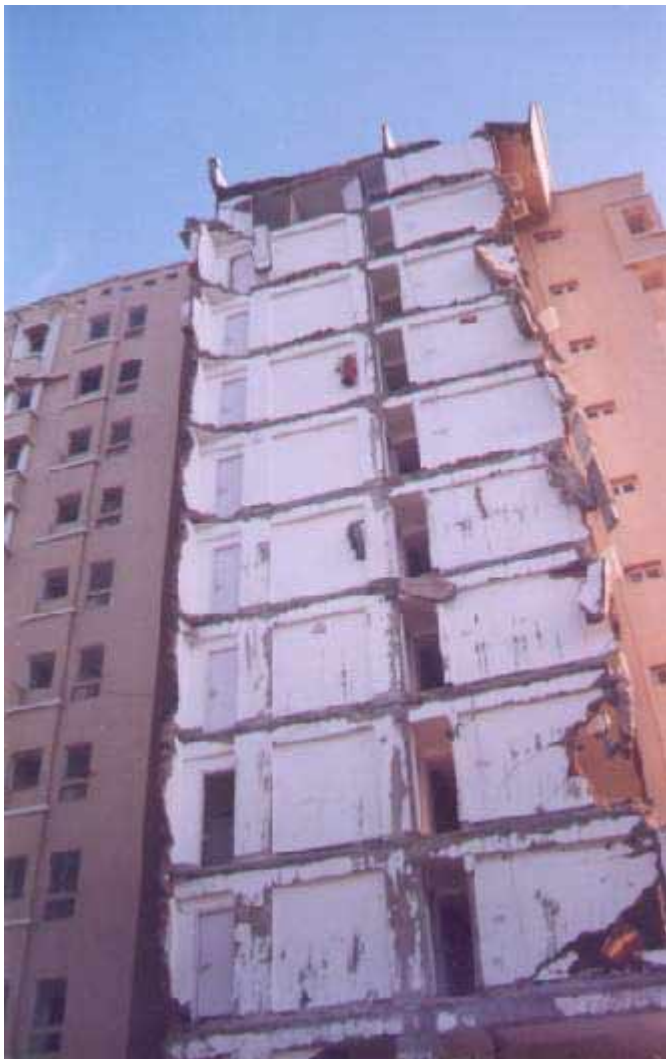
Photo No. 6 : Total Collapse Of Framed Structure At Ahmedabad (Shikhar tower)

Shikhar Tower is 10 storied structure whose foundations rest on yellow soil. One of the 4 wings of the tower has literally come down with a death toll of 98. The reasons for the failure are as follows –

- a) Building was not properly designed. Size of column and reinforcement are not adequate even for gravity loads.
- b) Looking at the photograph 7, it is clear that the size of footing is insufficient for the strata available. From this failure, one is confused whether the structure was designed or not.

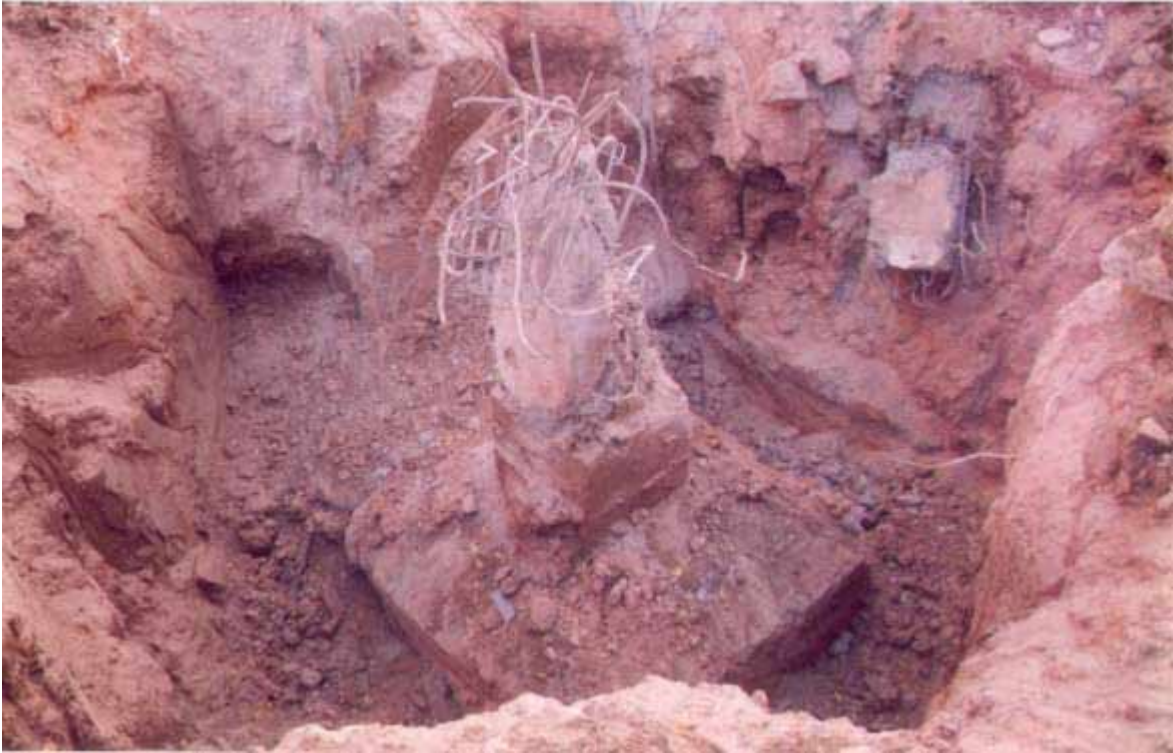
Photo No. 7: Exposed footing and column of framed Structure At Ahmedabad (Shikhar tower)

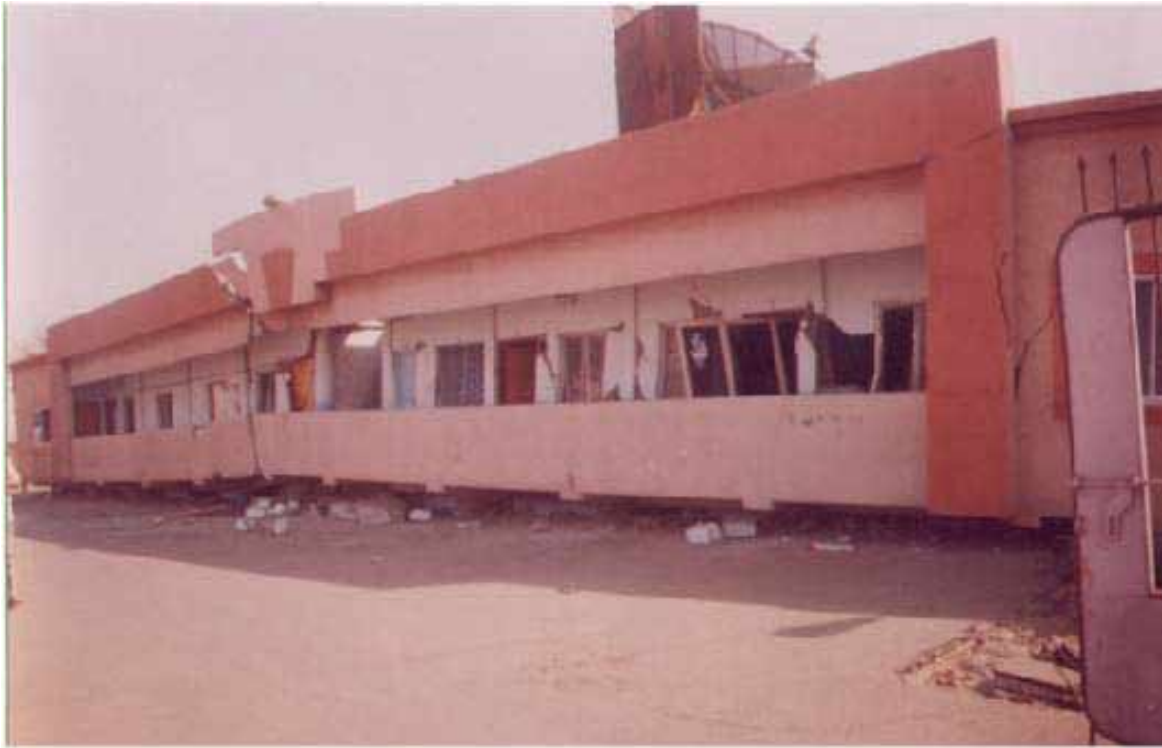
Photo No. 8 : The First Floor Looks Like Ground Floor (Hostel At Kandala Port )

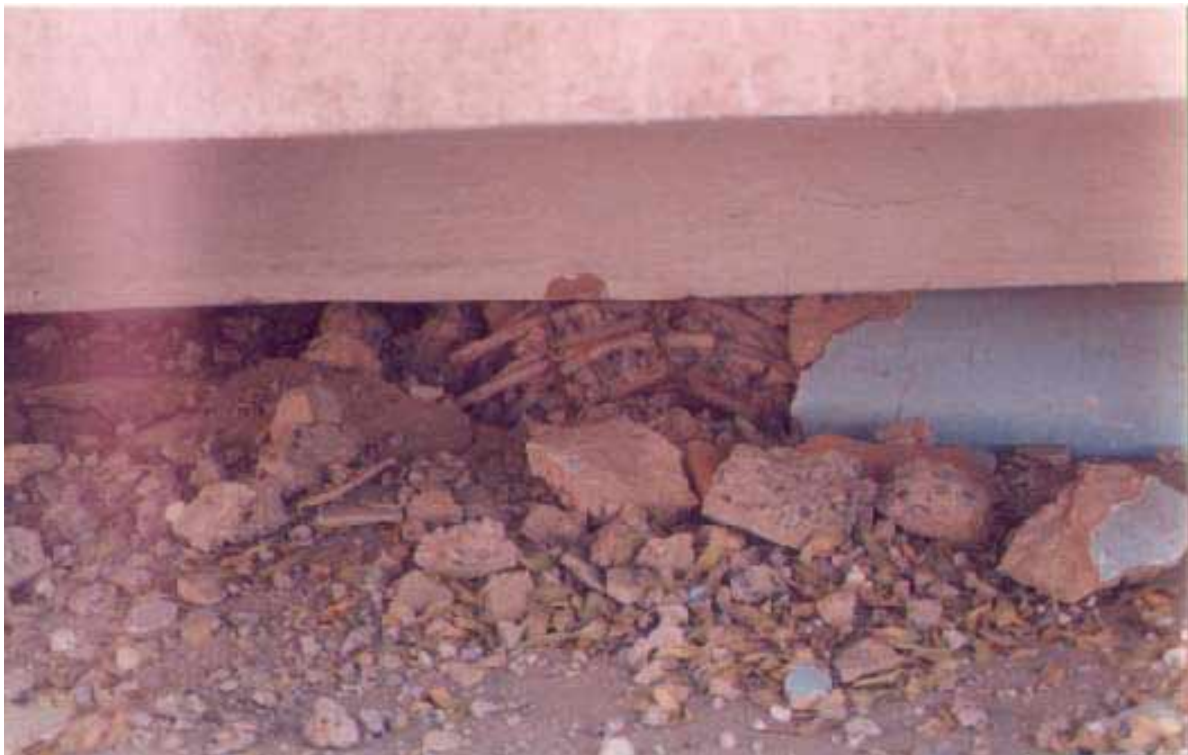
Phot No. 9 : Circular column for parking (Ground floor) after failure

Parking is generally provided on the ground floor. Being meant for parking, no partition walls are provided thereby lacking an inherited stiffness due to the infilled walls. Large moments are developed due to earthquake forces at the ground floor. Due to this, plastic hinges are formed at beam columns joint in the column , at the plinth and floor level because of this, the ground storey column are crushed. It can be seen in photo No. 8 & 9 . In epicentral area, most of the RCC framed structures with parking have faced this problem. To avoid this type of failure, special analysis given in code must be adopted .

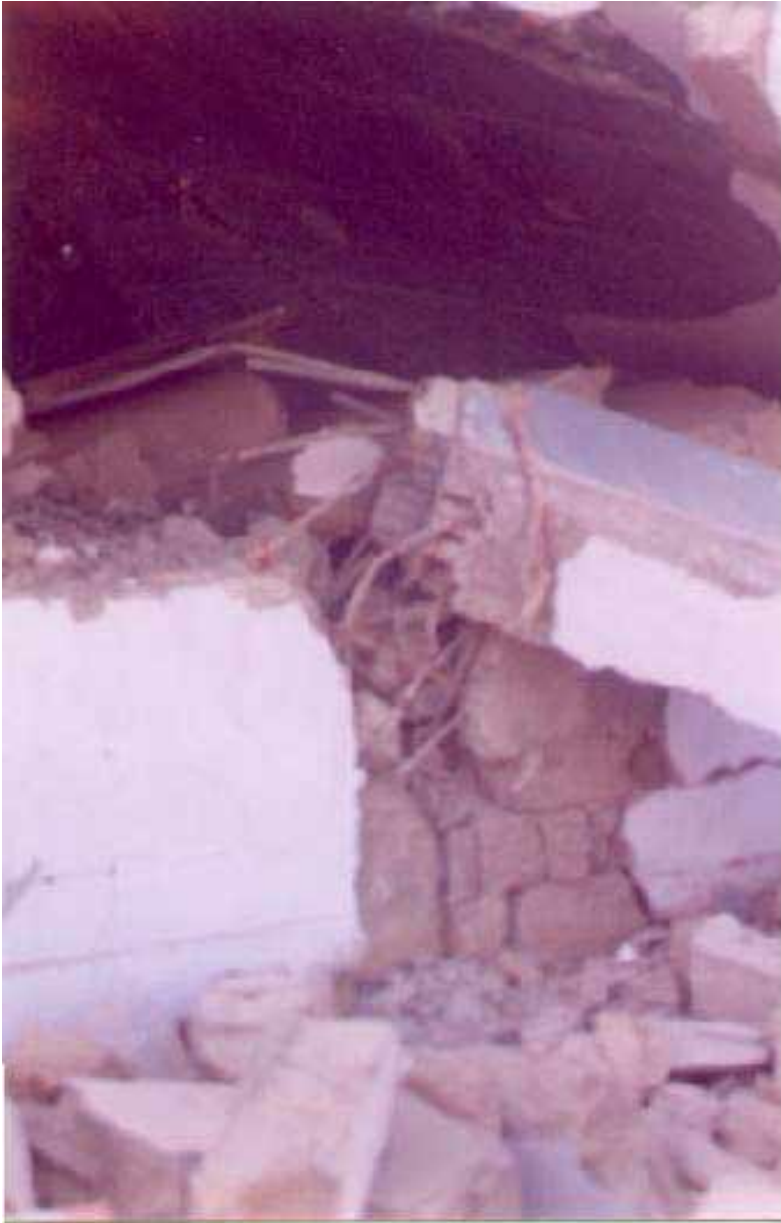
Photo No. 10 : Improper Detailing At Beam Column Joint.

Detailing plays important role in earthquake resistant design. If detailing is not proper then brittle failure is possible. Photo no. 10 shows beam column Joint for the building at Bachau.

- (a) Discontinuous bars.
- (b) Insufficient lap length provided for bars in column and beams.
- (c) No lateral ties and stirrups are available at junction where there is large demand of confining steel.
- (d) Over lap to all column bars are provided at critical point.
- (e) Poor workmanship

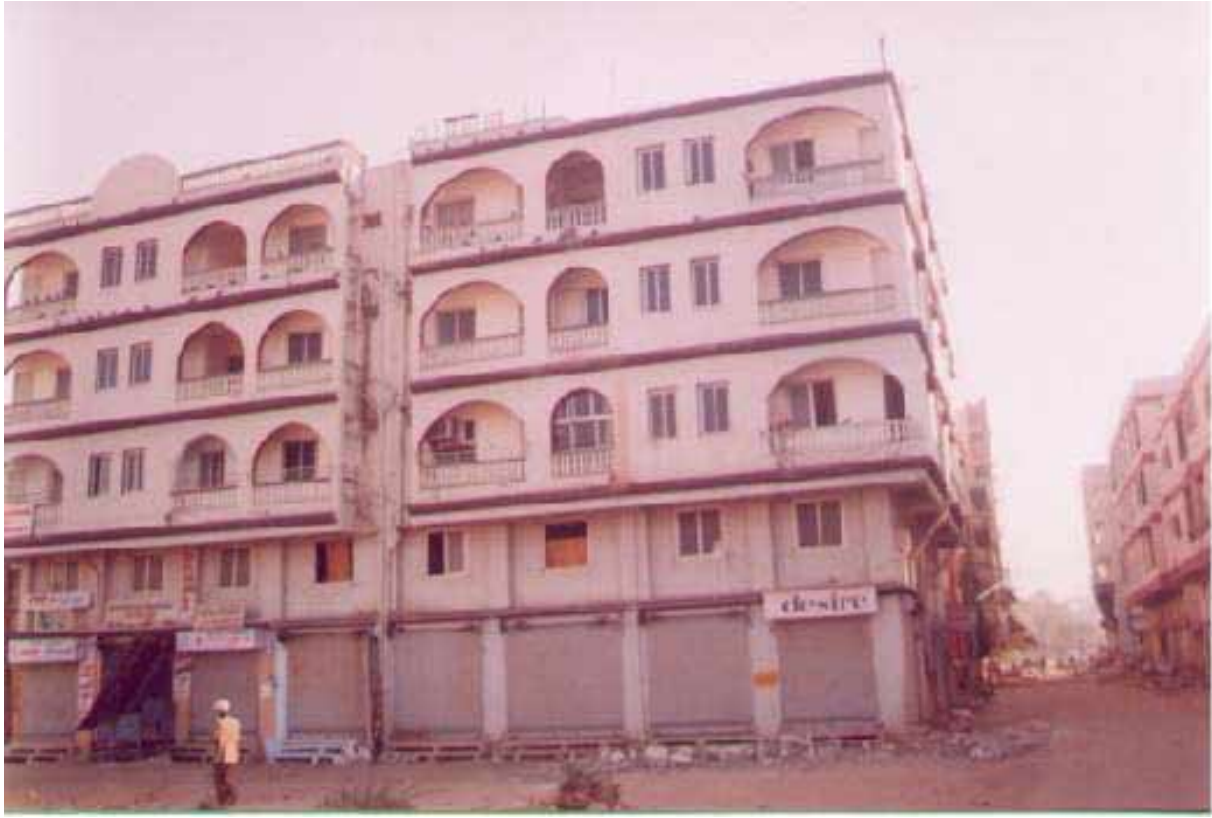
Photo No. 11 : Perfect RCC Framed Structure At Bhuj.

Photo shows five-storied RCC framed building, which remains in intact condition even after severe earthquake of magnitude 7.3. The possible reasons are as follows.

- a) Symmetric structure.
- b) Proper structural design.
- c) Proper detailing.
- d) Codal provisions strictly followed.
