SEISMIC RETROFITTING OF MANI MANDIR COMPLEX AT MORBI, GUJARAT, INDIA

Alpa SHETH¹, R D CHAUDHARI², Ejaz KHAN³, Divay GUPTA⁴ and Malvika SAINI⁵

SUMMARY

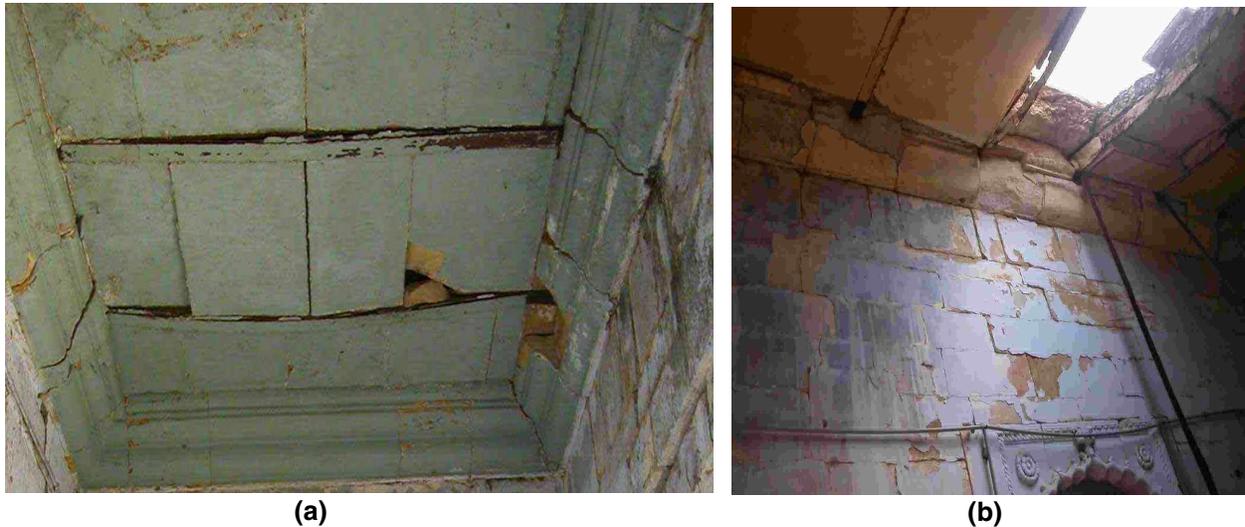
The floors are built of stone slabs of about 750mm width and of 200mm thickness. These slabs are wedged between flanges of steel joists (Figure 2a). The joists rest on a stone cornice (made of cornice pieces) running along wall lengths. A floor finish (of about 150mm thickness) was provided over the stone slabs. There are arches along the external façade walls and internally across passages.

Fig. 2: Details of Flooring (a) Stone Slab Wedged between Steel Joists, and (b) Separation of Joist Flanges and Failure of Stone Slab.

The entire roof slab showed considerable corrosion of steel joists and numerous deep cracks on the roof surface. As mentioned earlier, the waterproofing on roof slab was done in three layers amounting to about total 300mm thick; this additional load had caused sagging in some steel joists and subsequent cracking in the adjacent stone slabs (Figure 2a). Considering that more than 70% of the slab was partially or

completely damaged, it was recommended that the roof slab be completely removed and replaced with a suitable slab system. The replacement of the slab provided two challenges. The proposed new slab should be reminiscent of the original construction methodology as well as provide the necessary diaphragm action. The use of precast slabs in lieu of the stone slabs was considered but rejected as it would not provide the necessary diaphragm action and further costs would be entailed to provide this. Finally reinforced concrete in-situ slab system spanning between composite beams of concrete and epoxy coated steel joists was adopted as a compromise solution which essentially retained the philosophy of the earlier structural system besides appearing similar to the original ceilings.

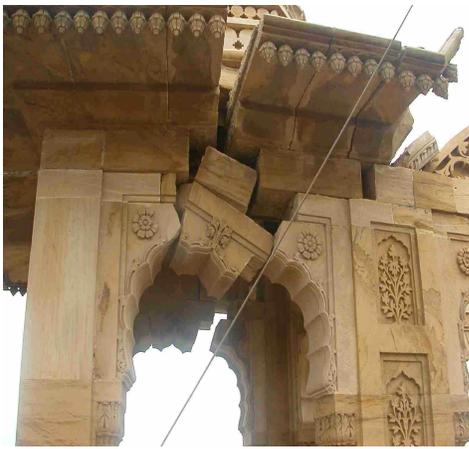
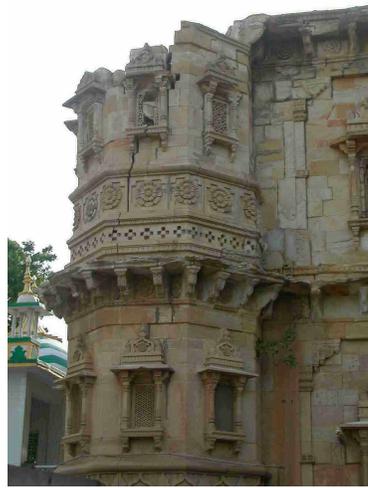
The earthquake caused severe damage and collapse of a large number of elements above the roof, extensive damage at the roof level, moderate damage at the first storey and little damage on the ground storey. Staircase cap slabs, parapets, *shikhars*, arches, portals and *chhatris* above the roof were very badly damaged; a large number of them were partially or completely destroyed (Figure 3a). The bastions at the extreme corners of the structure sustained severe damage including partial collapse; the portions standing are precariously balanced and have wide, through-cracks (Figure 3b). Similar observations were noted in the temple where the corners have been severely damaged (Figure 4a). Stone weather-sheds at the roof level were broken and destroyed at some places.

Fig. 3: Damage above Roof Level: (a) Destruction of Arches in Elevational Elements, And (b) Partial Collapse of Bastions.

Analysis showed that the corner bastions are very severely stressed; any amount of rebuilding with masonry, even with provision of seismic reinforcement such as horizontal steel bands would be inadequate. A 150 mm thick reinforced concrete (RC) skin wall was introduced internally. Double layer of reinforcement in both directions was provided based on the analysis of the retrofitted model. Cutouts were provided in this wall to match with the bastion windows. The RC wall was bonded to the external masonry bastion walls by noggling the RC wall into the existing masonry wall at intervals (Figures 9 and 13). The staircases in the bastions that had collapsed were to be rebuilt in structural steel and realigned to ensure the presence of a continuous diaphragm to allow for transfer of lateral forces from the floor slab to the RC bastion walls.

The partially collapsed *shikhars*, *chhatris*, decorative balconies and their walls which were pushed out or tilted are in a very precarious state and require emergency measures for their complete dismantling and shoring/strutting. Each stone has to be carefully numbered, removed and stored carefully. Many decorative stone blocks have broken. Identical carvings on similar sandstone are to be carried out by special artisans of the area. As there would be no bonding between the stones pieces, the stones will be connected to each other by means of crosspinning using 8mm stainless steel dowels.

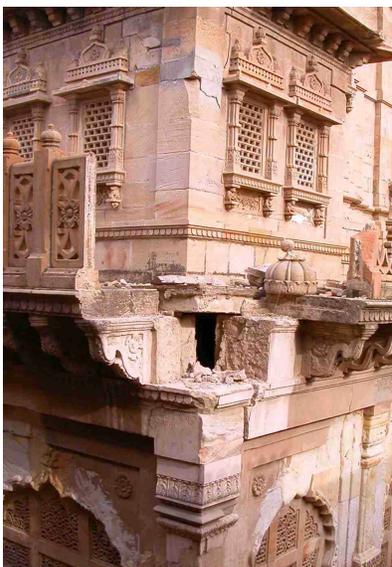
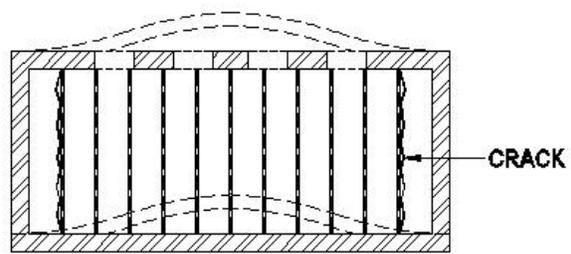
Fig. 4: Floor Level Damage: (a) Out of Plane Collapse at Corners of Temple Portion, And (b) In - Plane Separation in Slab along End Joist.

Some portions of the roof slab suffered collapse. This was primarily observed in the regions where the joists supporting the slabs rested on capitals of individual stone columns. These joists were significantly corroded. A large number of cornice stones at the junction were cracked, locally crushed or dislocated. A typical crack pattern was observed in the floor slabs: In many bays, there was a crack running parallel to the joists all along the junction of the end joist (Figure 4b). Weather sheds were broken at this level due to the falling debris.

As noted earlier, cracks parallel to joists are seen at some places on the underside of the slab, along the junction of the joist and stone slab adjacent to wall. These cracks occur due to the relative displacement between the rigid wall (parallel to the joist) which undergoes very little displacement, and the joist which undergoes significant displacement (Figure 4b). There is also maximum damage to the cornice at this location due to local crushing. Shear failure in the form of diagonal cracks (opening out of joints) was observed in many walls. There was no crushing of stone in the walls. The damage is most severe in walls that exhibit variation in the stiffness due to random locations of openings on different floor levels.

The Willingdon secretariat is a building of immense proportions with a large central courtyard and several internal courtyards in each of the wings. There are many reentrant corners thus formed. Expectedly, these corners suffered damage of much higher magnitude than other areas. The highly stiff bastions at the extreme corners of the building attracted very large forces and were severely damaged and collapsed partially.

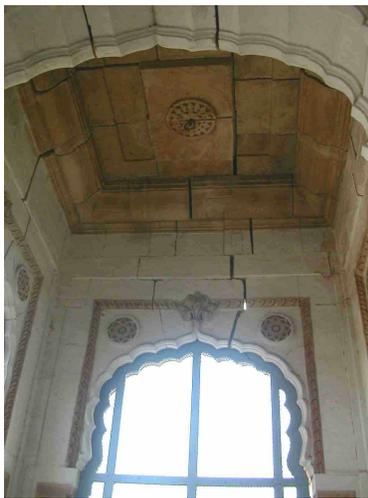
At the first storey, almost all joints in arches and pillars opened out (Figure 5a). A large number of the joints in walls also opened out in a typical diagonal pattern (Figure 5b). Cornices below steel joists were damaged at many locations (Figure 2a). The arches cracked heavily and the keystone were dislodged in most arches. Deformation of the arches was also observed. Many decorative galleries and some walls show a distinct tilt; they have been pushed out and away from the building. Numerous wide cracks were formed in walls. Many walls opened out at corners.

Fig.: 5 Damage to Vertical Elements: (a) Openings of Joints in Arch, and (b) Diagonal Cracks in Walls.

The arches in the structure have cracked heavily and the keystone has dislodged due to the induced tension in these arches during reversal of stresses. Dislocation (displacement) of the arch supports have also caused the first hinge to form at the center of the arch in the seismic event.

The arches suffered three types of failures: dislocation of keystone, severe cracking of arches and movement of supports. Two retrofit details for arch strengthening have been recommended based on the type of damage. Where there is movement of support and the arches are internal, a stainless steel tie with a turnbuckle is proposed (Figure 11a). In areas where there is no discernible movement of supports, the keystone is tied back into the wall above by means of stainless steel rods (Figure 11b). A lintel is formed by means of providing stainless steel reinforcing bars in the courses between the stones above the arch.

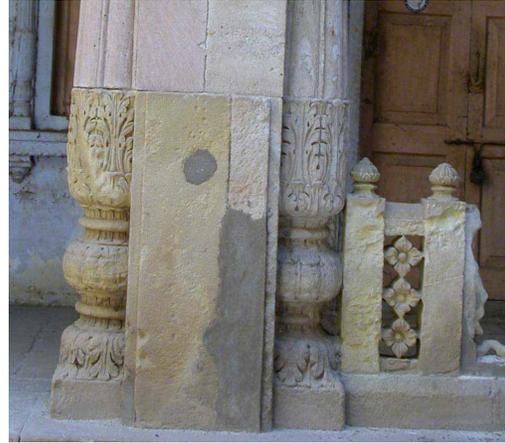
As mentioned earlier, there have been some earlier efforts to retrofit the buildings. Keystones of some arches and stone blocks of a few walls and portals were stapled to adjacent stones, possibly as a response to the 1956 Anjar earthquake. The steel stitching being stronger than the parent stone, caused local crushing of the stone even though it prevented complete dislocation of the stone from the adjacent one. (Figure 6a). There were attempts to contain the weathering of the buildings (Figure 6b). This was done by insensitively plastering the surface with cement mortar. At one location, some arch pillars that had weathered badly, had been fully jacketed in concrete.

Fig. 6: Earlier Interventions towards Restoration: (a) Fastening of Stones Using Mild Steel Staples, and (b) Repairing of Weathered Stone.

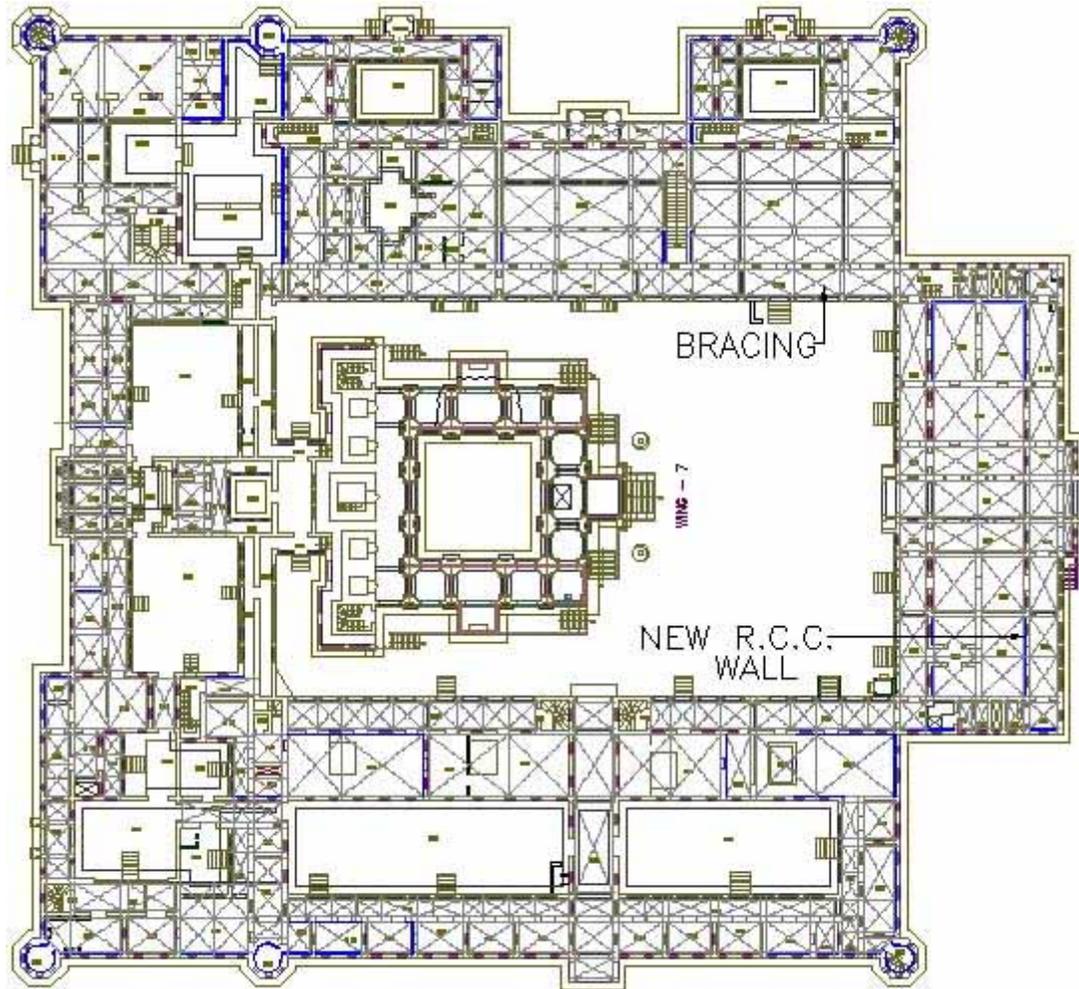
Fig. 7: Location of Proposed Bracings and R.C. Skin Walls at First Floor Level.

shotcreting in India is limited to a thickness of 40 mm primarily due to equipment limitations. The option of base isolation was considered to be a very expensive one and is not available indigenously; hence this option was not considered. Thus, the process of elimination led to the choice of additional reinforced concrete skin shear walls. (Figures 7 and 9a).

Based on the results of the analysis and the structural behaviour, reinforced concrete skin walls were introduced at select locations. A computer model was generated considering these new skin walls and ignoring the capacity of the masonry walls. The design force levels were reduced based on the response reduction factor for ductile detailed RC shear walls ($R=5$ for ductile shear walls). Initially a large number of thin walls of 100mm were introduced internally adjoining existing walls. Such an intervention would not be obvious as the internal walls were already painted. In the second iteration it was decided to reduce the total length of the RC skin walls and increase their thickness to 150mm. This model was further refined to arrive at the optimal positions and lengths of new RC skin walls of 150mm thickness. Existing foundations were suitably strengthened (Figure 9b).

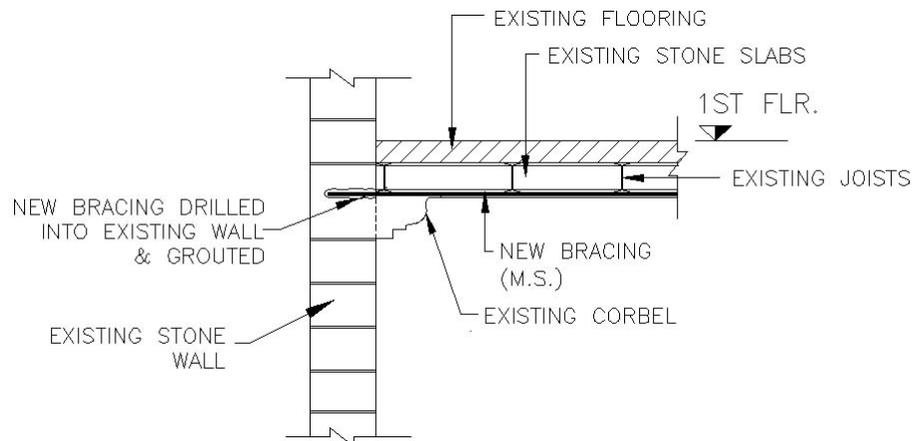
Fig. 8: Sectional Details of Anchoring of Diagonal Floor Bracing in Walls.

The option of diagonal bracing was an attractive one as it meant the least intervention into the existing structure and could be designed as a sleek, honest and aesthetically pleasing retrofit. However due to the existing wall foundations, it was not possible to provide foundations for the large axial tension and compression forces generated at the base of the braces. Hence this option was discarded. Typically,

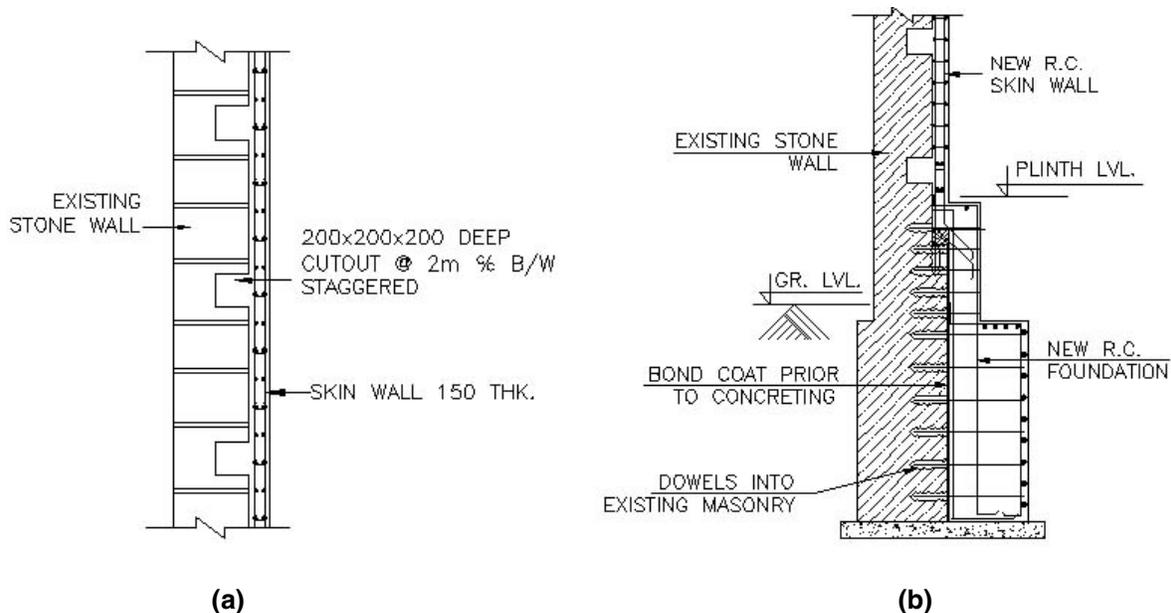
FIG. 9: Details of New R.C. Skin Wall (a) R.C. Skin Wall Nogged in to Masonry Wall, and (b) New R.C. Skin Wall Foundation.

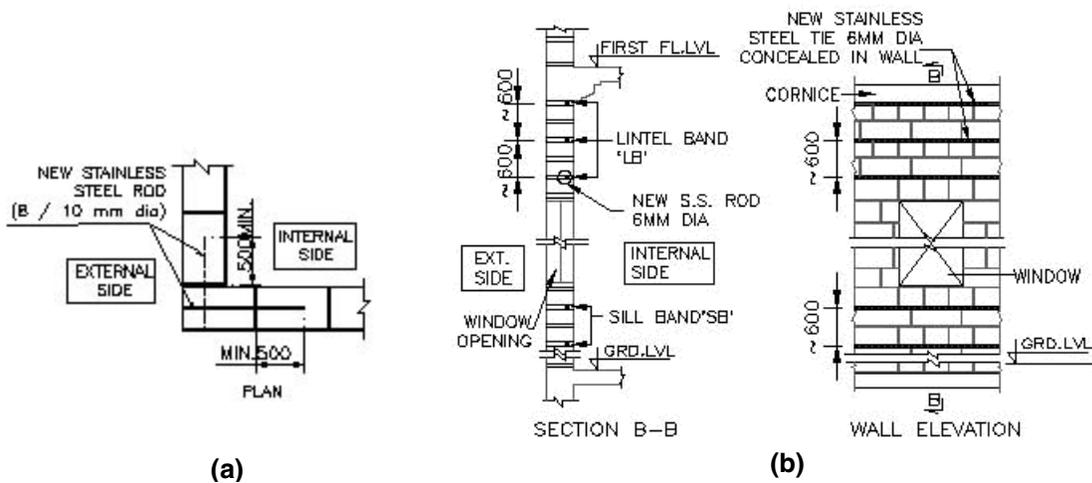
Fig. 10: Intervention in Walls: (a) End Pining at Wall Corners, and (b) Seismic Reinforcement Bands.

Many of the external and internal wall corners had opened out during the 2001 Bhuj earthquake, and are liable to do so in a future seismic event due to the poor masonry detail at the corner. Thus, it is proposed to securely connect the perpendicular walls to each other by cross-pinning with stainless steel rods of 8mm and 10mm diameters at every 600 mm along the height (Figure 10a).

While the new RC walls have been designed to take the full lateral loads, the original structure (without RC skin walls but with slab diaphragm action) was checked for its capacity to take 25% of the design seismic loads. This was found to be adequate. However, it was necessary to provide seismic features in the form of horizontal stainless steel bands to the existing masonry walls to improve their performance and ductility. Accordingly, 6mm stainless steel reinforcing rods were proposed between the stone courses at a spacing of about 600 mm along the height (Figure 10b).

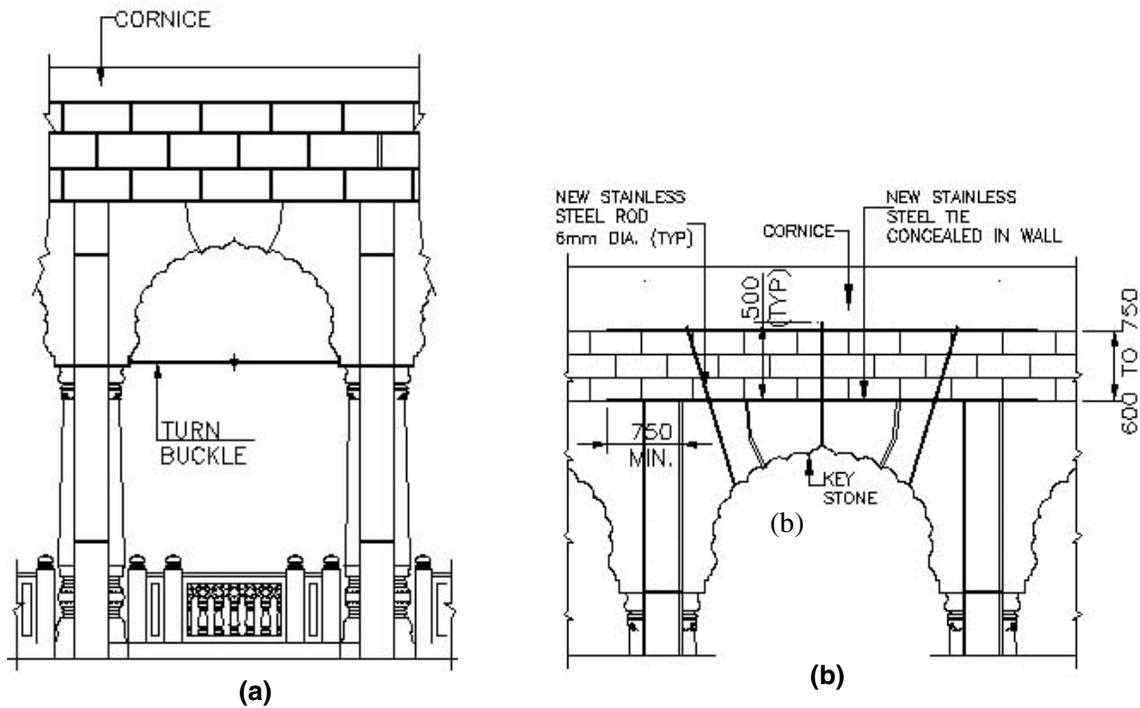
Fig. 11: Detail of Interventions in Arches: (a) Strengthening of Arches Using Ties, and (b) Strengthening Of Arches by Pining And Reinforcement Band.

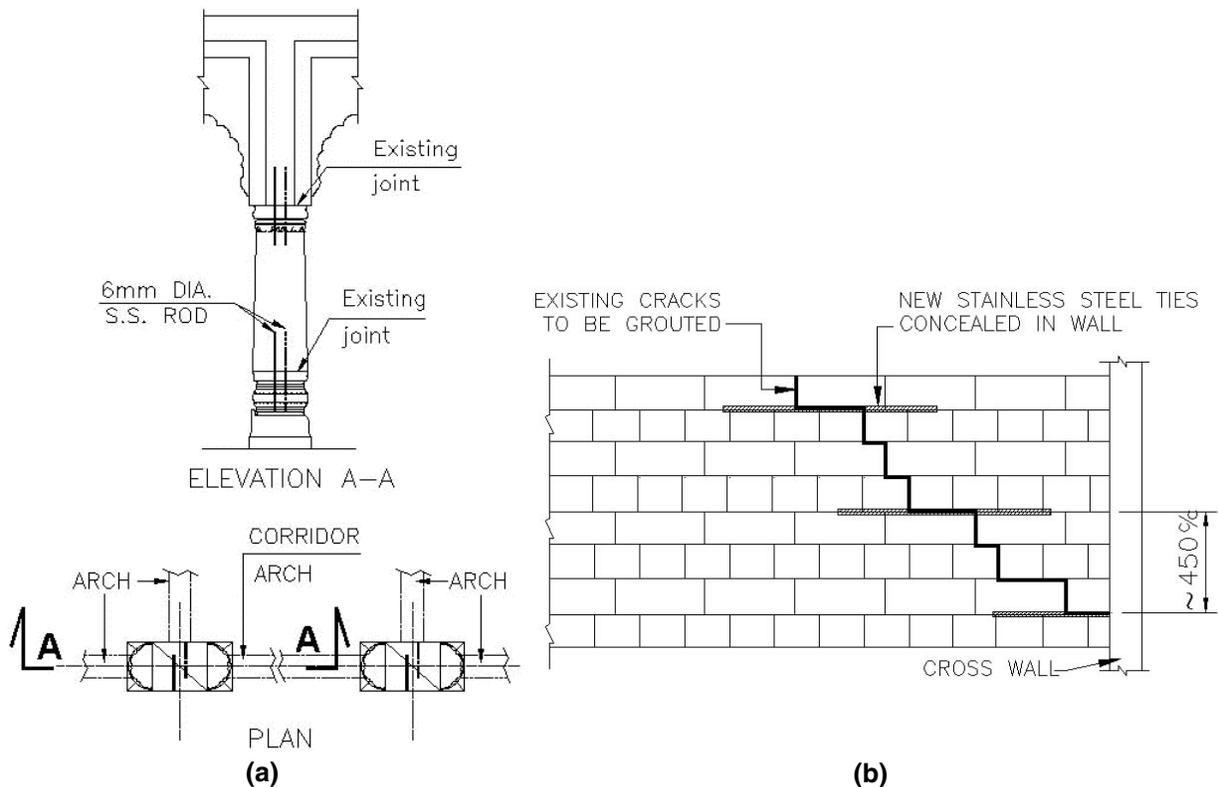
Fig. 12: Interventions in Vertical Elements: (a) Cross Pining of Corridor Columns, And (b) Detail of Stitching Cracks in Walls.

The columns in corridors towards the interior courtyards were significantly damaged during the 2001 Bhuj earthquake. The columns are made of three or more pieces of stone and negligibly socketted into each other. It is proposed to connect these stones to each other by cross-pinning (Figure 12a).

The cracks in the walls are to be grouted with a low-strength grout compatible with the stone. Walls with diagonal cracks are to be stitched using stainless steel bars before the cracks are grouted (Figure 12b). The grout needs to be tested before use for its compatibility with the stone.

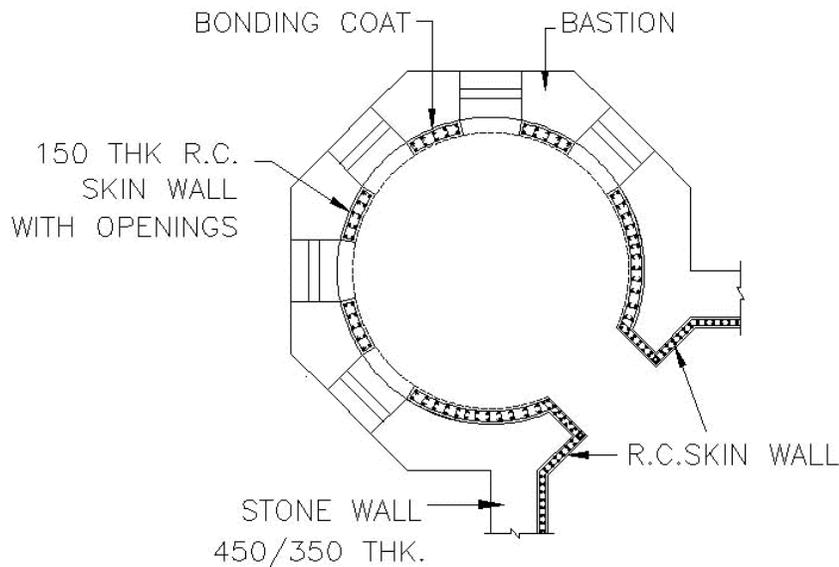
Fig. 13: Plan of Bastion with New R.C. Skin Wall.

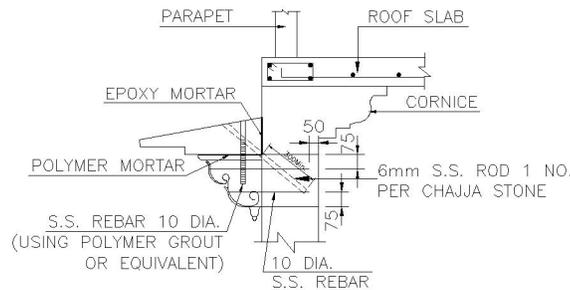
Fig. 14 Pinning Details For Weather Shed.

A significant number of stone pieces which constitute weather sheds have broken due to overturning or due to the impact of falling debris. These have to be dismantled and rebuilt similar to the roof parapets. All weather sheds are to be anchored to the supporting corbel and tied back into the supporting wall (Figure 14).
