A STUDY ON MICROTREMOR MEASUREMENTS OF TIMBER STRUCTURE ON SEISMIC RETROFIT DWELLING HOUSES

Katsuhiko KOHARA¹, Keiichi HIRATA², Ryo AOKI³, and Hitoshi TAMURA⁴

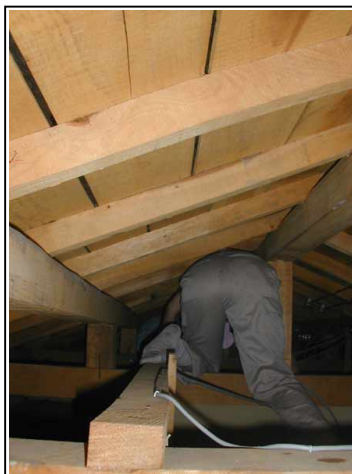
Photo. 1 Hangar Back

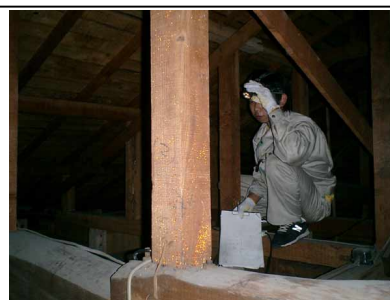
Photo. 2 Hangar Back

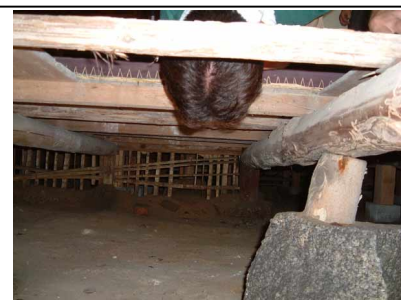
Photo. 3 Under Floor

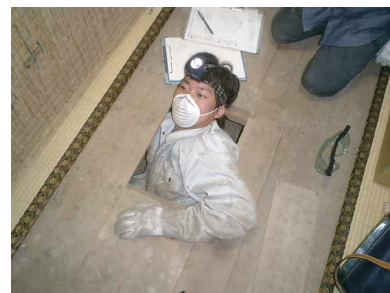
Photo. 4 Under Floor

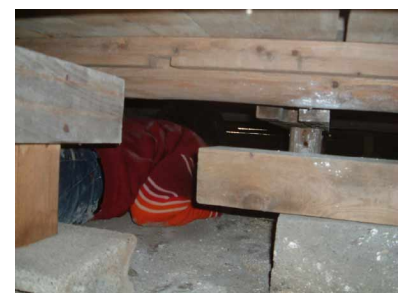
Photo. 5 Under Floor

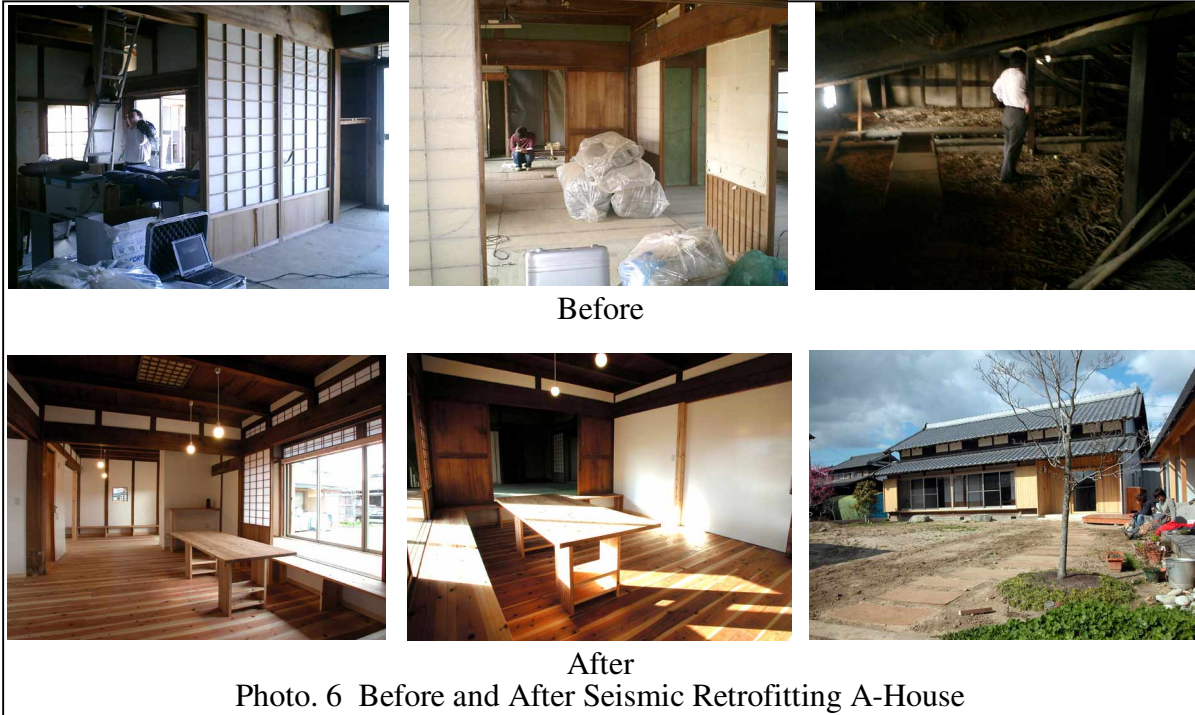
This one-storied house, which is shown in photograph 6, is a typical traditional house in Japan, and has built 100 years before. In the hangar back, a sericulture has been done ever, and a straw and soil are spread. These total weight is about 85kN.

The characteristics of vibration before and after seismic retrofitting is shown table 2. This seismic retrofitting change 3.2 Hz of the natural frequency into 4.7 Hz of one. This seismic retrofitting change 0.046 of the damping ratio on width direction into 0.029 of one.

It disposed all of these and there was to make the weight light, and it implemented to increase a effective bearing wall ratio.

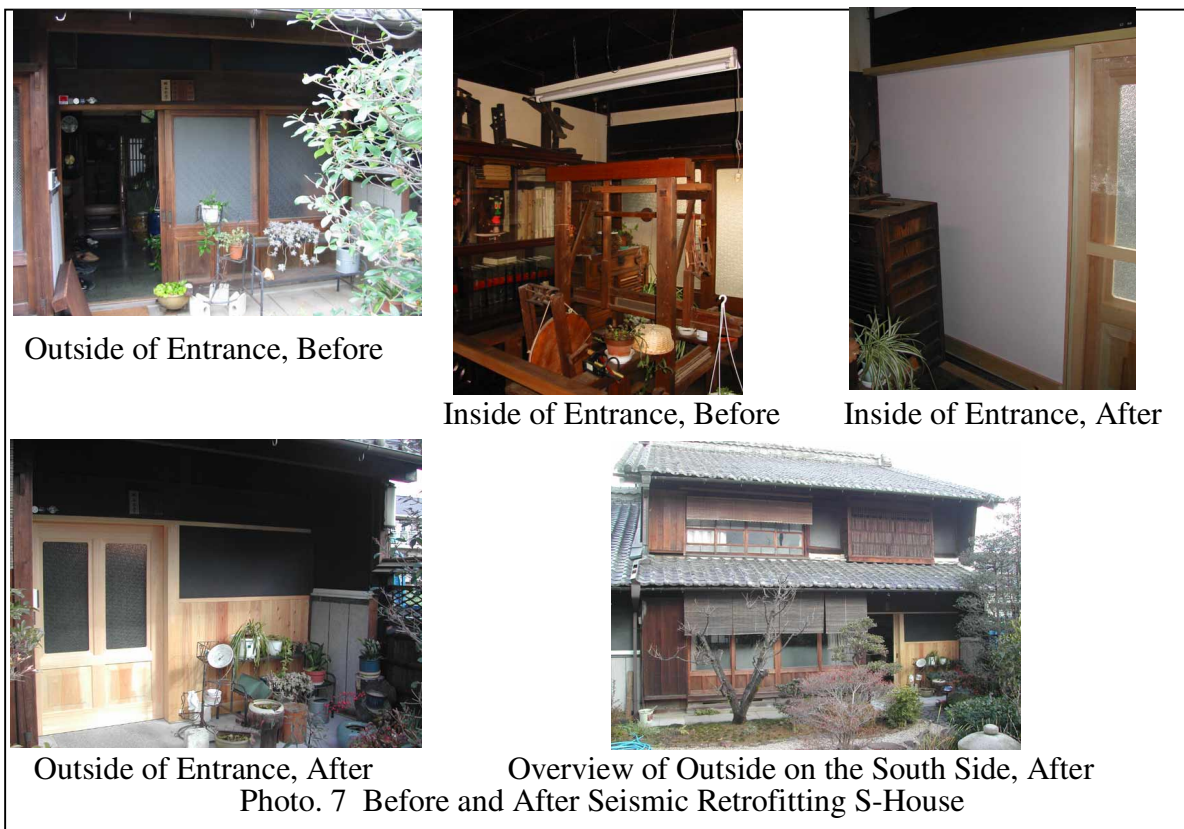
This two-storied house, which is shown in photograph 7, is a typical traditional house in Japan. It implemented to increase a effective bearing wall ratio. This seismic retrofitting changes 3.0 Hz of the natural frequency on width direction into 3.2 Hz of one. This seismic retrofitting changes 0.036 of the damping ratio on width direction into 0.043 of one.
