## EVALUATION AND RETROFITTING OF STRUCTURES DAMAGED DUE TO JAN 26, 2001, GUJARAT (INDIA) EARTHQUAKE

### SUMMARY

Colossal loss of life and property was observed due to Jan 26, 2001 earthquake. Seismic evaluation of structures is the most important feature, which must be undertaken and as per requirements of the structures suitable retrofitting measures must be adopted so that loss of life and property can be prevented during future probable earthquake. In this paper evaluation of various buildings is explained. This include following types of buildings

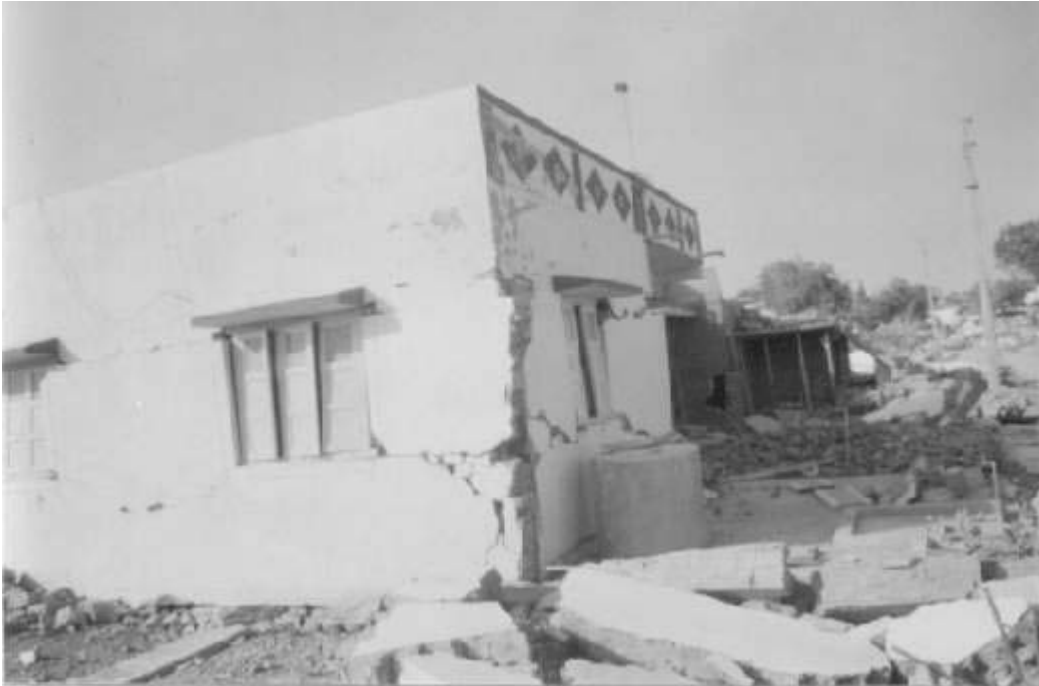
Bhachau was the town nearest from epicenter (10 to 15km away). MSK intensity at Bhachau was X. Almost all framed structures collapsed. Interestingly response of few load bearing buildings was better. Only four to five load bearing buildings were in good condition. This proves that if proper precautions are taken then load bearing buildings can survive intensity X. Photo No 1 shows partially damaged load bearing building.

**Photo No 1 Partially Damaged Load Bearing Building**

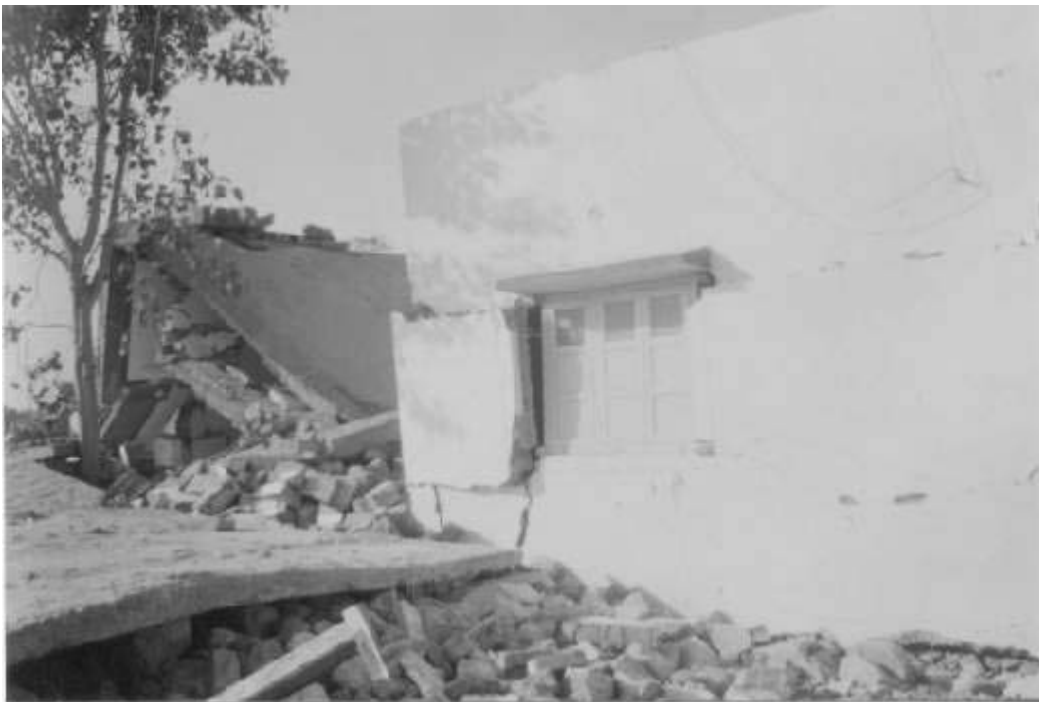
**Photo No 2 Partially Damaged Load Bearing Building Another View**

In this building continuous lintel band was provided. Due to provision of lintel band this building survived. Band at sill level was not provided. The effect of this can be seen prominently, that is cracking and bulging of wall at sill level (Photo No. 2). Due to provision of continuous lintel band there was no appreciable damage to the structures above lintel level.

Provide temporary support to the slab and lintel. Remove bulge portion of brick wall between sill and lintel level. Provide band at sill level in new brick work, anchor bars for sill band in existing wall. Fix welded wire mesh to the cracked portion of wall where severe cracks are developed. Also fix chicken wire mesh to the wall, plaster this wall by rich cement mortar.

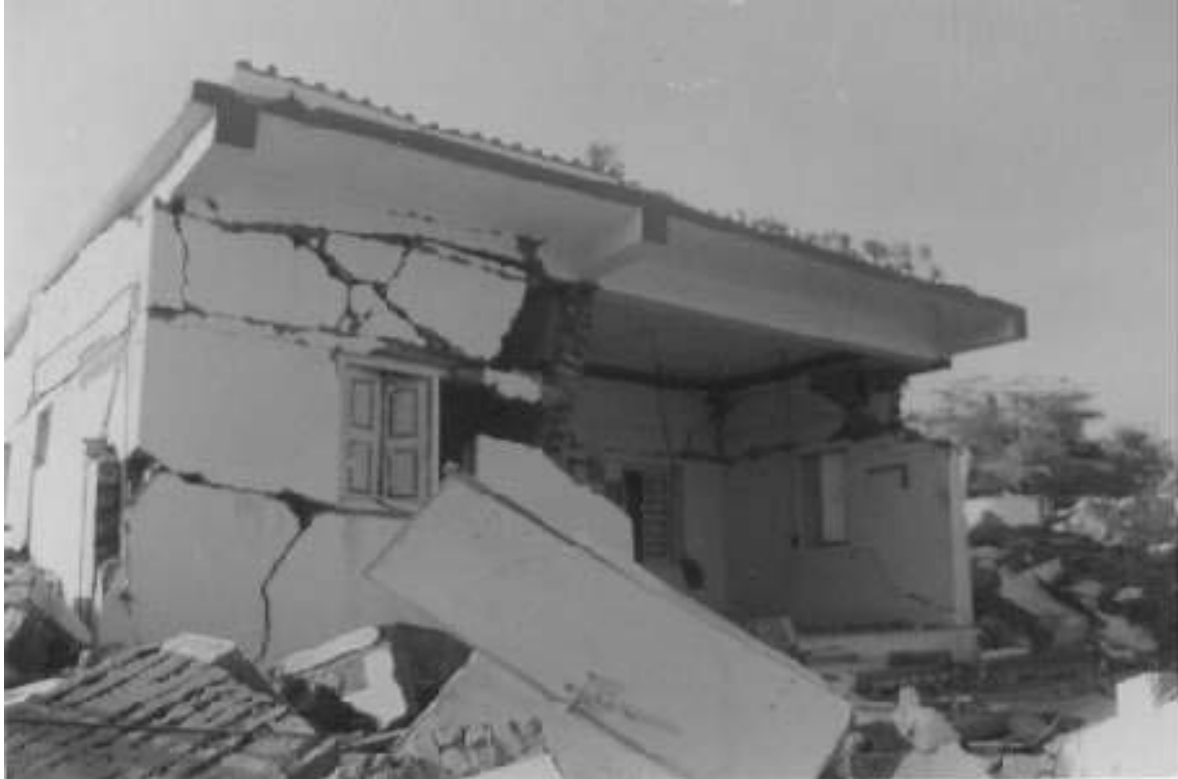
### **Photo No 3 Severely Damaged Load Bearing Building**

Photo No 3 shows severely damaged building at Bhachau. This building was damaged due to very large opening provided in the front wall. Sill band was also not provided. Looking at condition of the building it is better to reconstruct this instead of repair.

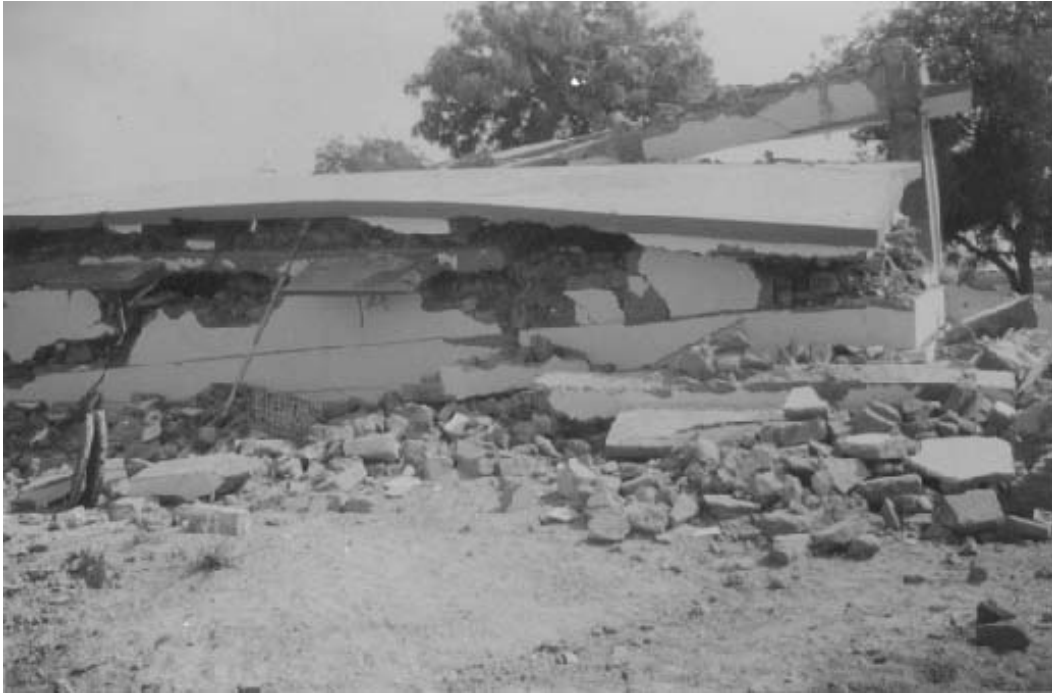
Railway Station Building was badly damaged. (Photo No 4 and 5)

1. As slabs were provided at different level proper diaphragm action was not developed. Continuous R.C.C. lintel was provided but precautions regarding continuity of bars and development length were not taken. (Photo No 4 and 5) Due to these reasons there was opening of joints and

**Photo No 4 Damaged Railway Station Building Rear View**

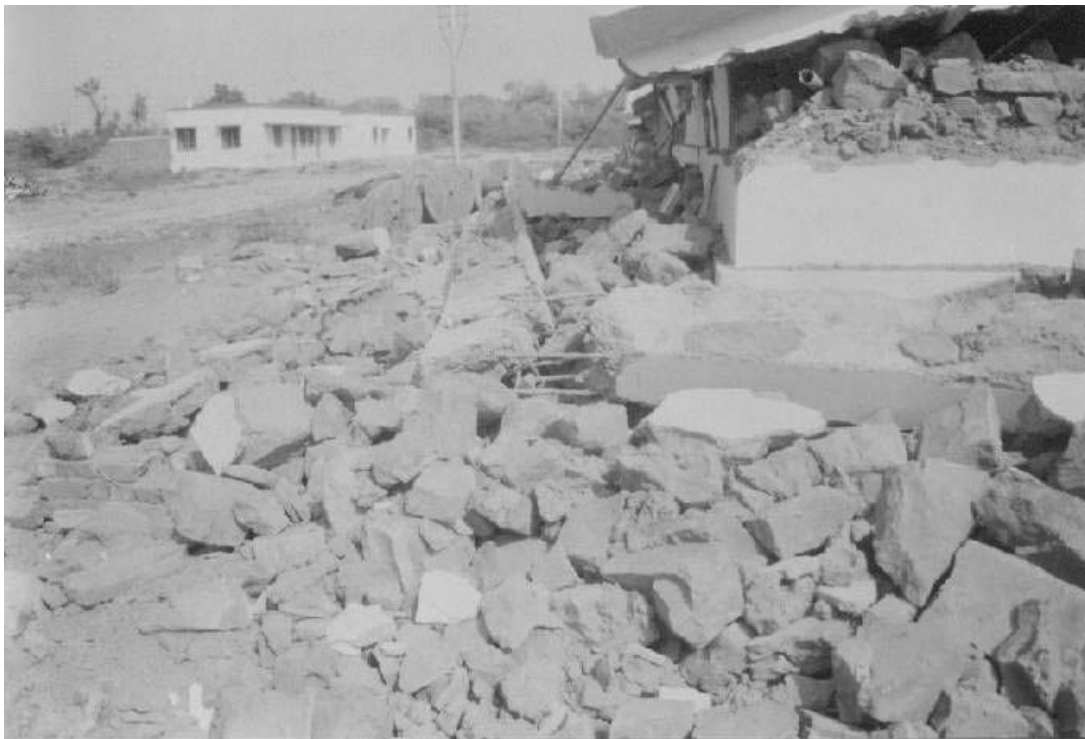
**Photo No 5 Damaged Railway Station Building Side View, In The Background Staff Quarters Can Be Seen Which Are In Intact Condition.**

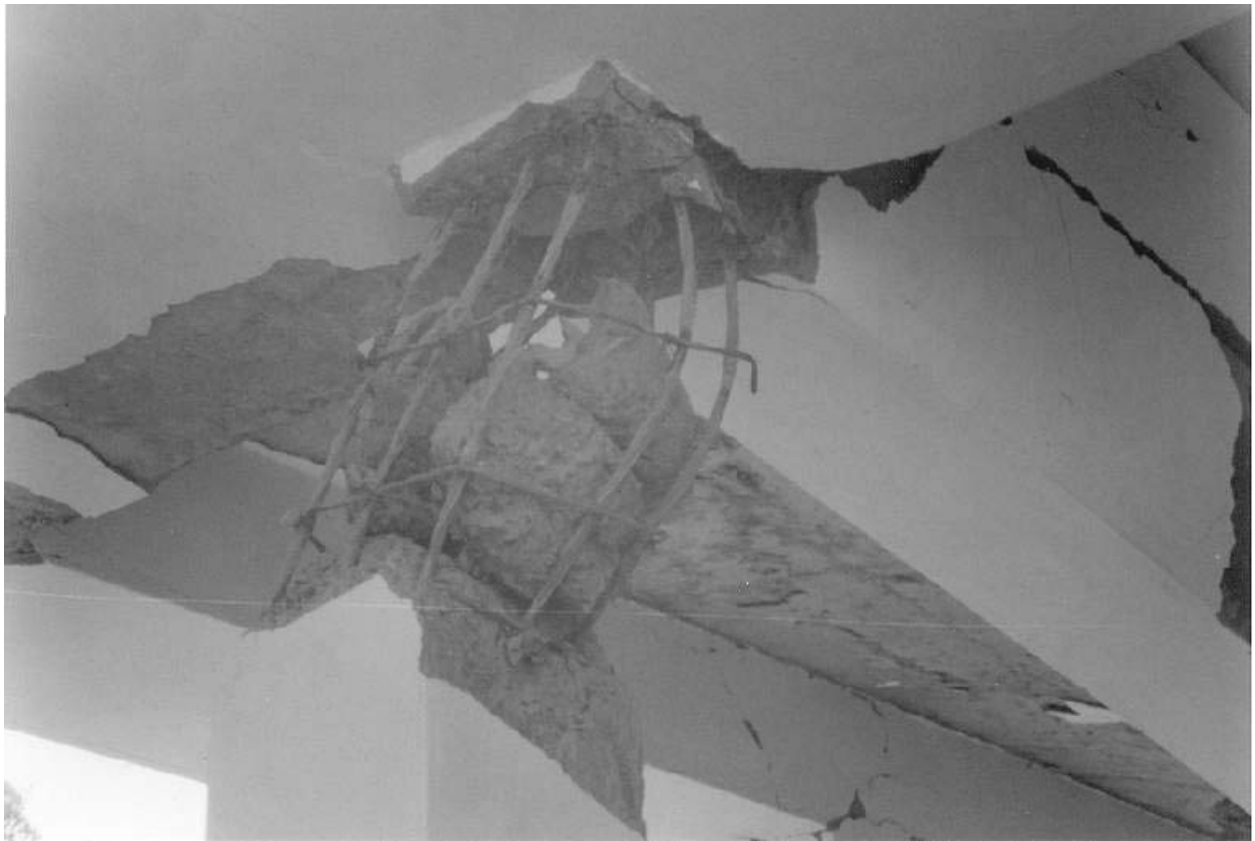
anchoring of ends of stirrups of beams and lateral ties for columns (Photo No 6) were not done which resulted in opening of these ties leading to failure of structural element.

**Photo No 6 Crushing Of Column Due To Improper Detailing**

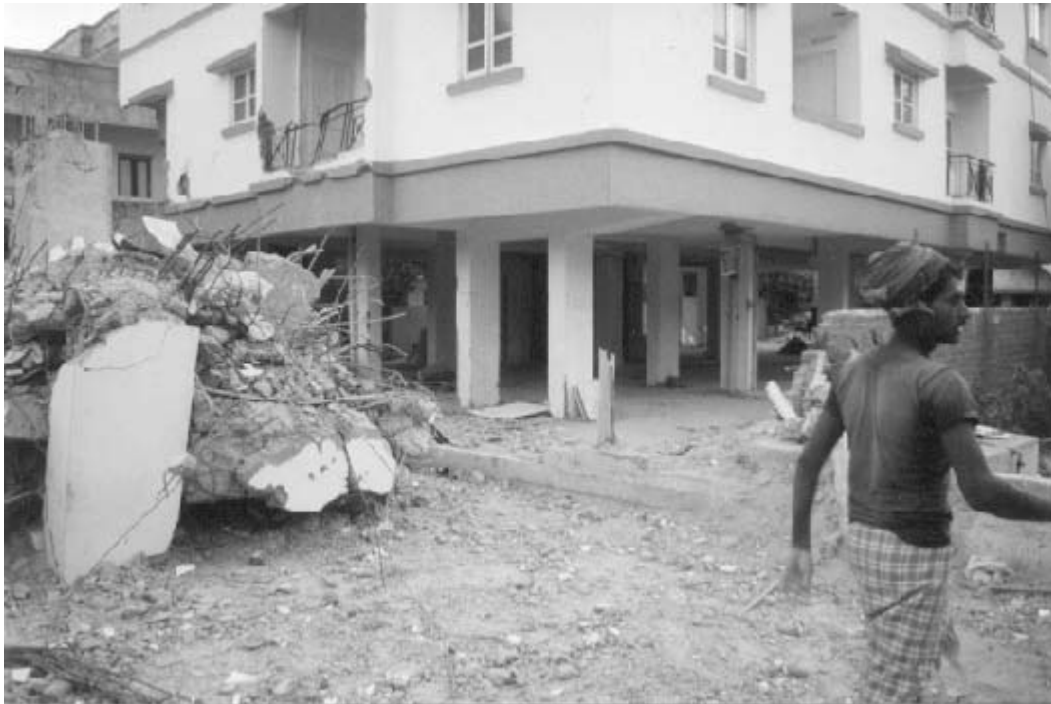
designing these columns otherwise failure is possible. Photo No 7 is from Ahmedabad, 250 km away from the epicenter. MSK intensity at Ahmedabad during this earthquake was V. As per seismic zoning map of India Ahmedabad is located in zone III where the probable intensity as per Comprehensive Intensity Scale (MSK) is VII. In Photo No.7 building on left hand side collapsed due to flexible ground floor. Building on right hand side is in intact condition, still seismic evaluation of this

building is essential because the building must be capable of resisting the MSK intensity VII. There are number of such buildings where seismic evaluation is essential. After seismic evaluation suitable retrofitting measures must be adopted to prevent failure of such buildings during probable earthquakes. Photo No. 8 shows building where infilled walls are provided in some portion of the building. In the critical portion of columns and beams special confining steel is essential. Anchorage of lateral ties is most important. Due to absence of these features the failure of column is visible.

**Photo No 7 Frame Structure With Flexible Ground Floor.**

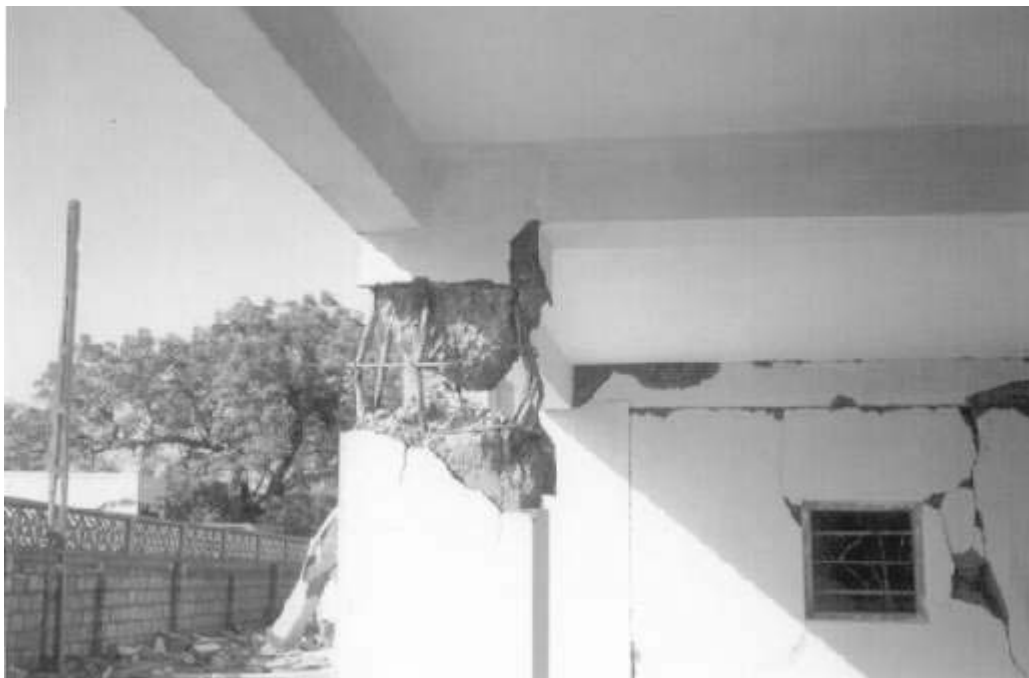
**Photo No 8 Failure Of Ground Floor Column**
