13th World Conference on Earthquake Engineering
Vancouver, B.C., Canada
August 1-6, 2004
Paper No. 2644

AN EXAMINATION OF DAMAGES OF REINFORCED CONCRETE CONSOLED BUILDINGS IN TURKEY DUE TO 17 AUGUST 1999 KOCAELI EARTHQUAKE

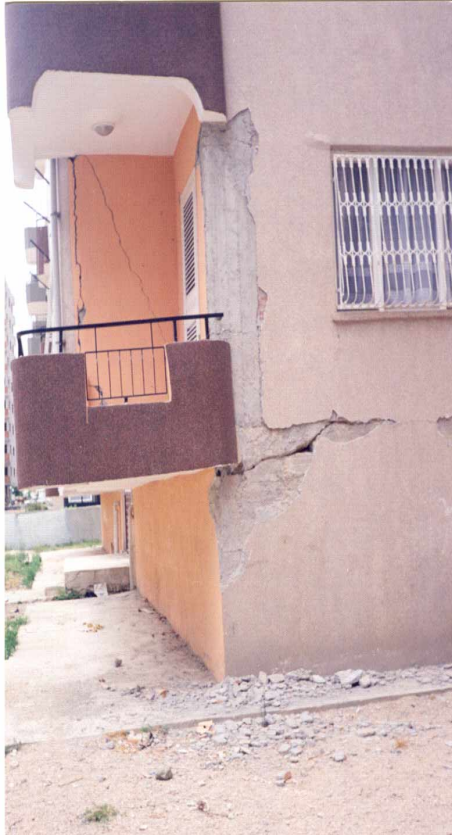
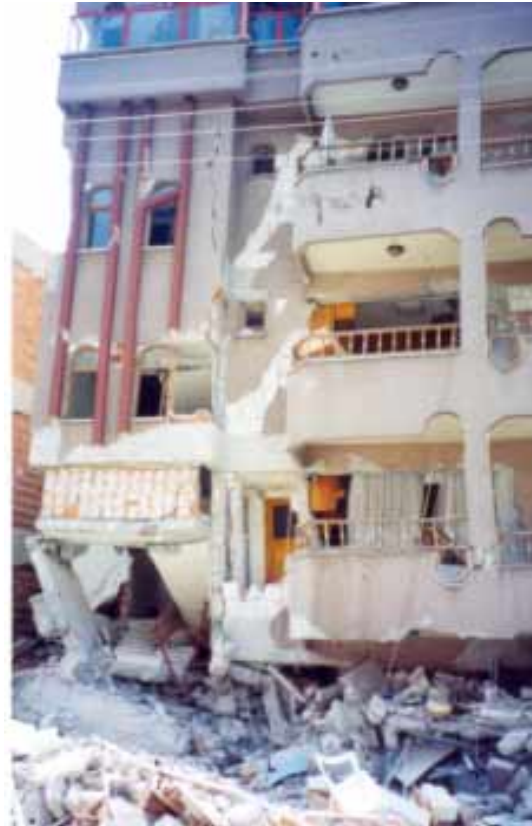
Figure 1 General view of two buildings having first kind of consoles damaged (a) moderately, (b) heavily

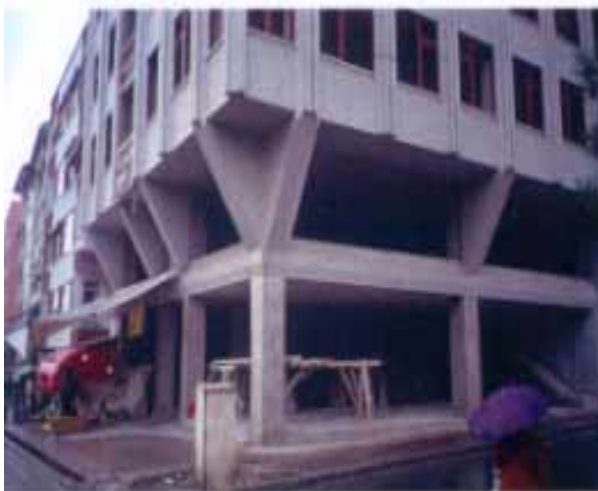
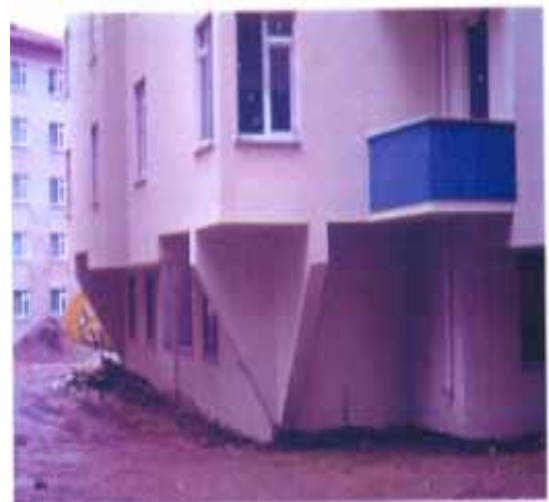
In the urban planning, the construction area in plan and the number of story of buildings are determined depending on various parameters, such as area of parcel, earthquake activity of the region and soil conditions. To obtain greater area of usage, in Turkey it is customary to arrange architectural consoles over ground floors and consoles are permitted up to 1.5m at the periphery of the buildings. In this case the extensions are produced by arranging either cantilever beams (first kind console) or offsetting the side columns to the periphery of the building and supporting them on corbels (second kind console). In the first kind of designs, architects do not prefer to see beams at the ceiling and the beams of the periphery frames are offset to the end of cantilever beams and the periphery walls are supported on those of beams (Figure 1). This application prevents to arrange regular frames, thus the structure becomes an irregular one. Usually balconies are located at the corners of the building (Fig. 1a). It is common that the earthquake damages of the infill walls are on the cantilever beams that the first kind consoled buildings (Fig. 1) moderate and heavy. Although they are not structural damages, it requires additional repairing costs. Sometimes the parts of the damaged walls can drop and it may cause injuries and even deaths. The general views of two buildings having the second kinds of consoles are given in Figure 2. As it is shown, all the side columns (Fig. 2a) or only corner columns (Fig. 2b) offset to the end of consoles and a vertically irregular structural system is arranged.

Figure 2 General views of two buildings having second kind consoles

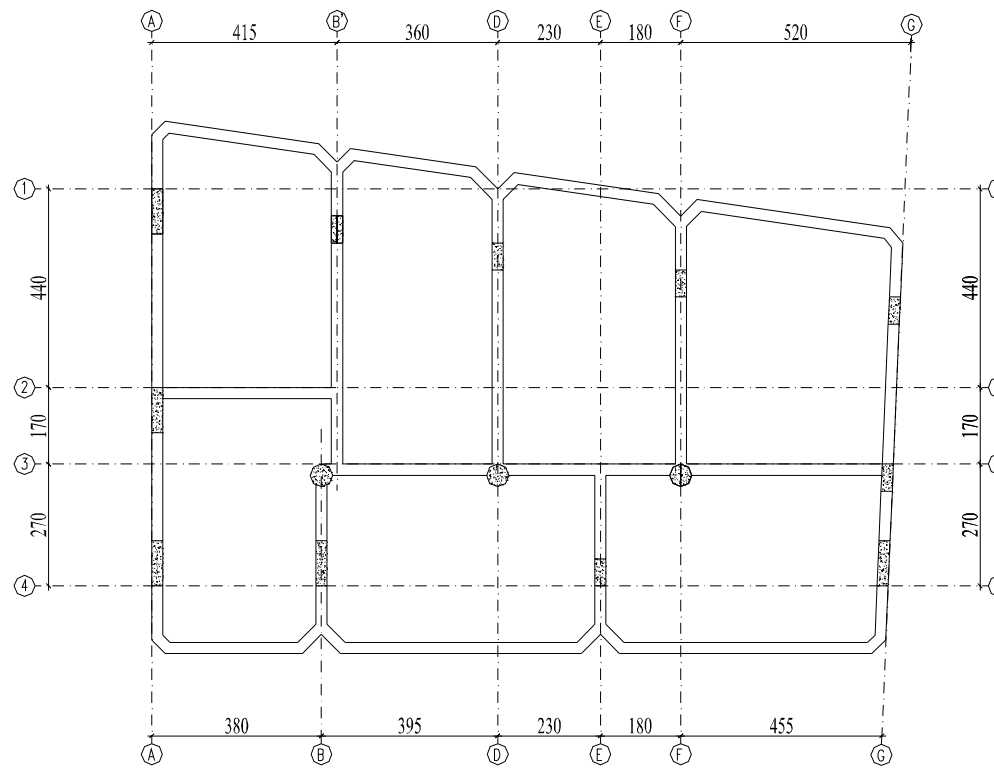
The explanations on structural system deficiencies used commonly are given in various slab plans, sections and pictures of buildings in and around of Istanbul. The first story slab plan of a building collapsed in the Kocaeli Earthquake is given in Figure 3. There are four frames in y -direction (the axis $A-G$), while only one regular frame exists in x -direction (the axis of 3). If there were no consoles a frame system could establish through the axis of 1 and 4. In the present case a significant eccentricity exists between the mass and rigidity centers which may produce large torsional effects, when the system is subjected to an earthquake. As it is seen, the main reason is the lack of a frame system due to the consoles.

Figure 3 Structural layout and deficiencies in the frame system

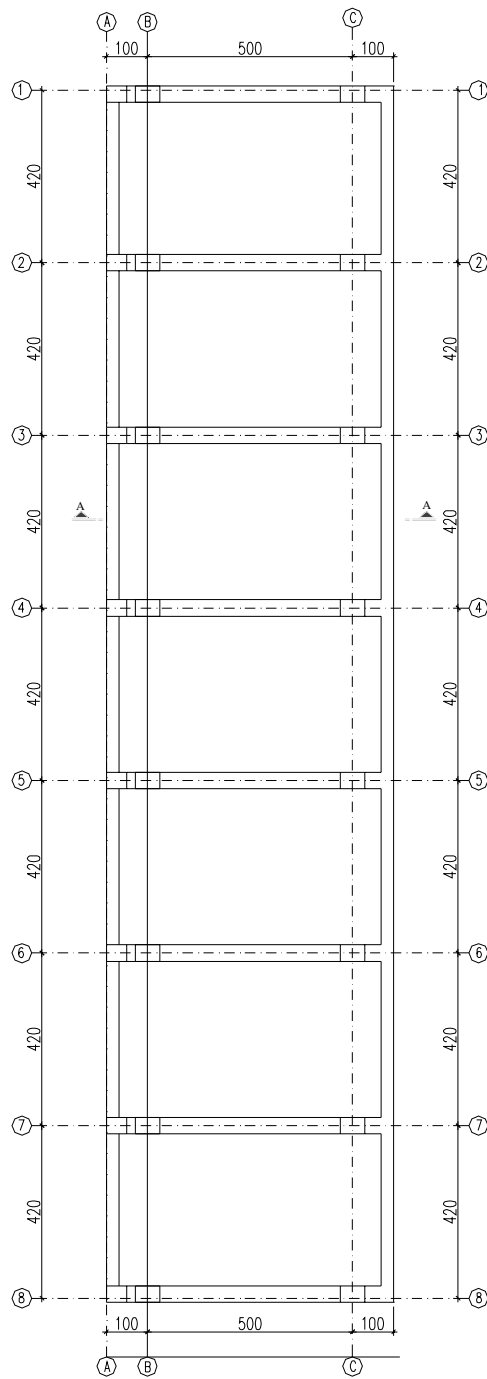
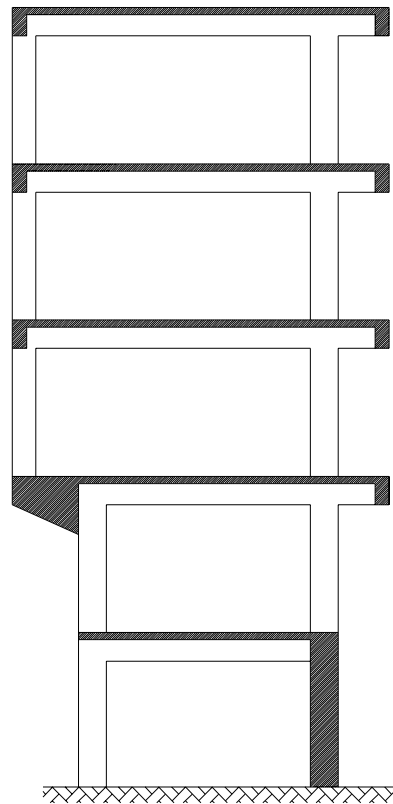
This arrangement is generally produced, because the structural engineers tend to fulfill the design needs of architects. The layout and elevation of a five-story building is given in Figure 4. As it is seen, the building has two kinds of consoles, cantilever beams through the axes of *I* to *8* on the right side and the corbels on the left side of the building. Over the level of second floor, no frame system exists along the short and long directions. The regular frame system is only established at the ceilings of the first and second stories and no any regular frame system exists at other stories. It is not easy to predict the behavior and the failure modes of that building under lateral loads. Slab plans and damaged pictures of a five-story building are shown in Figure 5. The closed consoles are arranged on the left and right sides of the building and a number of beams are usually supported indirectly and there is almost no frame on the axis between *A* and *G* (*y* direction). Frames are arranged between the axis of *G* and *O* and the center of rigidity is probably around the axis of *J*. It means that the torsional stiffness of the building is quite poor around the axes of *A* and *O*, while various regular frames are established between axes of *I* and *10* (*x* direction). During the Kocaeli Earthquake, the part of the building the axes between *A* and *F* (left part) were collapsed, while other part was still standing without heavy damages on the structural system. It is obvious that the reason of the building is not only due to the structural deficiencies, but also poor material (concrete) quality and workmanship of reinforcement decrease safety of the system. However, in the present case the dominant effect was torsion (eccentricity between the mass and the rigidity centers of the building was quite greater).

Figure 4 a) Structural layout b) elevation of building of five stories having two kinds of consoles

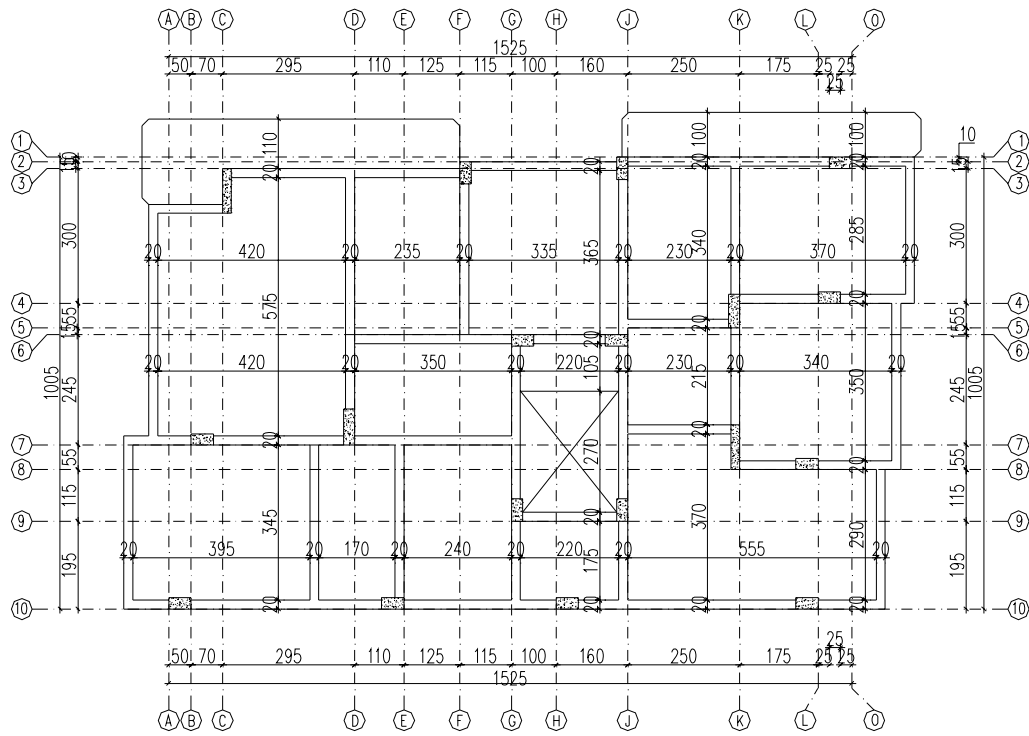
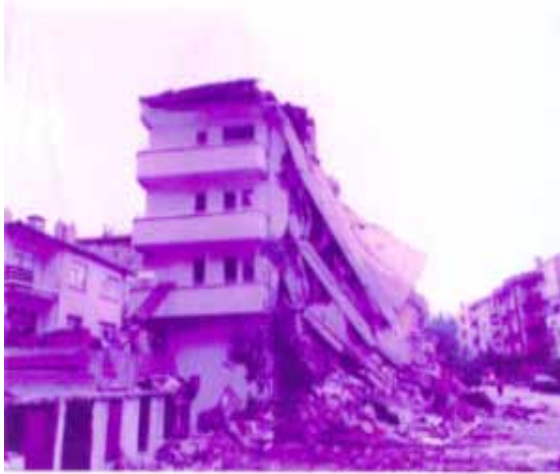
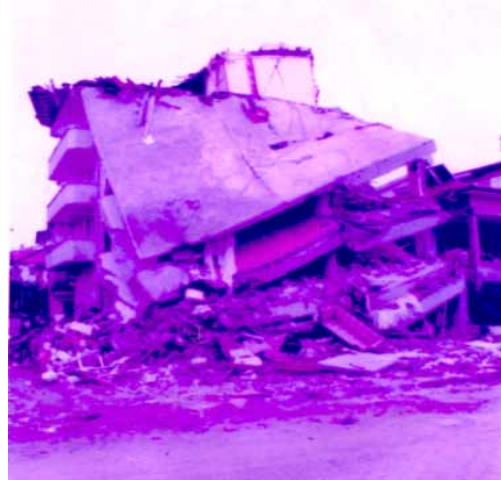
Figure 5 (a) Structural layout of the building of four stories, and (b,c) the same building after the earthquake

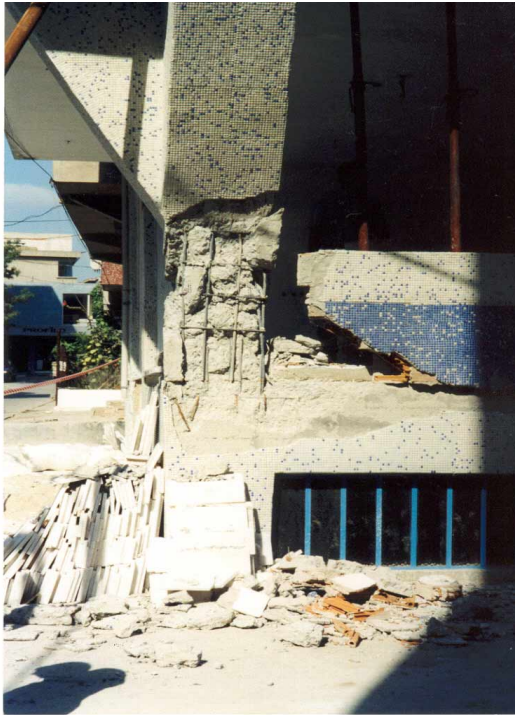
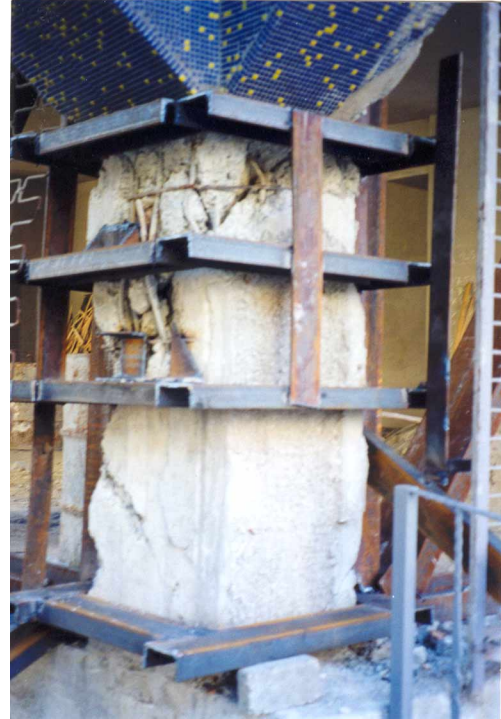
the main reasons of damages. Detailed definitions and provisions on regularities of structures in plan and elevation are given in Turkish Code. The design of second kind consoled buildings is not permitted. The corner columns of the two buildings damaged in 17 August 1999 Kocaeli Earthquake is shown in Figure 7a and 7b. The abrupt change in rigidity of the ground story changed the distributions of shear forces and the short column parts (the part between the corbel and the bottom end of the column) could not carry the additional shear forces due to by the torsional effects, consequently typical shear failure is developed just after the earthquake the damaged column (Fig. 7b) is temporarily strengthened. No damages detected at the corbels or at the inner beams connected to the corbels. It indicates that the main cause of the damage is deficiencies in the structural system and the existence of the short column. Moreover, poor material quality and workmanship of the reinforcement (including 90 degrees arrangement of stirrups) can be mentioned as the other main damage reasons.

Figure 7 Corner columns damaged heavily connected corbels in two directions (shear failure)

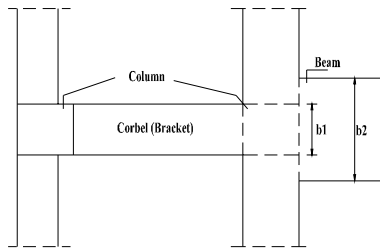
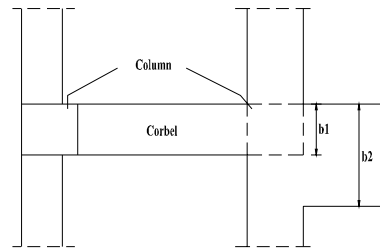
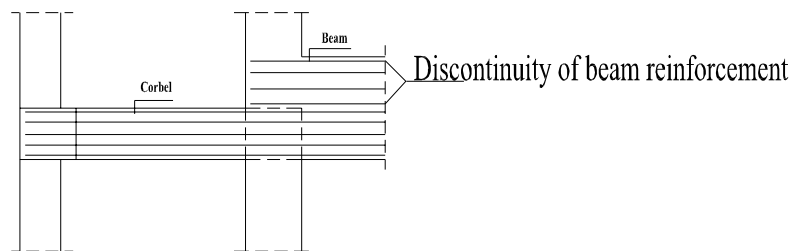
Figure 8 (a, b) Layout of corbel and internal beam connection and (c) discontinuity of reinforcement at the joint

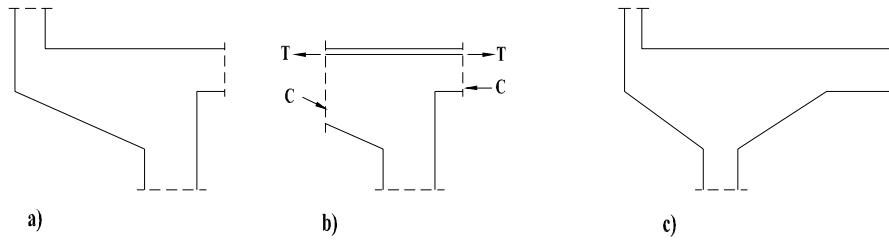
Figure 9 Elevation of corbel and internal beam (a) discontinuity, (b) unbalanced internal forces and (c) improved arrangement of the joint
