## NUMERICAL STUDY ON DAMAGE TO BURIED OIL PIPELINE UNDER LARGE FAULT DISPLACEMENT

**Endong GUO<sup>1</sup>, Guangbiao SHAO<sup>2</sup> and Hongli LIU<sup>3</sup>**

### SUMMARY

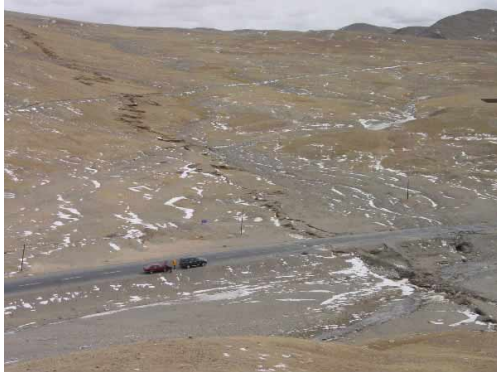
The ground surface rupture of Ms 8.1 earthquake traversed a road near Kunlun Mountain pass, the type of the fault is strike-slip with reverse slip. The maximum of horizontal displacement is about 3.5m, and the maximum vertical displacement is about 0.8m. Fig. 1 is sketch of the ground surface rupture. Fig. 2 shows the distribution of horizontal fault displacement on site of the pipeline. You can find that the fault displacement is larger in right, medium in left and smaller near the road.

Fig. 1 Ground surface rupture

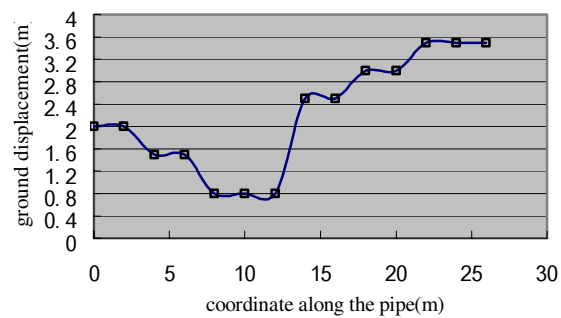
Fig. 2 Distribution of horizontal fault displacement

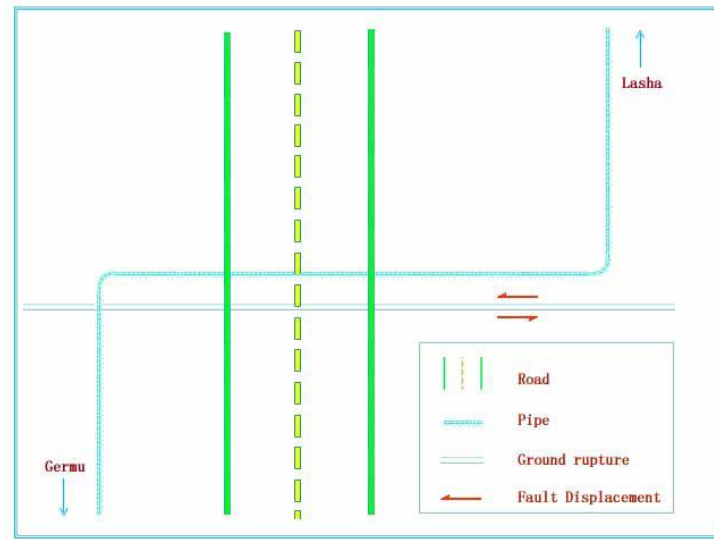
An oil pipeline passed through the road at the same place as the ground surface rupture. Fig. 3 shows the relative position of road, pipeline and the rupture. The pipeline can not withstand the action of fault displacement, it was definitely broken. Fig. 4 and Fig. 5 are photos of damage state of the pipeline after earthquake.

Fig. 3 Relative position of pipe, road and the rupture

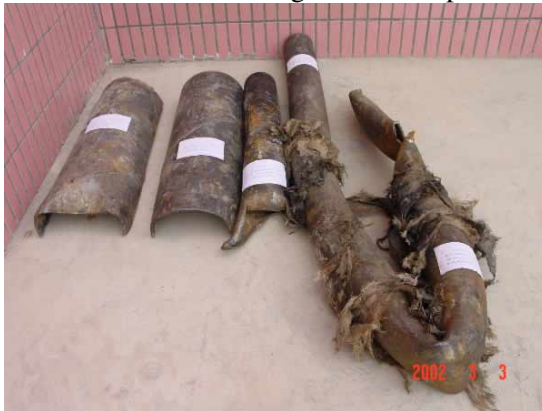
Earthquake	Ms 8.1 earthquake near Qinghai-Xinjiang border
Fault type	Strike-slip with reverse slip
Displacements of ground surface rupture	Horizontal: 0.6m~3.5m, Vertical: 0.0m~0.8m
Pipe	Oil pipeline with $\phi=17\text{cm}$ , $t=8.5\text{mm}$
Angle $\beta$ of pipe and surface rupture	$180^\circ$
Soil condition	Plateau frozen soil
Damage state of pipe	Z-shape buckling deformation 3m right to the road

Fig. 4 Pipe damage state(a)

Nonlinear finite element method was applied to study the damage of buried pipeline which had been broken on the Ms 8.1 earthquake near Qinghai-Xinjiang border. Z-shape buckling deformation was reproduced and the position of the buckling was in accordance with the post earthquake investigation. Parameter study results shown that the following seismic countermeasures could be recommended for pipeline crossing fault. a) try to use pipeline with larger diameter and thicker wall, b) reducing the restrain of the pipeline caused by site soil, better to bury the pipe with backfill which is softer, c) using pipe with high strength, d) it is better to adjust the direction of the pipe to the fault so as to avoid the pipe being in compressive state in future earthquake.

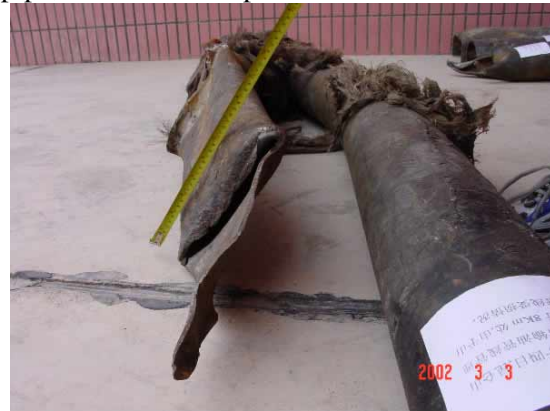
Fig. 5 Pipe damage state(b)

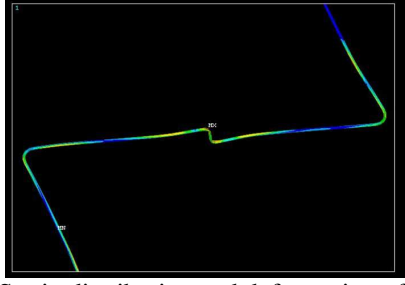
Based on the construction achieve of the pipeline engineering, a 3-D shell-spring finite element model was built to simulate the interaction of site soil and pipeline under fault displacement. The model consists of pipeline crossing the road and two 10m length pipeline parallel to the road. The pipe is modeled as shell element that local buckling and large deformation can be considered. Site soil is modeled as soil spring element. The two-linear strain-stress model is applied in the analysis. ANSYS was used to perform the numerical analysis. The damage state of the pipeline model was obtained with the same displacement input as post earthquake investigation. The pipeline suffered a buckling damage. The position of Z-shape buckling deformation was in accordance with the actuality. It is clear that the analysis method is practicable. Fig. 6 shows the strain distribution and deformation of pipeline model, Fig. 7 is Z-shape buckling deformation of the pipe model.

Fig. 6 Strain distribution and deformation of pipeline

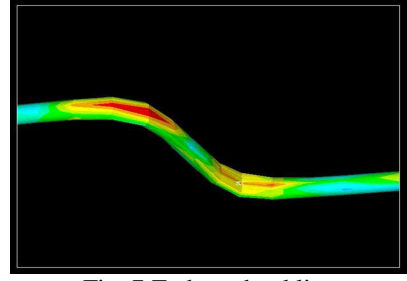
Fig. 7 Z-shape buckling

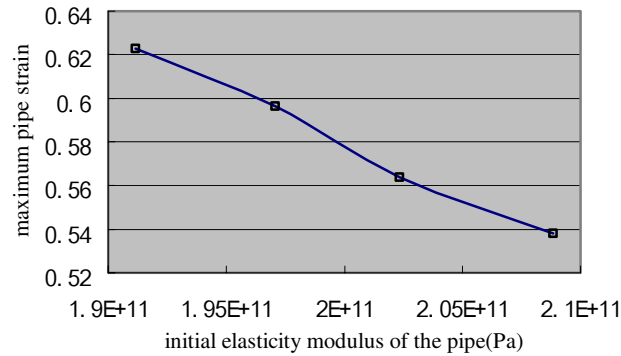
Based on the model above, a set of pipe material properties are proposed in the analysis. The maximum strain of the pipe with different initial elasticity modulus and same yielding point stress are shown in Fig. 8, it is obvious that the pipe strain becomes smaller when the initial elasticity modulus become bigger which means higher capacity.

Fig. 8 Pipe strain with variable pipe initial elasticity modulus

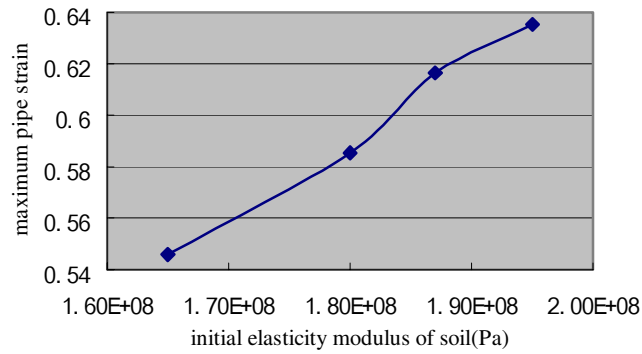
Soil spring stiffness is decided by the size of pipe element and site soil properties. Large pipe element and site soil with higher stiffness leads to larger soil spring stiffness. The soil stiffness is related to its initial elasticity modulus and yielding capacity. Pipe strain calculating results with different elasticity modulus are compared, as shown in Fig. 9, while soil elasticity modulus increases, the strain responses of pipe elements goes up, it is clear that softer site soil is better for pipe crossing fault.

Fig. 9 Pipe strain with different initial elasticity modulus of soil

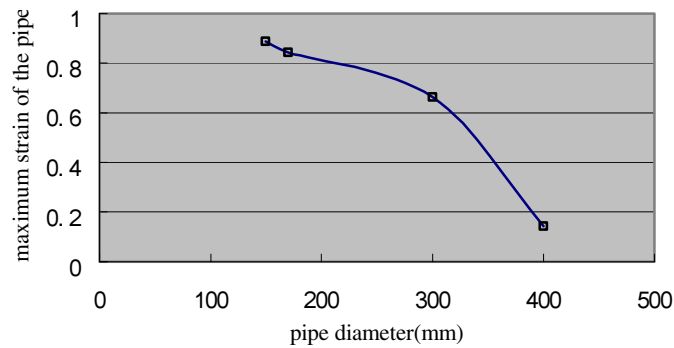
For pipeline with different diameter of 150mm, 170mm, 300mm and 400mm, other parameters remain the same, the pipe elements' maximum strain response is 0.8870, 0.8424, 0.6638 and 0.1439 respectively, the analysis shows that larger diameter pipelines can resist larger fault displacement.

Fig. 10 Pipe strain with different pipe diameter

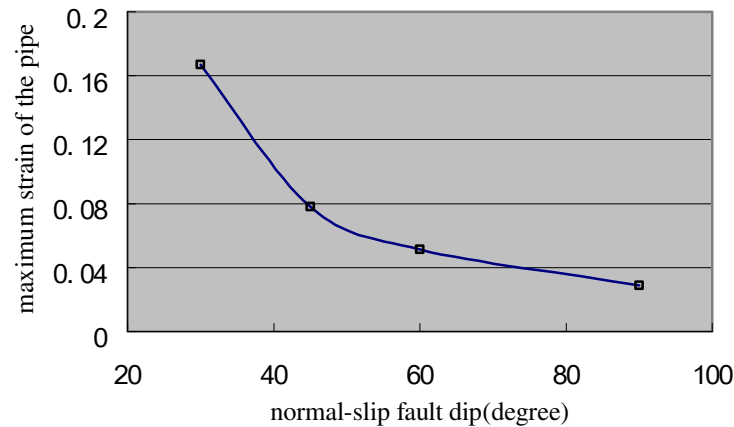
Under the action of same normal-slip fault displacement with different fault dip of 90 degree, 60 degree, 45 degree and 30 degree, the maximum pipe element strain is 0.029, 0.0511, 0.0782 and 0.167 respectively. It means that gentle dip leads to larger pipe element strain. As to reverse fault with fault dip of 45 degree, 60 degree and 90 degree, the maximum pipe element strain is 0.089, 0.0378 and 0.029 respectively, it also means that gentle dip results in larger pipe element strain. From the study, it implies that fault dip of 90 degree is not the most dangerous case under certain site conditions.

Fig. 11 Pipe strain with different dip of normal-slip fault

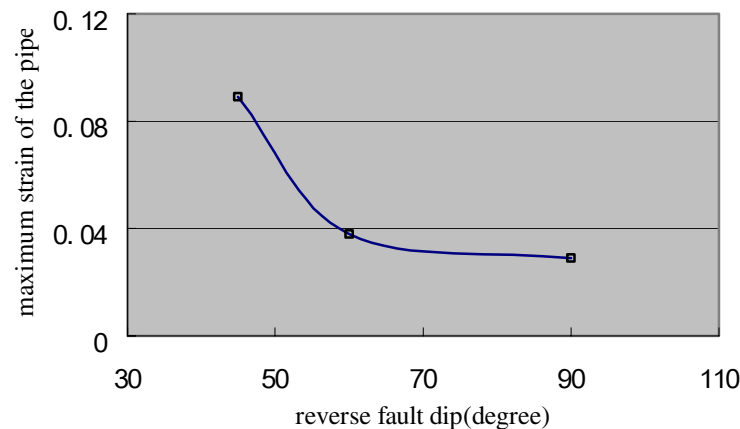
Fig. 12 Pipe strain with different dip of reverse fault
