## **SPATIAL DISTRIBUTION OF PIPELINE DAMAGE IN DÜZCE CAUSED BY THE 1999 KOCAELI AND DÜZCE EARTHQUAKES**

**Iain TROMANS<sup>1</sup>, David MARLOW<sup>2</sup>, Julian BOMMER<sup>3</sup>**

### **SUMMARY**

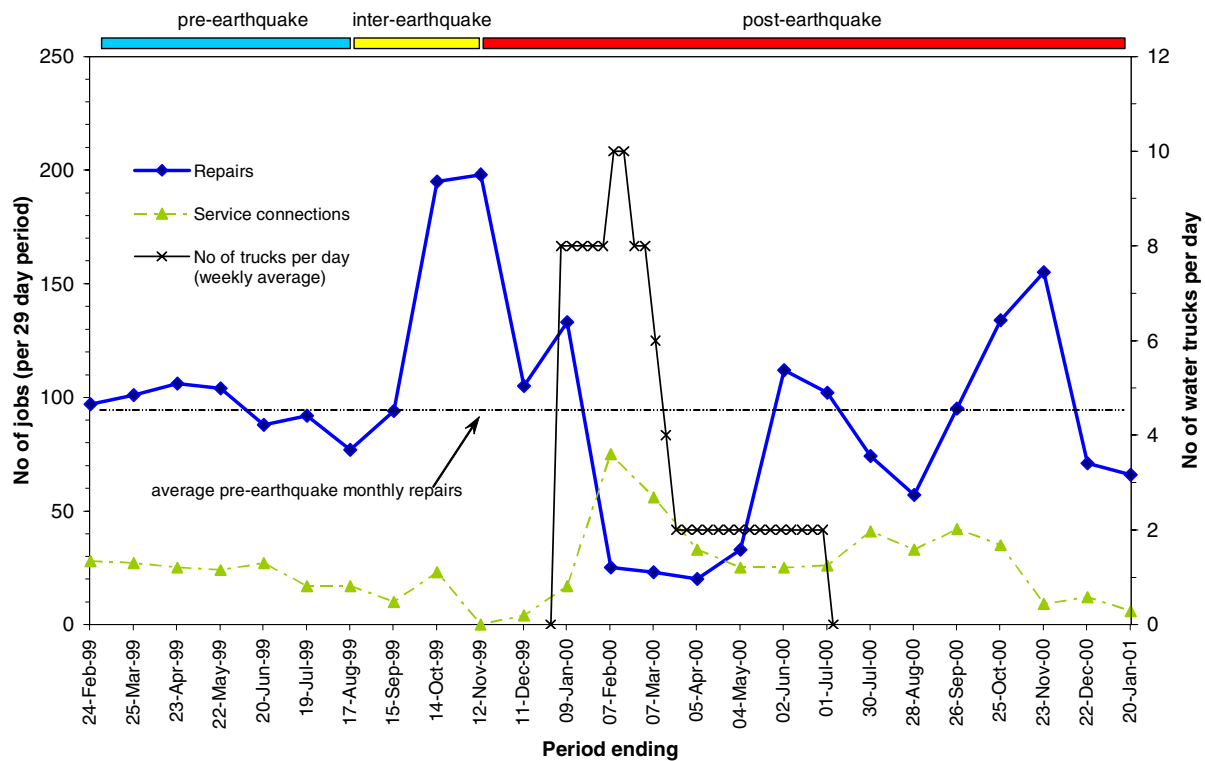
It was decided to aggregate the pipeline repair data according to nominal monthly periods. As time between the Kocaeli and Düzce earthquakes corresponds to exactly three 29-day periods, this was taken as the nominal month length. The temporal variation in network repairs for the whole of Düzce is plotted in Figure 3. Prior to the Kocaeli earthquake, the network repair rate is seen to be very stable from month to month. Immediately after the earthquake, there was a marked increase in pipeline repairs. A monthly repair rate about twice the pre-earthquake level was sustained for 2 months, which reflects the response of

the Municipality to the extensive earthquake damage to the water network. A sharp drop in repair rates to almost pre-earthquake levels occurred in the month immediately following the Düzce earthquake. This corresponds to the two week period during which the majority of water division staff were repairing the 600 mm diameter AC transmission line which suffered extensive damage where it crossed the Düzce fault zone (ASCE/TCLEE [8]). Once this work had been completed, attention was returned again to the water distribution network, evidenced in the sharp increase in numbers of repairs carried out in the period ending 9 January 2000. This was followed by a sharp decrease for a period of four months to an average repair rate around a quarter of pre-earthquake levels. A UNICEF field report dated 13 March 2000 (UNICEF [9]) stated that 90% of mains pipes in Düzce were reported to be functioning following the extensive post-earthquake repair works. The trend observed in the repair rate suggests that the majority of repairs to the most important pipes had already been completed some time between 9 January and 7 February 2000. This conclusion is also supported by the trend observed in the time line of service connections. The sharp reduction in mains repairs between January and February coincided with a sharp increase in service connection jobs. Such a shift in focus in work carried out by the Water Division staff is only likely to have happened once the mains network had been largely re-established.

**Figure 3 Temporal variations of network repairs, service connections and provision of potable water by truck within Düzce.**

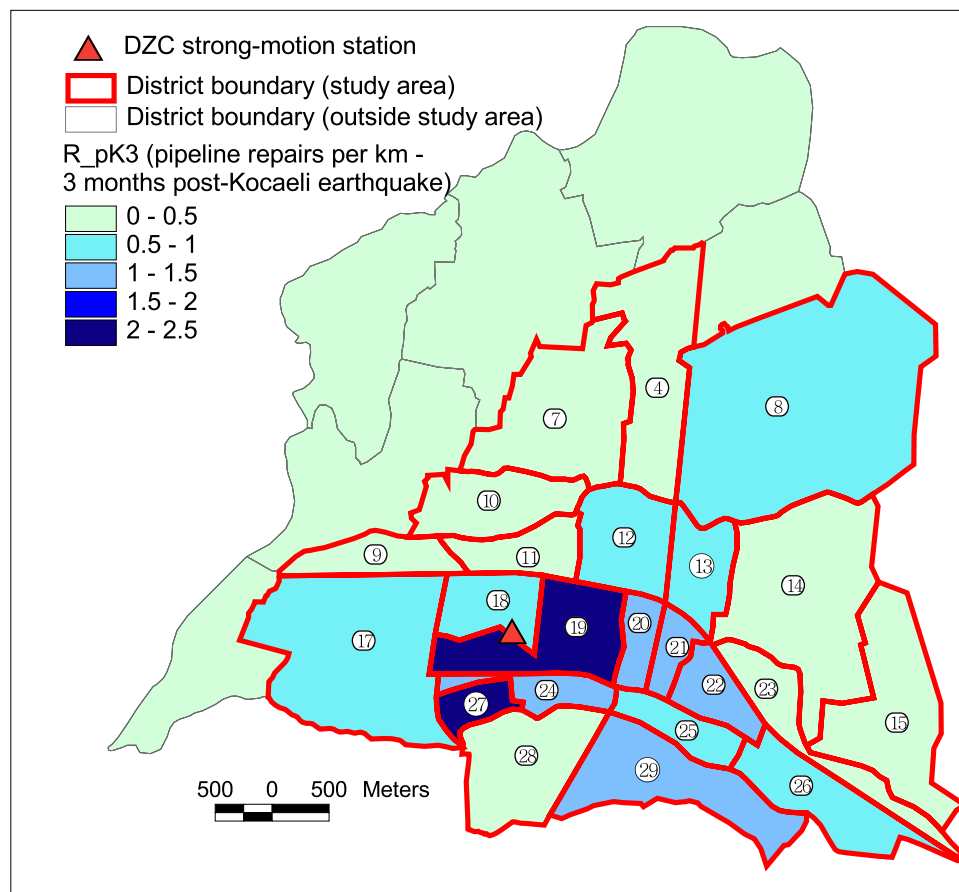
From the trends observed in the time lines, it was decided to aggregate the monthly post-earthquake repair data from the log books according to three time-frames. These datasets, along with the pre-earthquake repair data, formed the basis of the spatial analysis. The time-frames and descriptions of the quantities are summarised in Table 2. Values for each quantity for each district are summarised in Table 1. The spatial distribution of the post Kocaeli repairs,  $R_{pK3}$ , is illustrated in Figure 4.

**Figure 4 Post-earthquake pipeline repairs (per km of pipe) summed over the 3 months immediately following the Kocaeli earthquake,  $R_{pK3}$ .**

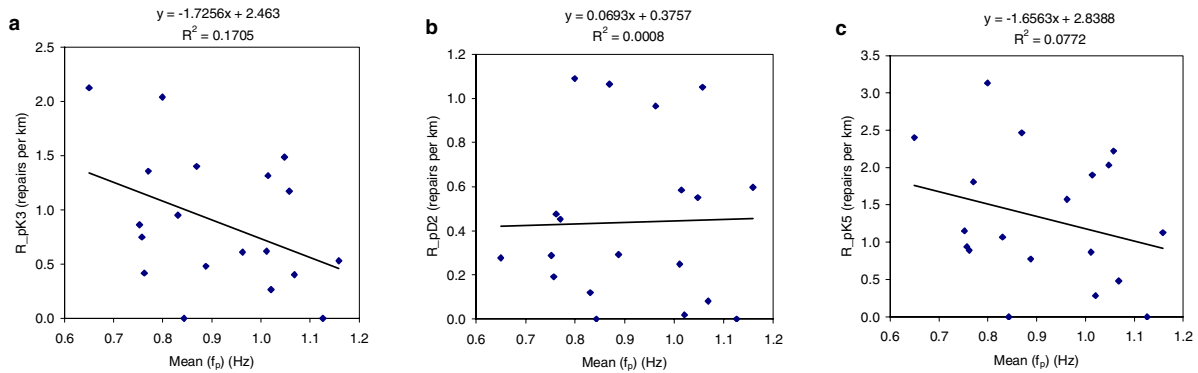
**Figure 7 Relationship between mean  $f_p$  and various pipeline damage parameters**

The relationships between various damage parameters and the mean value of  $f_p$  are presented in Figure 7. Regressions excluded data from districts outside of the central part of Düzce (as explained in the Introduction) and additionally, districts 4, 7, 8 and 10, which had very sparse microtremor survey coverage. Figure 7 (a), which represents damage from just the Kocaeli earthquake, appears to show decreasing pipeline damage rates for higher values of mean  $f_p$ , as anticipated. However, the  $r^2$  value for

this dataset is very low (approximately 0.17), calling into question the significance of any apparent trend. The correlation between mean  $f_p$  and the quantity  $R_{pK5}$  is even less significant. Any dependency of pipeline damage on site conditions in Figures 7(b) and (c) is obscured by uncertainties in pipeline damage statistics following the Düzce earthquake.

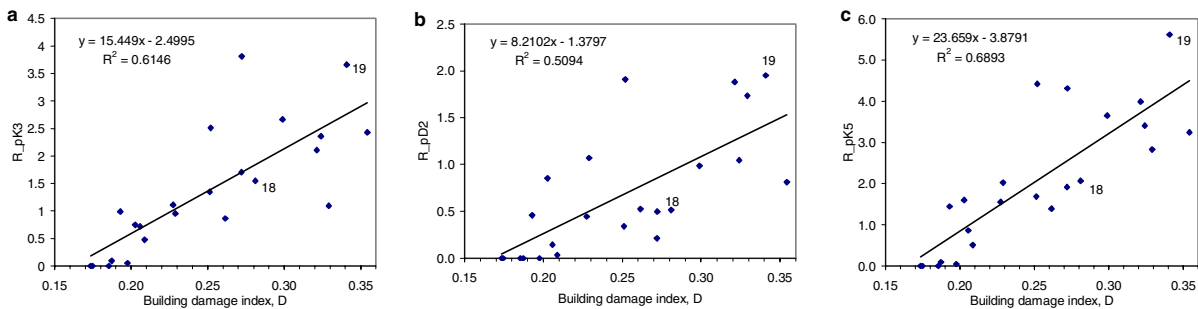
Comparisons between measures of pipeline damage and the building damage index,  $D$ , are presented in Figure 8. All three measures of pipeline damage are seen to correlate reasonably well with building damage, with  $r^2$  values ranging from 0.51 – 0.69. It is notable that the best correlation is seen for  $R_{pK5}$ , which includes the combined effects of both the Kocaeli and Düzce earthquakes (as is the case for the building damage statistics).

**Figure 8 Comparison between pipeline damage rates and building damage rates for all districts of Düzce. Data points referring to districts 18 and 19, in the vicinity of DZC strong-motion station, are highlighted.**

None of the trends shown in Figure 8 passes through the origin. This implies that a greater level of ground motion is required to cause pipeline damage than building damage. O'Rourke [27] observed no pipeline damage in areas with  $PGV < 10$  cm/s as a result of the 1994 Northridge earthquake. Isoyama [28], in deriving pipeline fragility relations based on data from the 1995 Hyogoken-nanbu earthquake, suggested strong-motion thresholds of  $PGV = 15$  cm/s and  $PGA = 100$  cm/s<sup>2</sup> for pipeline damage to occur.

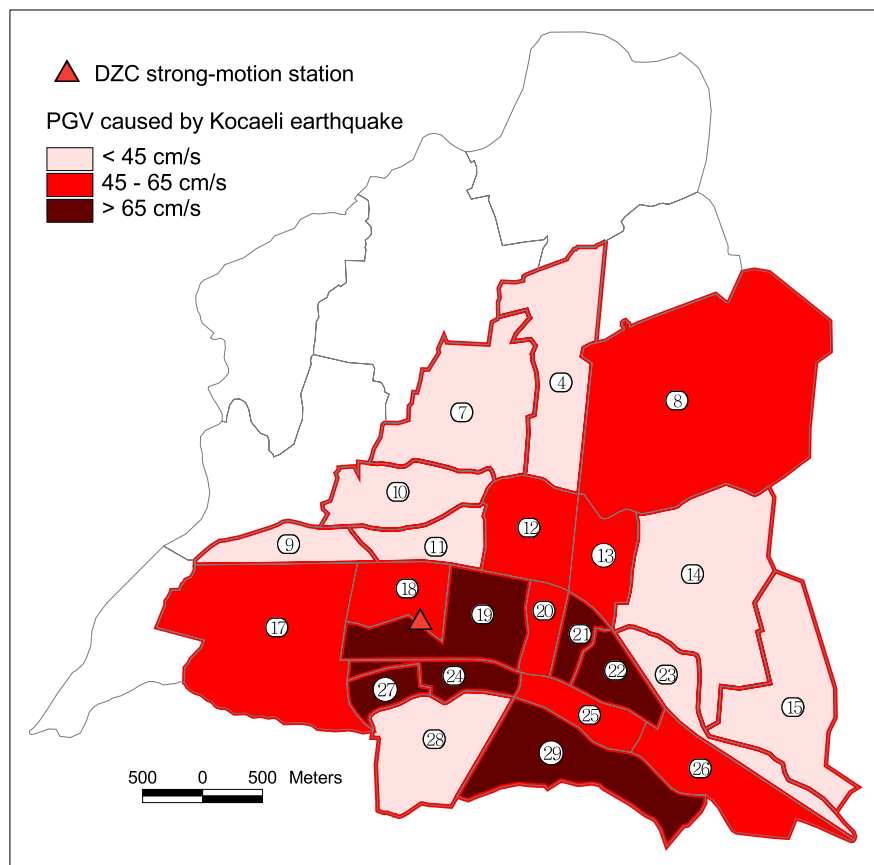
**Figure 9 Estimated distribution of PGV in Düzce as a result of the Kocaeli earthquake, inferred from pipeline damage distribution. Predictions are in terms of  $PGV_L$ , the largest of the two horizontal components of PGV.**

Figure 9 shows the distribution of PGV as a result of the Kocaeli earthquake, inferred from pipeline damage data. This map is based on the assumption that the strong-motion experienced at DZC was representative of the district in which it is located (district 18). PGV was calculated using the HAZUS fragility relationship, which predicted a pipeline damage rate in district 18 very similar to the observed value (see Table 3). Due to the uncertainties associated with the data, predictions have been restricted to three levels of PGV:
