Seismic Upgrade of Prestressed Concrete Water Tanks

Eric Fieberling¹ and David Lee²

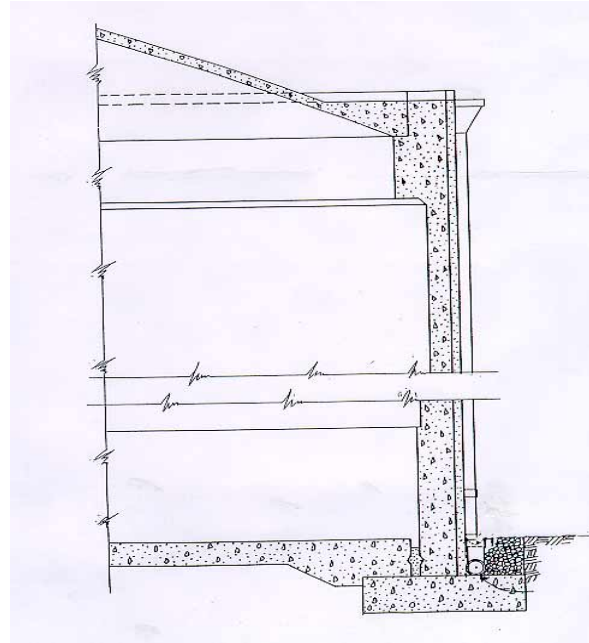
Figure 2. Typical Wall Section

The tanks were built with little connection between the wall and ring footing or interior slab. The wall base was designed to move radially outward with increased water inside the tank. The outer edge of the interior slab sits on the footing with a continuous “ring” joint between slab and the interior face of the tank wall. Figure 2 shows a typical wall section. Beginning in the early 1950’s radial keys were cast in the ring footing (and bottom of core wall) to resist tangential in-plane wall movement but allow radial outward movement. However, the shear capacity of the keys is well below the expected earthquake forces. Excessive movement of the wall would breach the ring joint seal causing severe leakage. Pounding against the interior slab would cause excessive stress in the slab and wall resulting in damage and possible permanent deformation.

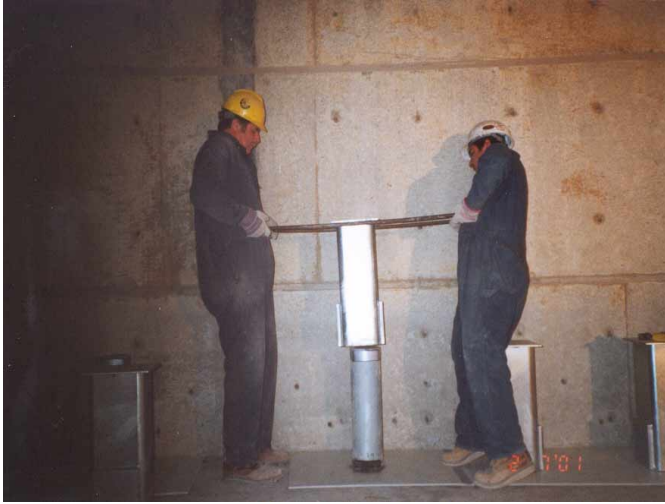
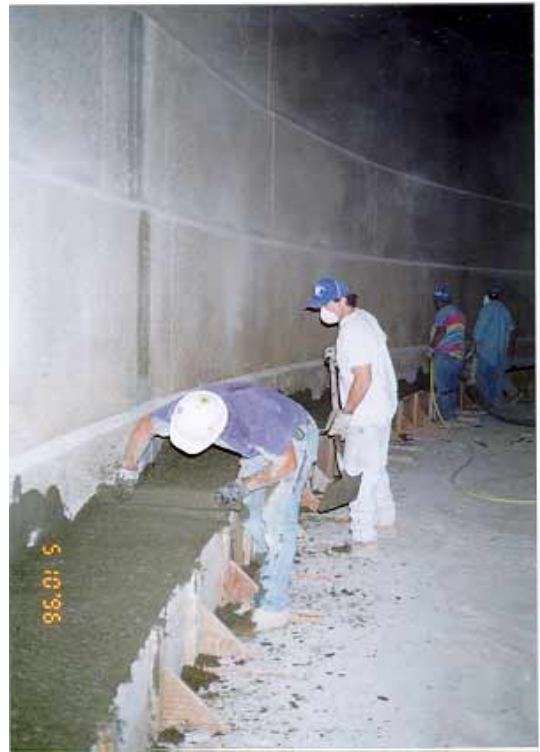
Figure 3. Interior Sliding Restraint Curbs

Two primary design methods have been developed and constructed to resist sliding. The first incorporates new interior perimeter concrete curbs with connections to the existing floor slab and the tank wall. For this method the tank must be drained for the upgrade. The curbs are poured tight against and dowelled to each vertical wall panel. The curb ends are separated by gaps at each of the vertical wall joints. The bottom rests on a slip pad and the floor slab connections consist of steel pipes inside tube steel sockets. The steel pipes are grouted into the floor slab and filled with grout. This allows for wall movement in the radial direction for normal hydrostatic and thermal loads but provides resistance in the tangential direction (i.e. parallel to wall) for seismic loads. The seismic sliding load is thus transferred to the slab is ultimately resisted by friction on the soil below the slab due to the weight of the contents. Figure 3 shows construction photos of a typical interior curb.

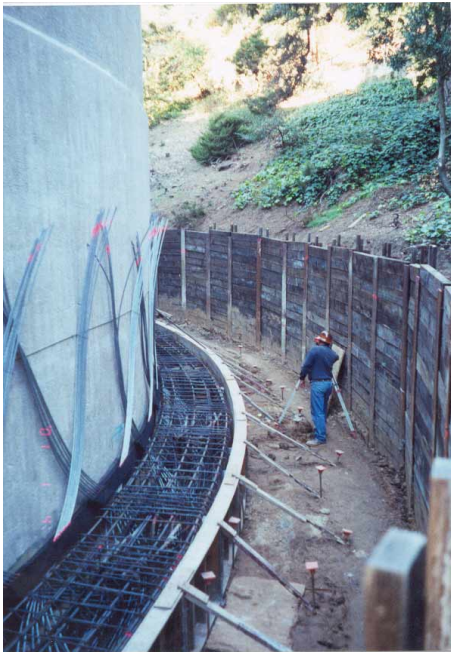
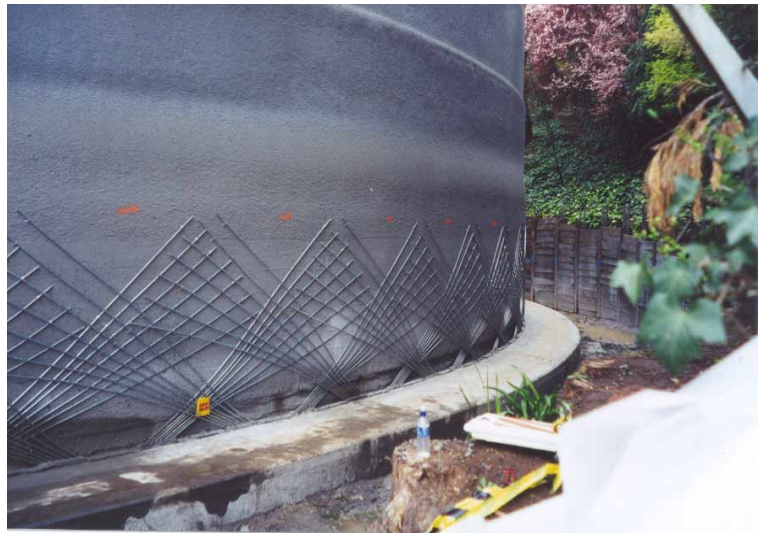
Figure 4. Exterior Seismic Cables & Ring Footing Addition

The second method includes an exterior ring footing addition with diagonal seismic cables attached to the exterior wall surface and extending into the footing. The ring footing addition is typically anchored to the foundation sub-grade with drilled concrete piers. This upgrade can be done even if the tank remains in service. The cables are high strength galvanized seven-wire strands and bond to a layer of new shotcrete on the wall under the new prestressing. The cables pass through a neoprene sleeve at the wall base to allow for perpendicular wall movement. Figure 4 shows construction photos of this method.

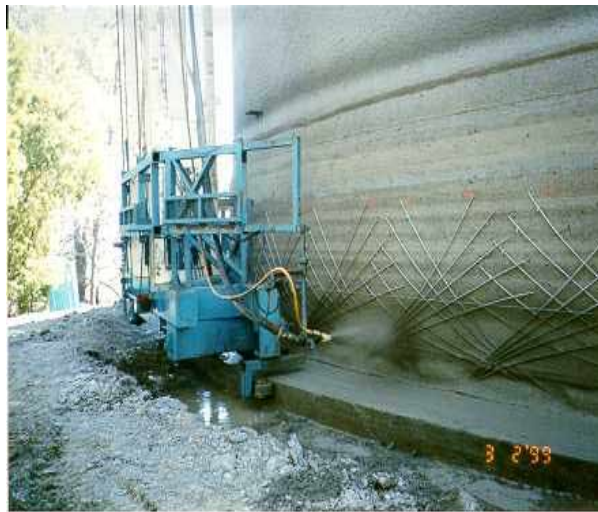
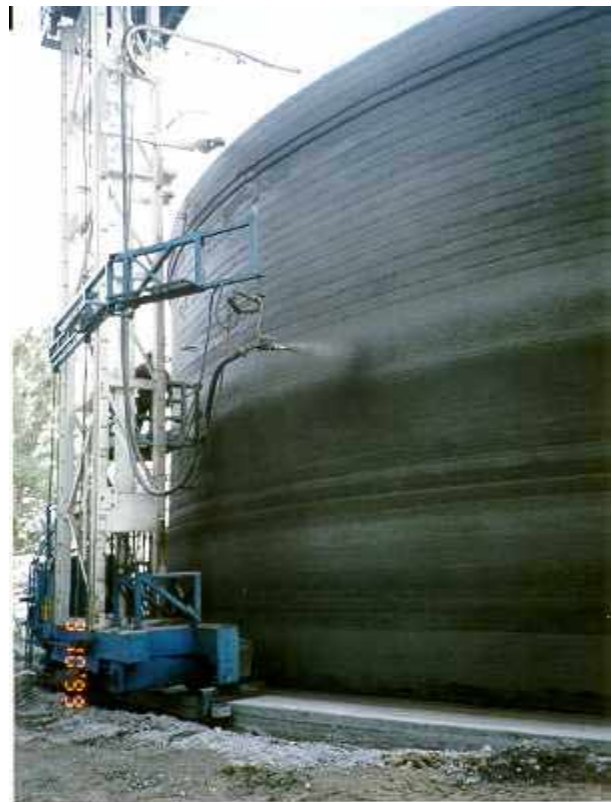
Figure 5. Automated Wire or Strand Wrapping and Shotcrete

To mitigate hoop tension overstress, new circumferential wire-wound, strand-wound, or tendon prestressing is applied to the tank. The degree of new prestressing depends on the area of steel, remaining force and condition of the existing prestressing. Elastic shortening will also further reduce the force in the existing prestressing. On most tanks, wound wires (or strands) have been preferred due to economics and quality control. The wires or strands are high strength steel, hot dipped galvanized and applied with an automated wrapping machine that continuously monitors the applied stress. Two inches of shotcrete cover is applied over the wires (or strands) to bond and protect them. Photos of the wrapping machine and shotcrete application are shown in Figure 5 below. Tendon prestressing has been primarily used on smaller tanks that have lower demand (i.e. less degree of hoop overstress) or for tanks that have little clearance around the tank or difficult access for a wire or strand-wrapping machine. The Tendons are typically epoxy coated 7 wire strands, greased and encased in plastic sheathing. They are applied by hand and tightened with hydraulic jacks at coupling anchors located at specific points on the tank circumference. The couplers are staggered between tendons and friction losses are monitored to ensure a uniform application of stresses on the tank. Figure 6 below shows a relatively small but tall tank with tendons installed prior to the application for shotcrete. The shotcrete is required for protection against corrosion and vandalism. This method is typically not as economical as wire or strand wrapping due to the automation of the wrapping and shotcreting.

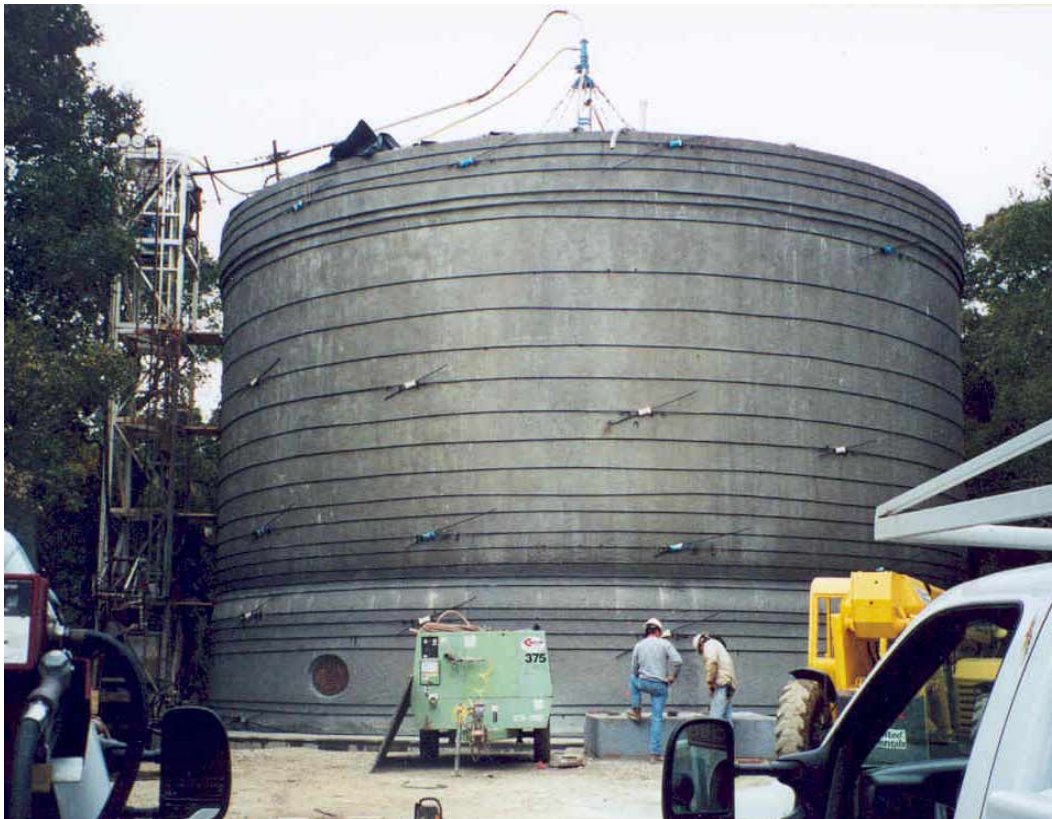
additional dead load to resist uplift. At a few sites with high uplift demands and rock sub-grades, rock anchors consisting of grouted multiple strands, were used. The anchors were installed in grouted holes drilled tight against the tank wall & through the existing ring footing. The top of the strands were splayed out and attached to the tank wall prior to the application of shotcrete and strand wrapped prestressing. The new prestressing and shotcrete provide sufficient bond to anchor the strands.

Figure 6. Post-tensioned Tendons prior to final shotcreting
(Note: bottom of wall has new seismic cables that are encased in new shotcrete)
