BUILDING DAMAGE PATTERNS IN BINGOL-TURKEY AFTER THE MAY 1ST, 2003 EARTHQUAKE

Ahmet TURER¹, Ahmet YAKUT², Ugurhan AKYUZ³

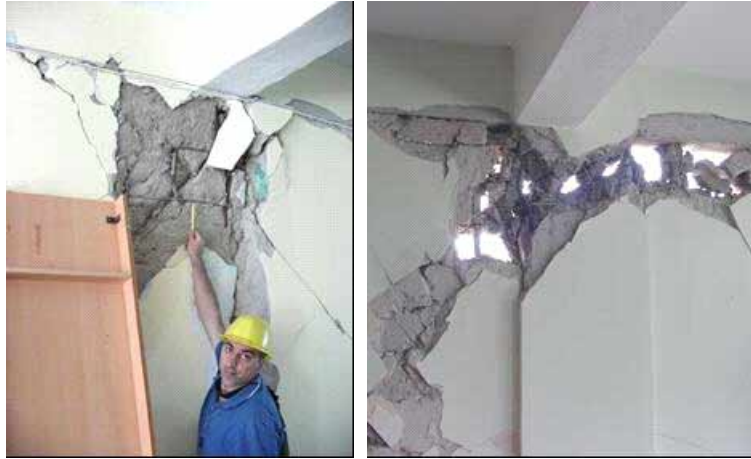
A spectacular example of the diagonal tension crack at the upper end of the column due to a combination of inferior material quality and inadequate transverse reinforcement is shown in Figure 5. These columns belong to a three-story residential building. In this building, despite extremely poor performance of the columns, the masonry walls, which were made of unreinforced solid brick blocks, are believed to have prevented the total collapse.

Figure 5 Column hinging and shear

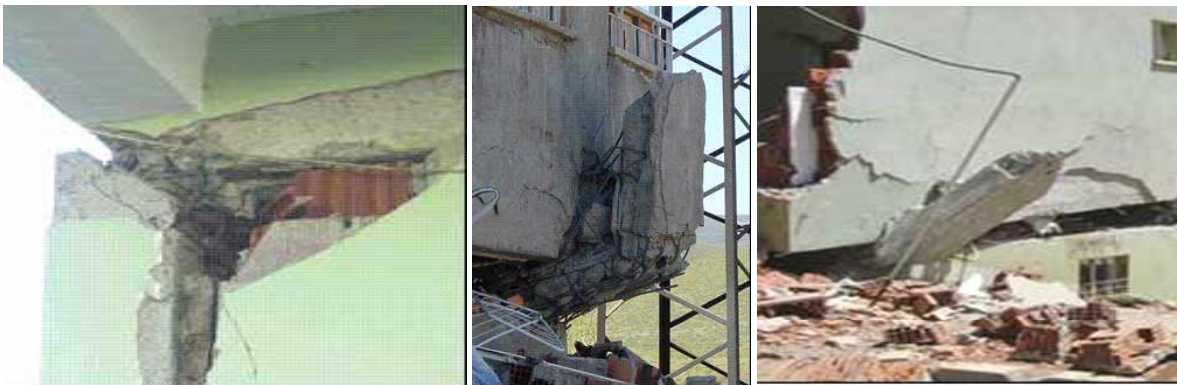
Figure 6 shows loss of story in reinforced concrete frame buildings due to insufficient column confinement. As it is known, insufficient structural resistance combined with the poor construction quality and detailing causes catastrophic failure of the structures. Shear failure, plastic hinging, and joint failure often times coexist at the same time causing member dislocations and floor collapses.

Figure 6 Column connection shear/dislocation in weak axes

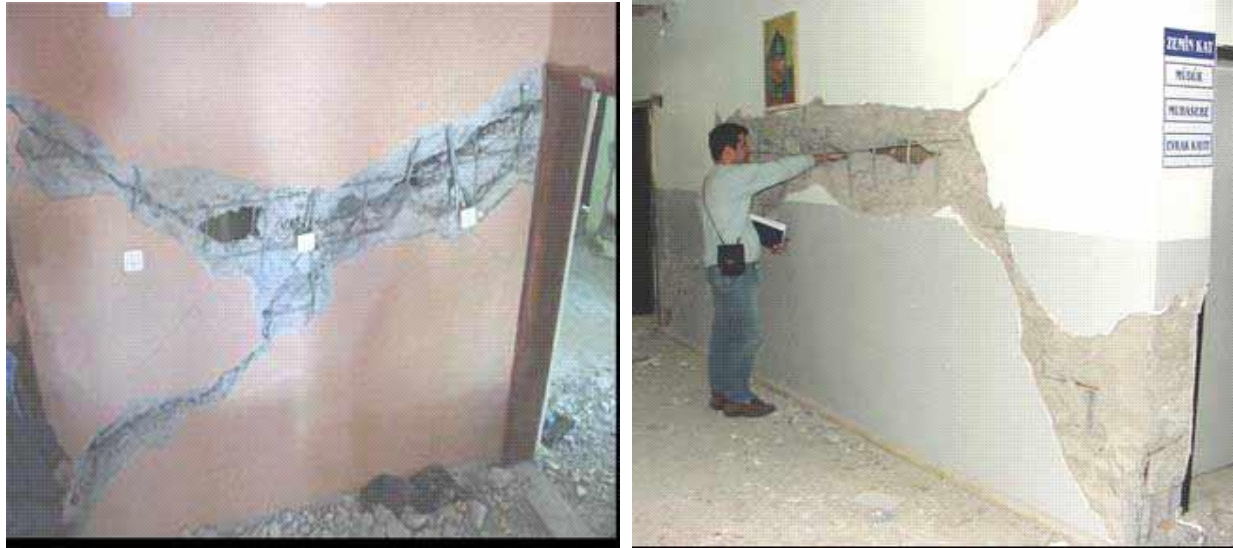
Among the concrete buildings that were surveyed throughout the city only a few had limited and in some cases primitive shear walls contributing to their lateral load resistance. The presence of these shear walls very likely prevented the collapse of the buildings despite their inferior material quality. The walls picked up a significant part of the seismic force experiencing substantial damage. In Figure 7 heavy damages in shear walls are given. Once again substandard construction and material quality were the major factors that led to heavy damage.

Figure 7 Heavy damage to shear walls

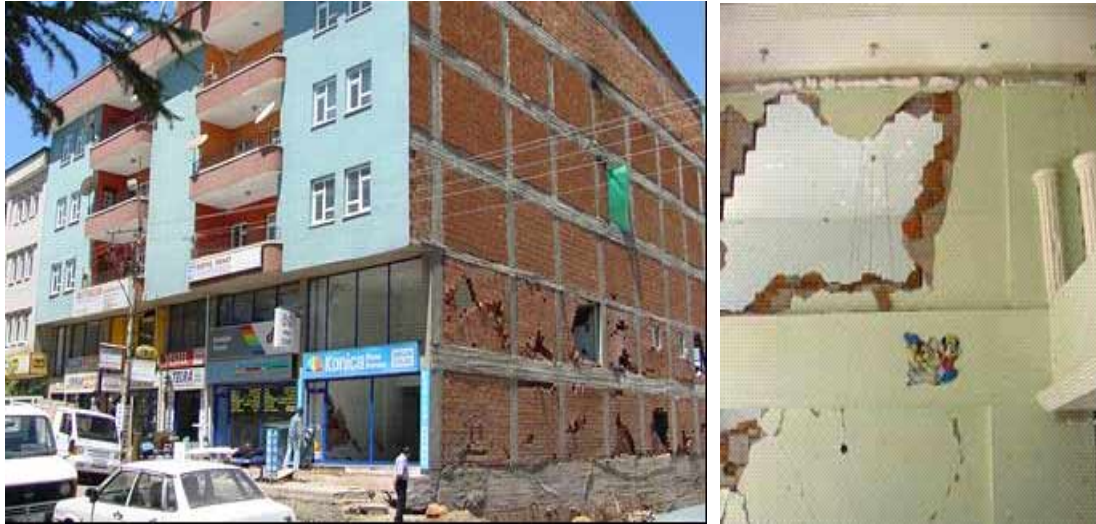
Besides heavy damages, there were some buildings which experienced moderate damage indicating that load-resisting elements performed well with respect to life-safety. An example of such building is given in Figure 8. This building does not have any shear wall and the resistance to lateral loads was mainly provided by the columns and hollow clay tile infill walls. The increased strength demand in the first floor was supplied by the contribution of infill walls as evidenced by heavy infill wall damage concentration in that floor.

Figure 8 Infill wall damage
