SEISMIC DAMAGE OBSERVED ON PREFABRICATED INDUSTRIAL STRUCTURES AFTER 1999 EARTHQUAKES IN TURKEY AND PROTECTING MEASURES

T. Öztürk¹ and Z. Öztürk²

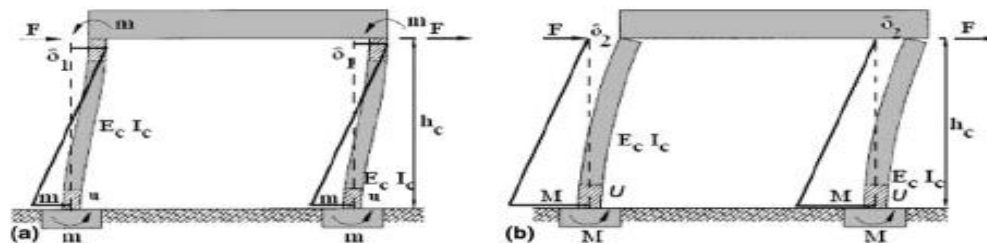
Depending on the supervision of the concrete fabricated and reinforcement qualities of the prefabricated members, no material-based deficiency has been observed in the prefabricated structures (Aydogan, 2002; Arslan, 2006). Satisfaction of sufficient strength, lateral rigidity and ductility, is a crucial concern for such structures. Previous research demonstrated that the most vital complication in prefabricated structures is sustaining the lateral loads exerted during earthquakes (Tankut, 2000). The industrial-type structures especially with their fixed-base and crown-hinged (reverse-pendulum type) design tend to convert the entire lateral load to displacement by Eqn. 2.1. In Fig. 2a, a system possessing monolithic joints and in Fig. 2b, a crown-hinged system are presented. The displacement in the latter system far exceeds that of the former. Another significant distinction among the systems is the variation in the location of the potential plastic hinge formation. Whereas in Fig. 2a hinging occurs at both tips of the columns with a moment having a value of u , in Fig. 2b, it forms at the bottom ends of the columns with a moment reaching a value of U , where U is twice u . The weakness of the crown-hinged prefabricated system regarding both lateral rigidity and ductility can clearly be seen ($U > u$, $M > m$, $d_2 > d_1$). In the light of the above explanation, the pictures of failed prefabricated structures are worth examining (Fig. 2).

Figure 2 Monolithic and hinged prefabricated systems

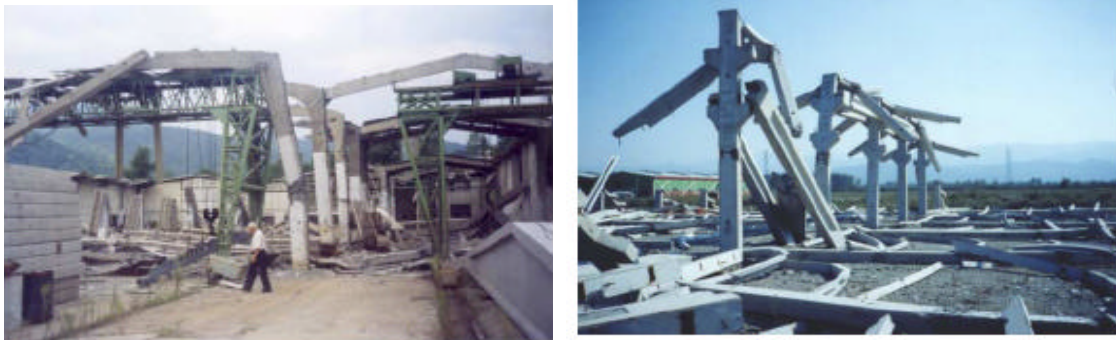
TEC-98 states that the structural behaviour coefficient R may be assumed as 5 for hinged connection frames. When this value is compared with that of in situ cast frames, i.e., 8, it corresponds to a 60% increase in lateral loads for the former. The inter-storey drift is limited to a maximum value of 0.0035. Furthermore, while the code allows only 1 storey construction for crown-hinged structures, it also insists on the requirement of in situ cast shear wall application for higher storey construction. Following the earthquakes, numerous totally failed and many highly damaged prefabricated buildings were reported (Zorbozan, 1998; Ersoy, 2000). An inventory illustrating the damage status of the buildings constructed in the region by the Turkish Prefabricated Construction Association member firms is given as follows: total number of precast building 481, heavily damaged 17, partially damaged 14 and non-damaged 450. Even though the number of damaged structures seems low, tens of failed buildings were excluded from these records. In Fig. 3, the post-earthquake view of a structure is portrayed.

Figure 3 Overall collapse of the prefabricated systems

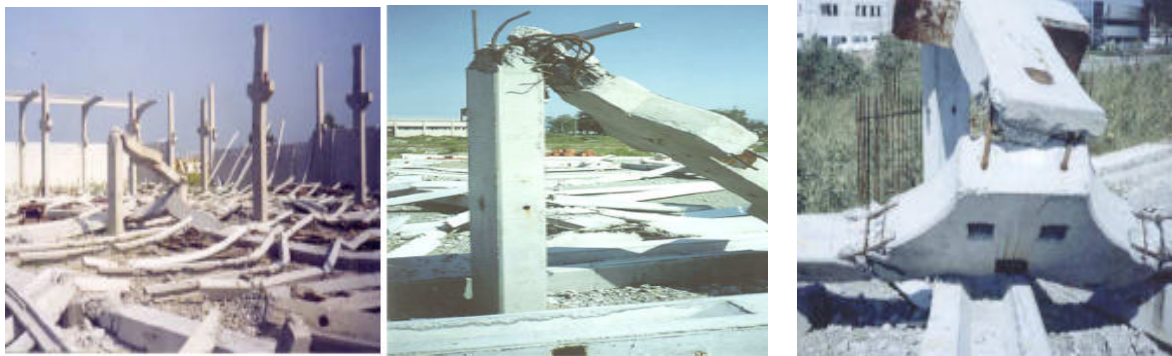
7) The presence of exterior walls besides non-existence of interiors particularly in buildings having two or more spans resulted in differential displacements out-of-plane. In such structures, columns located in the span experience more out-of-plane displacement compared to the column-couples at the sides. In some prefabricated systems, damages concerning this type of failure were observed.

Fig. 4 has been shot from a double-span prefabricated industrial structure constructed in Adapazari Organised Industrial Zone. Columns in the middle were damaged (and failed) significantly compared to the columns in the edges. Fig. 4 shows the post-earthquake state of the interior-column and interior-beam connection section of a triple-span one-storey industrial site constructed in Izmit.

Figure 4 Seismic damage of the system
