## SEISMIC PERFORMANCE OF ELECTRICAL SUBSTATIONS' EQUIPMENTS IN IRAN'S RECENT EARTHQUAKES

### ABSTRACT:

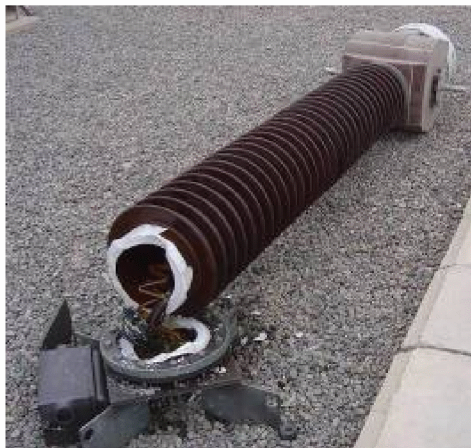
two main rigid bus bars. The configuration of this substation is almost one and half breaker which has a high degree of redundancy. Current transformers in 4 of the 6 modules were pot-headed and therefore very vulnerable in which 70% of them experienced severe damages and toppling. In figure 2 a broken CT is shown. Toppling of an equipment can cause damage to adjacent ones. Figure 3 shows a broken circuit breaker due to the failure of the attached current transformer. It should be noted that in some cases the connection of the conductor to the top of the equipment has been flexible enough and this has helped the equipment not to fall. One of these flexible along with the weak clamps are shown in figure 4.

Figure 2: A broken CT

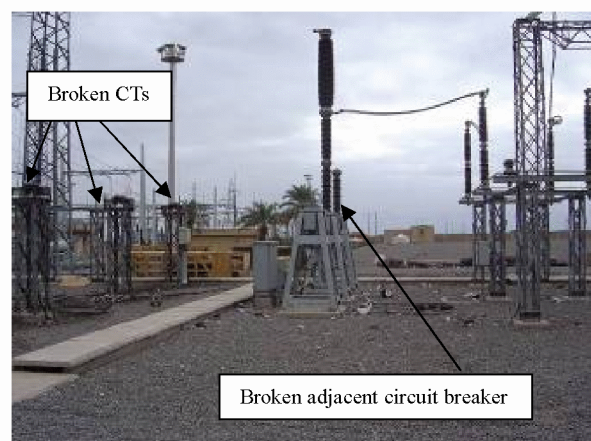
Figure 3: Fallen adjacent equipments

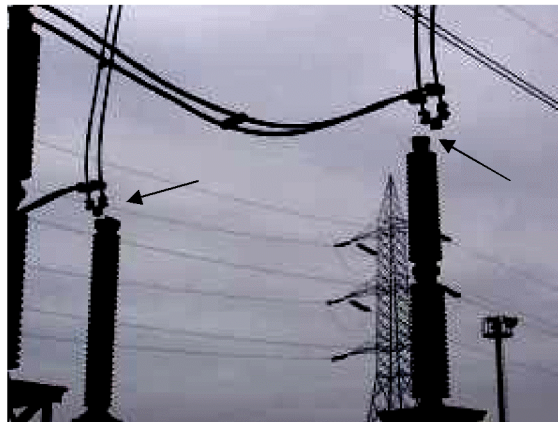
Figure 4: A flexible clamp

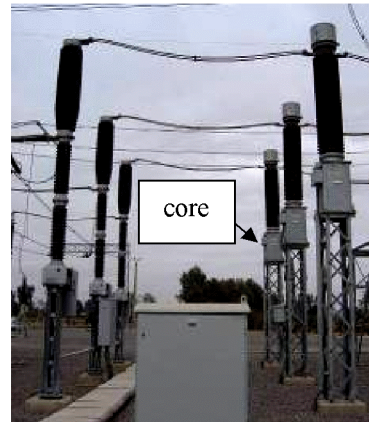
In the cases of current transformers with an electrical core near the base or supporting lattice structure no damage has been reported. As seen in figure 5 the adjacent equipments are not damaged as well.

Figure 5: standing equipments

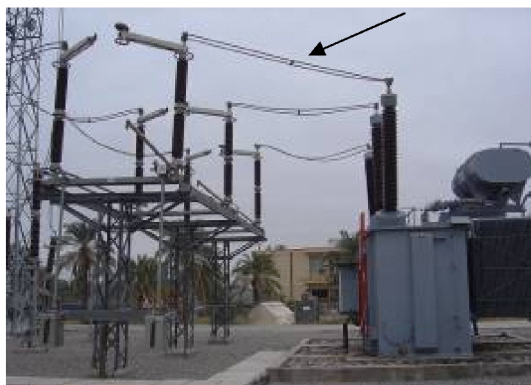
In this substation an electrical reactor with no anchorage at the base has slid about 30 cm. The weight of this equipment was almost 70 tons. According to this sliding movement the disconnect switch connected to this component has been pulled by the conductors and has gotten damaged. Figures 6 and 7 show this interaction.

Figure 6: Pulled conductor

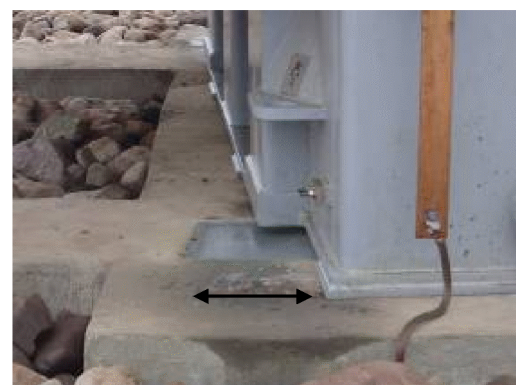
Figure 7: Sliding of non-anchored equipments

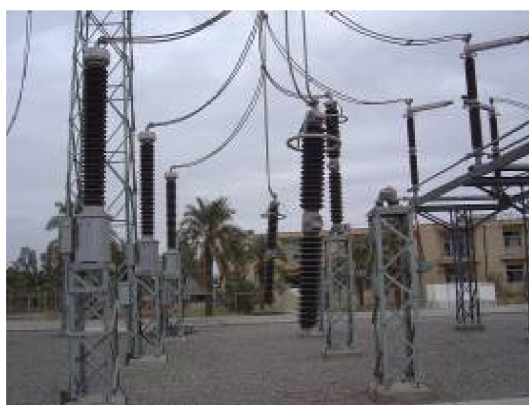
The surge arresters in this substation experienced extensive damage. Figure 8 illustrates one of these equipments. The voltage transformers in this substation and the post insulators, as shown in Figure 9, were completely safe and only the flexible connection to the equipment was broken.

Figure 8: Broken surge arresters

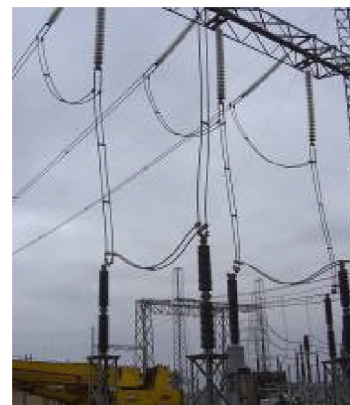
Figure 9: PI and voltage transformers

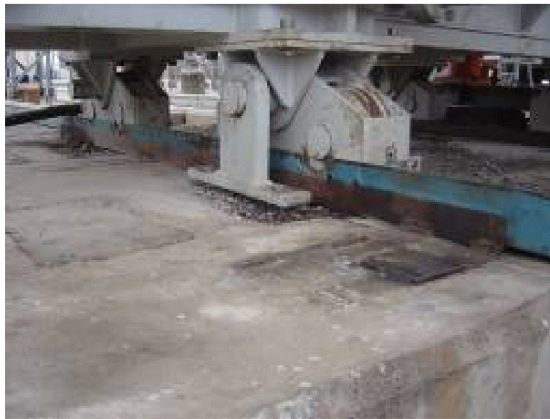
At this part of the substation two similar power transformers had been installed. One of this transformers (T3) did not experience any damage because it has been under service and all the connections were off, but the other one slid on the concrete pad about 50 cm due to lack of base anchorage. Figure 10 shows this movement. Due to this sliding the transformer bushings were pulled and cracked at its base, where connected to the steel part, and this led to oil leakage. The cracked bushing is shown in figure 11.

Figure 10: Transformer base after retrofit

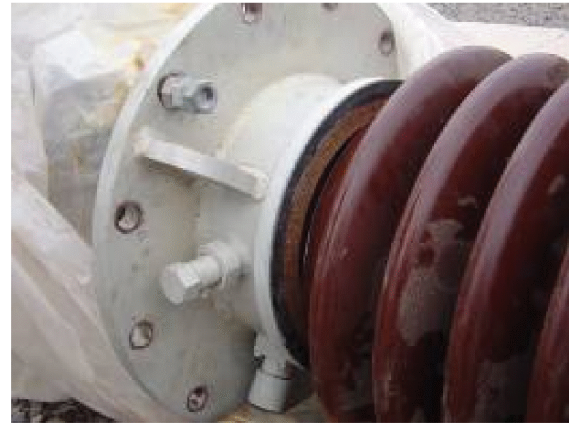
Figure 11: Cracked bushing

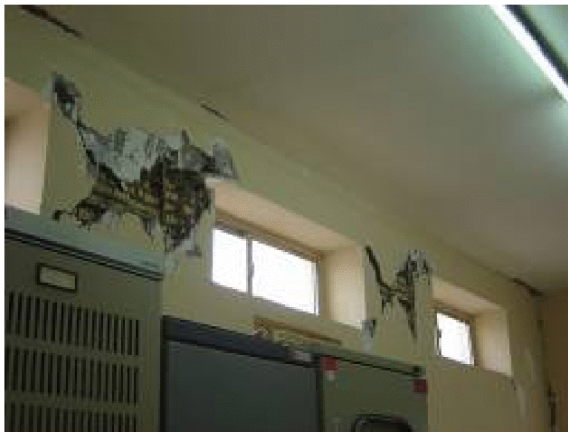
There is a control building in each of the two mentioned areas. The nonstructural elements in these buildings got slightly damaged, especially the batteries in the battery room which were not supported sufficiently. The control panels were bolted to the building floor, and they did not experience any damage. Figures 12 and 13 illustrate the damages to the building and DC batteries respectively.

Figure 12: Damages to control building

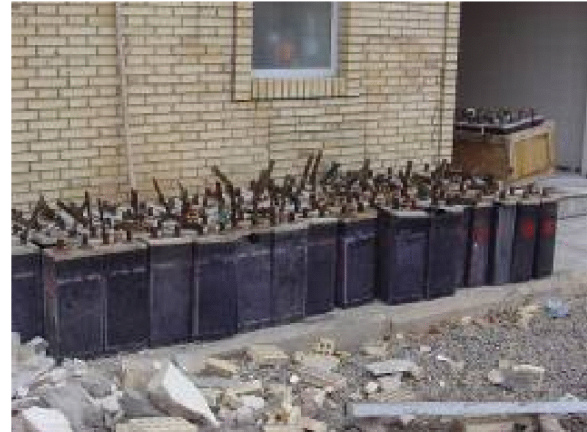
Figure 13: Damaged batteries

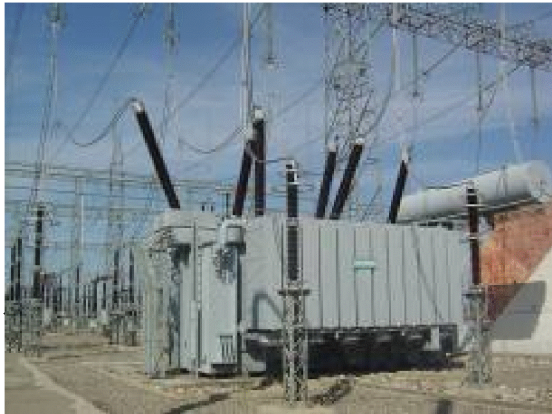
There was a very important high voltage substation in the affected area, the Ali Abad substation. All the equipments in this 400 kV substation were safe and the only problem was the crack at the base of the power transformer which led to oil leakage. This crack was at first very narrow and the transformer was under load without any problem, but due to the aftershocks the crack was opened and the bushing was completely drained after 10 hours. This 600 cm bushing had the weight of 1450 kgf and was replaced after the earthquake. Figures 14 and 15 illustrate the transformer and the cracked bushing respectively.

Figure 14: Replaced bushing

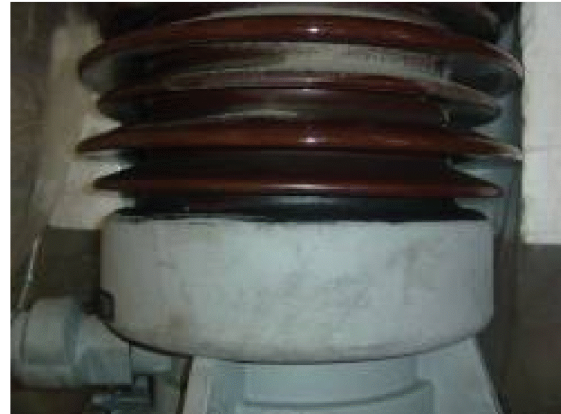
Figure 15: Damaged bushing

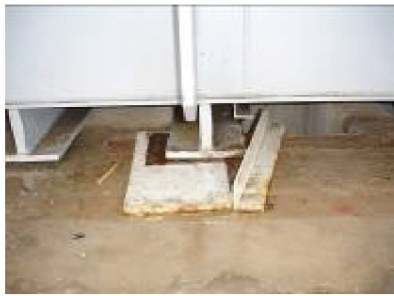
In this 230kV substations some moderate damages were reported, including sliding of control panels on the floor of control building because of the lack of anchorage, damage to the battery racks, sliding of the power transformer and toppling of the top core CTs (similar to Bam). Other equipments performed satisfactorily. Figures 18 to 20 illustrate the damages.

Figure 18: Trans sliding

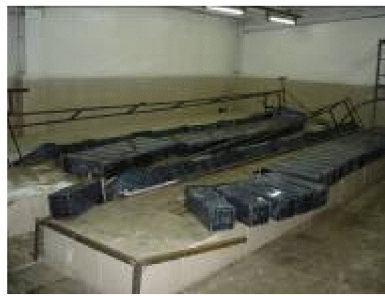
Figure 19: Damaged batteries

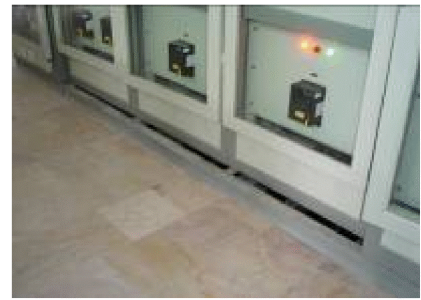
Figure 20: Panel sliding
