A COMPARATIVE SEISMIC PERFORMANCE ASSESSMENT AND REHABILITATION OF EXISTING SCHOOL BUILDINGS

A. Yakut¹, Y. Tonguç² and P. Gülkan¹

ABSTRACT :

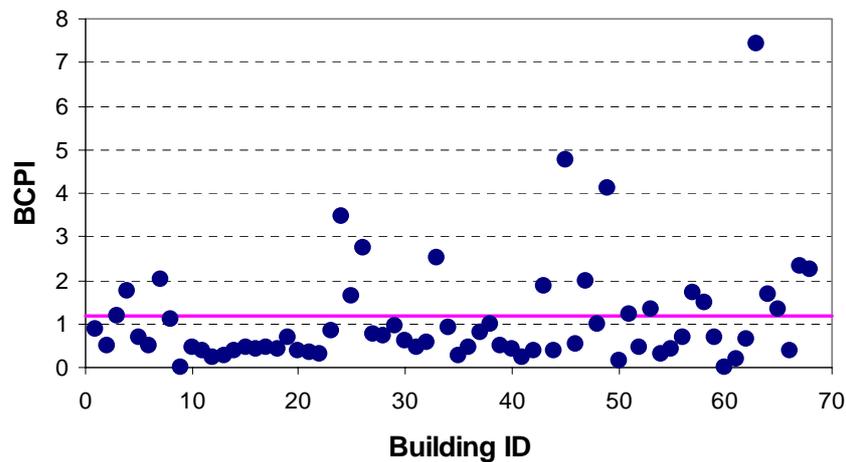
Figure 6 Shear wall density of the buildings

The results of this evaluation show that forty seven buildings have inadequate capacity and are considered highly vulnerable (Figure 6). Included in the forty seven building set with high vulnerability are generally the ones without shear walls (forty buildings).

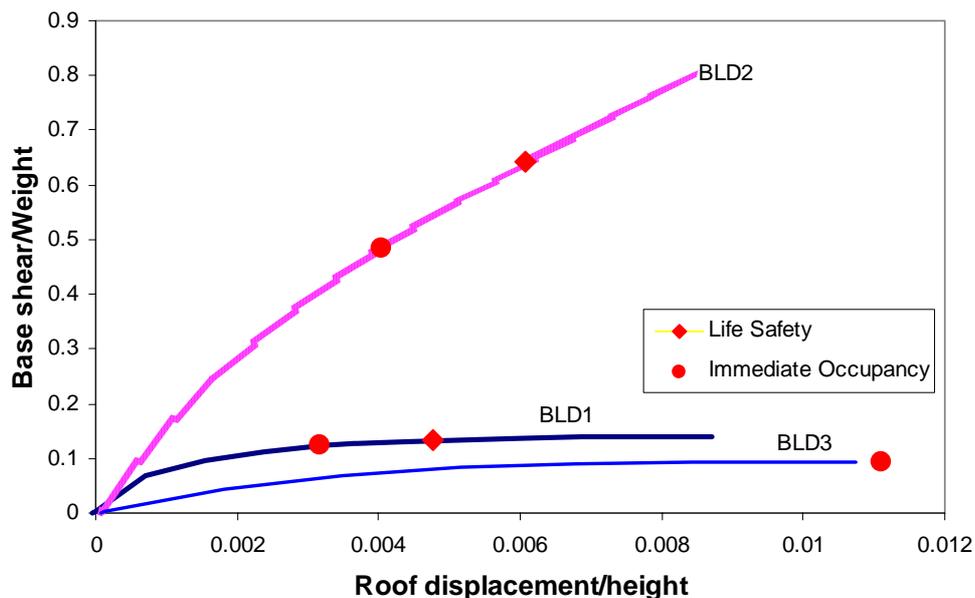
Figure 7 Pushover curves and performance points

The building identified as BLD2 has much larger capacity than others mainly due to its small total plan area (1531 m²) and high concrete strength (15.4 MPa). BLD3 has no shear walls and relatively low concrete strength (10.8 MPa) leading to very low seismic capacity as illustrated in Figure 7. Although BLD1 has shear walls (with a density of 0.31 percent) its low concrete strength (7.5 MPa) resulted in low capacity. As can be seen from Figure 7 the target displacements corresponding to the two required performance objectives reveal that BLD1 and BLD3 do not satisfy the performance requirements. BLD2 satisfies life safety requirements but fails immediate occupancy performance. It is worth noting that all of these buildings were classified as highly vulnerable in the preliminary assessment phase. Although, both nonlinear and linear procedures suggest that these buildings be retrofitted, the number of members not satisfying any given performance objective are much larger in the linear procedure. This is due to that the damage limit states expressed in terms of steel and concrete strains in the nonlinear procedure are very high.
