BASIC STUDY FOR BRIDGE BETWEEN ENGINEERING AND CONSTRUCTION PRACTICE OF NON-ENGINEERED HOUSES

This is a basic study to construct a bridge between engineering and construction practice of non-engineered houses. We implemented monitoring of construction procedures of confined masonry houses with brick walls in Lima in Peru and Yogyakarta in Indonesia to grasp actual situation of construction works and profile of workers for the basic information/data. Based on them we elaborate recommendations through discussion with researchers of each country and neighboring countries. We conclude we should identify most critical issues among various kinds of aspects for safer structures because smaller number of issues is the very basic condition for non skilled or semi skilled local workers to understand and accept. We tentatively propose that bending works of rebar of reinforced columns and beams and anchorage of brick walls to RC members are most critical issues for safer confined masonry houses and also present several alternatives of designs and detailing.

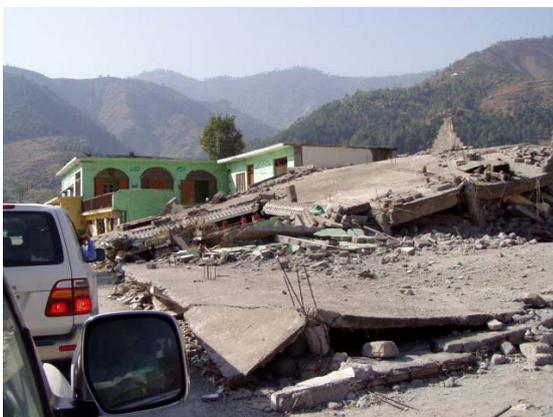
When I joined the first field survey in affected area by Northern Pakistan Earthquake 2005, I found collapsed houses/buildings with RC members which are not usually observed in Japan. Most of them got broken at connection of structural members and often got flattened as seen in Figure1 and 2 and all the reinforcing steel bars were not broken, but seemed like to come off, judging from the fact that all the ends of rebar did not have signs of yielding. I asked the reason to engineers of Pakistan and got answer that construction workers are non-skilled and do not have knowledge or are totally negligent and never follow the correct way. Since then I always check ends of rebar of broken houses in every survey area and found no case of broken/yielded rebar. Answers of engineers of each country are also same as in Pakistan.

Figure1 Collapsed buildings by Northern Pakistan Earthquake 2005 in Balakot

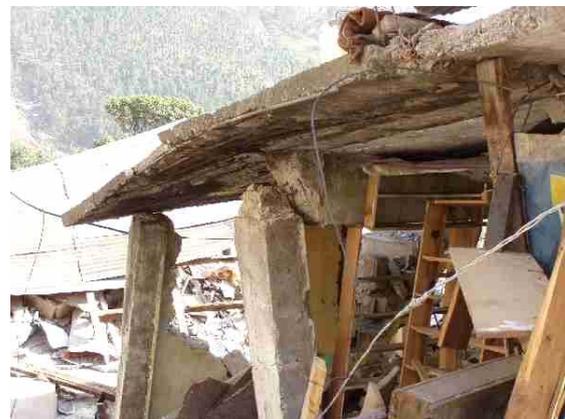
Figure2 Failures often occurred in connections of structural members

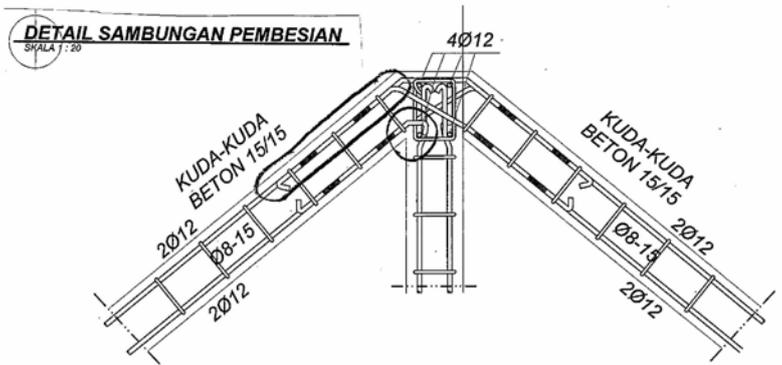
Afterwards I had several opportunities to conduct field survey on construction practices on construction sites. I investigated how coming off of rebar occurs. Figure3 is a drawing of bending works of rebar prepared by consultants of an Aceh reconstruction project. We can see the consultant required lapped splices to prevent coming off of rebar. Whereas the construction practice on sites are shown in Figure4 as rebar are assembled on the ground (Figure5) and assembled rebar is just placed like Figure6. Tools for bending work are usually timber bending bed with nails and steel bar with hook. It is impossible to implement bending works required by the drawing with usual tools by usual construction way. I interviewed several consultants on the matter. Their explanations are as follows; they draw the bending drawings according to the guidelines/recommendations they learn at schools, training programs or others, most of which are direct quotation from those of developed countries. Regarding construction practice on site, some actually do not know the situation because they have completely no interest in them. And some believe their job is limited to design and drawings. Even though they know it is impossible for workers to follow the drawings, they claim that it is responsibility of workers to follow as they exactly follow the way they learned.

Figure3 Drawings of bending works for reconstruction houses in Banda Aceh, Indonesia

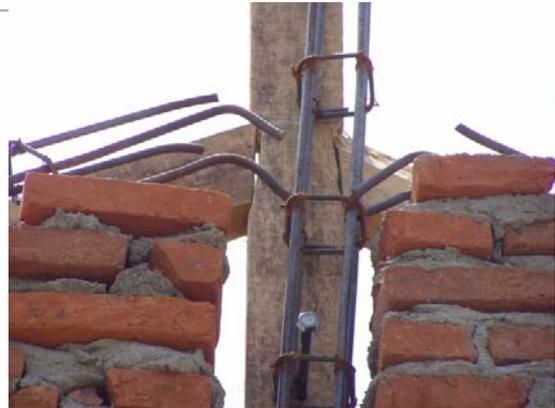
Figure4 Construction practice on site
 Insufficient connection of longitudinal rebar

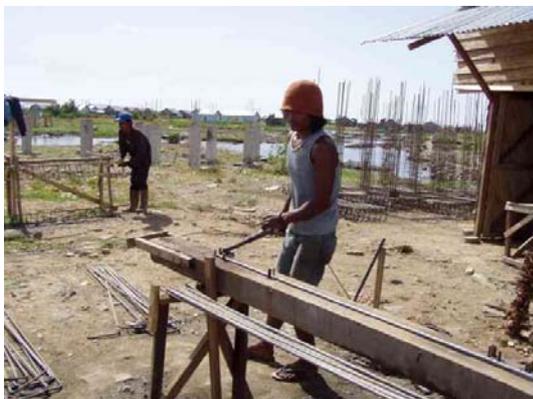
Figure5 Bending works on site with simple tools
 Fabrication of rebar is also conducted on ground

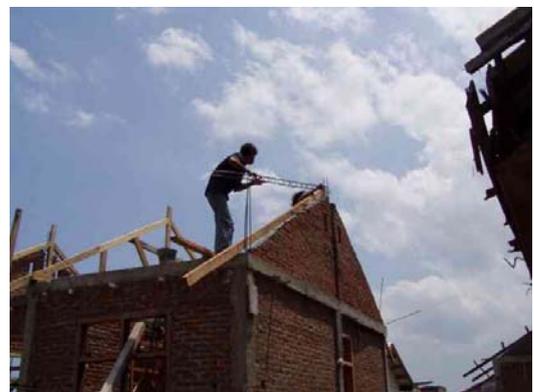
Figure6 Placing rebar of a roof beam fabricated on ground

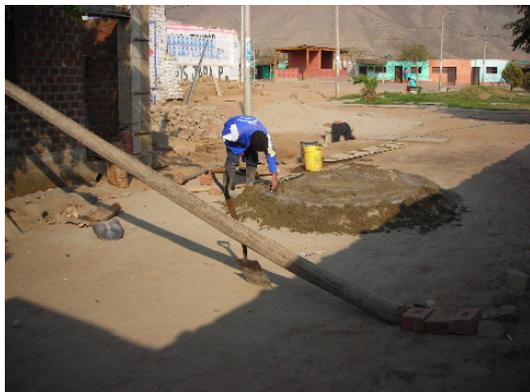
- Concrete mixing: Cement, sand and aggregate are mixed directly on ground (figure7). Those are batched by volume with barrow.

Figure7 Concrete mixing on ground on site
Mixing is carried out without sheets or others tools

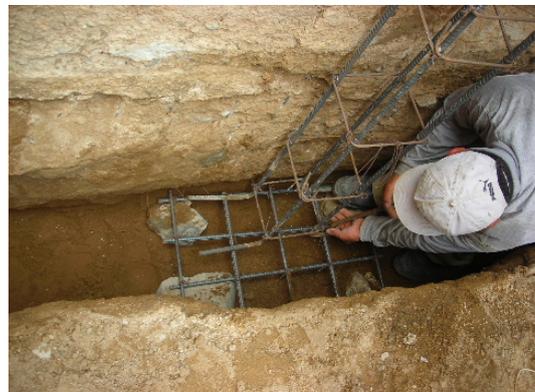
- Excavating and foundation: Excavating depth is around 50cm. Foundation is about 40cm in width and about 40cm high above ground level. (Figure8)

Figure8 Excavation works for foundation

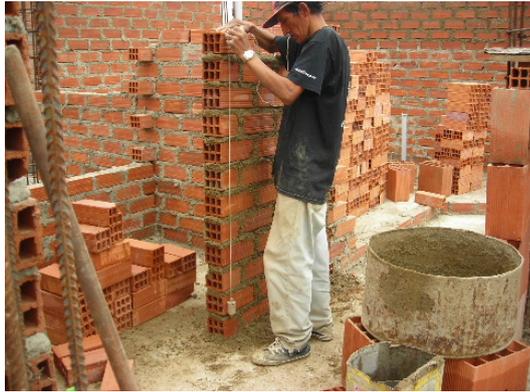
- Brick laying: Brick laying is conducted neatly and accurately with taut line and plumb bob (Figure9).

Figure9 Laying work of bricks with plumb bob
Taut line is usually used

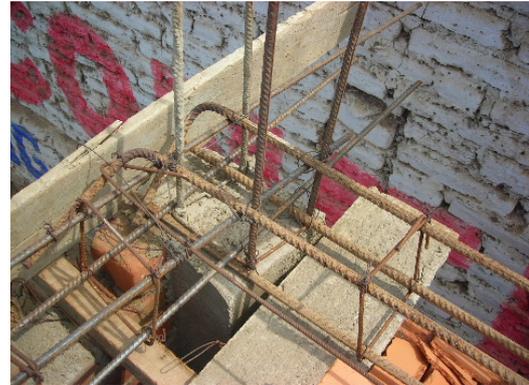
- Bending work of rebar: Lapped splices are not long enough as rebar is fabricated with hoops on ground, placed and no bending works on the spot (Figure10).

Figure10 Corner of beams and column
Length of lapped splices is limited to the dimension of
RC members' section size because of fabrication method

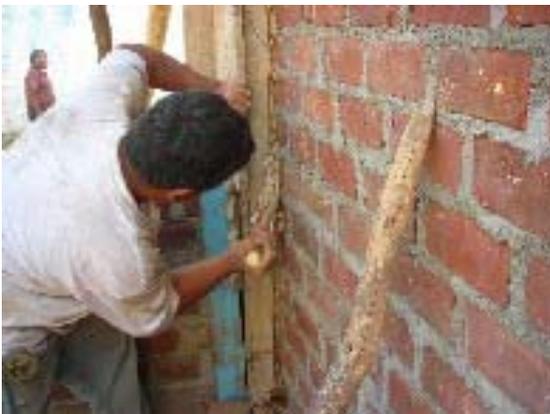
- Forms for concrete placing: Forms are made of timber. Packing of small piece of cement bags to fill crevices is usually found (Figure11).

Figure11 Form works
Packing of small piece of cement bags is usually
observed

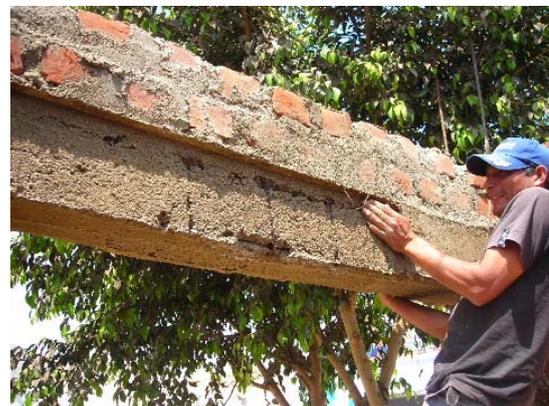
- Concrete placing: Compaction is not enough. Honey comb and exposure of rebar is often found (Figure12).

Figure12 Honey comb in beam
Some of rebar is exposed to air

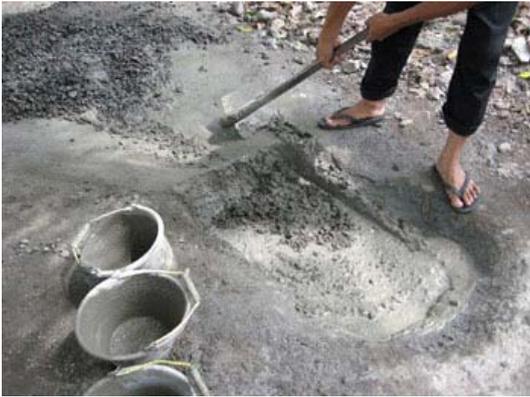
Figure13 Concrete mixing on ground on site
Mixing is carried out without sheets or other tools

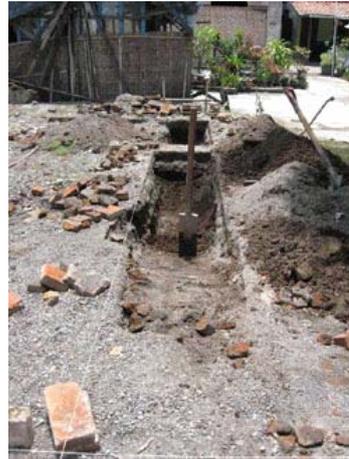
Figure14 Excavation works for foundation

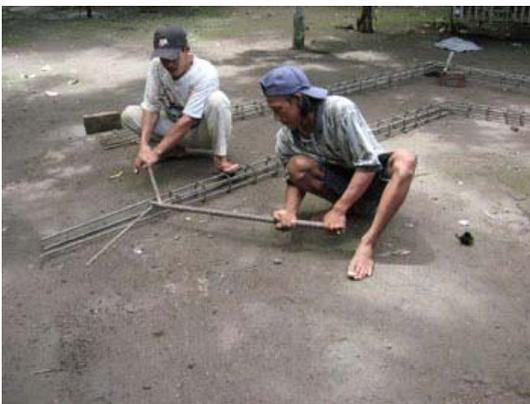
Figure15 Bending works of rebar on ground
with simple tools without machines

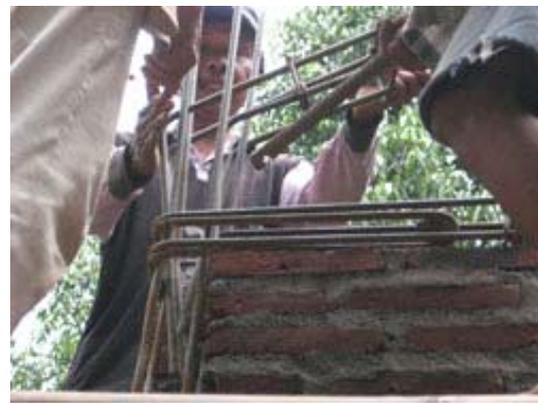
Figure16 Connection of RC members
Horizontal rebar is not connected at the corner,
but using continuous rebar

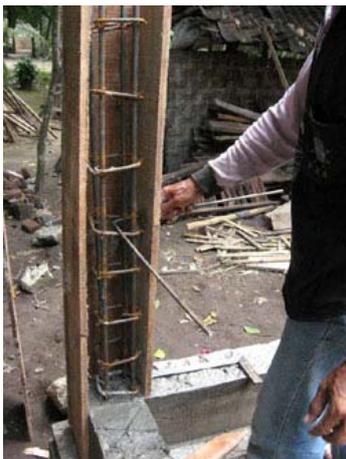
Figure17 Anchorage of walls to column

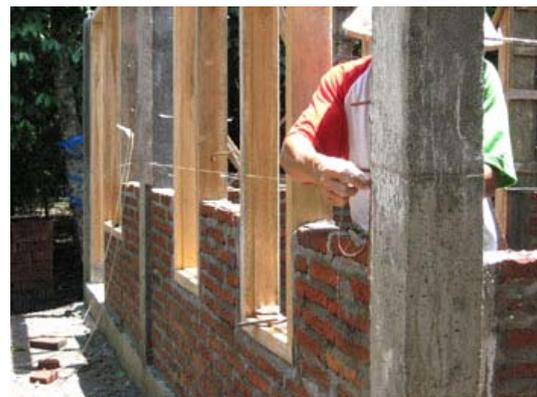
Figure18 Laying work of bricks with taut line

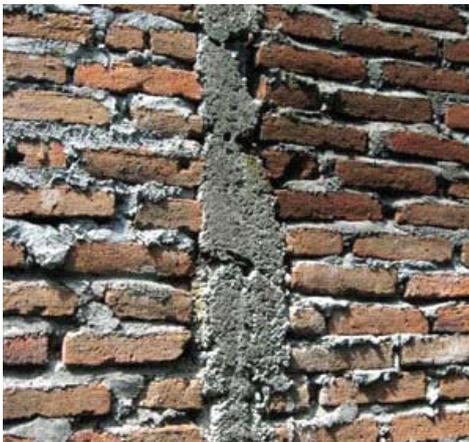
mortar is just 25.9% before the earthquake (Figure9) and it becomes to be almost 100% after the earthquake. As we stated in 3.3 with Figure16 and 17, there is significant improvement in construction works. These prove that appropriate technical intervention could be accepted by people and enhance seismic safety. However those technical interventions still need betterment especially from the view point of efficiency/ease of construction work. On the other hand, we also found serious defects in construction. Figure21 and 22 show an example of concrete placing. Insufficient compaction with simple tools like steel bars (not effective ones like vibrators) and congested rebar within small section of RC elements are the most probable reasons.

Figure21 Poor concrete placing work with a lot of honey comb and void
