## GENERAL DEFECTS ANALYSIS OF MASONRY BUILDINGS DAMAGED IN WENCHUAN EARTHQUAKES AND ITS INSPIRATIONS

Sun Baitao Hu Changli

*(Institute of Engineering Mechanics, China Earthquake Administration, Harbin, 150080)*

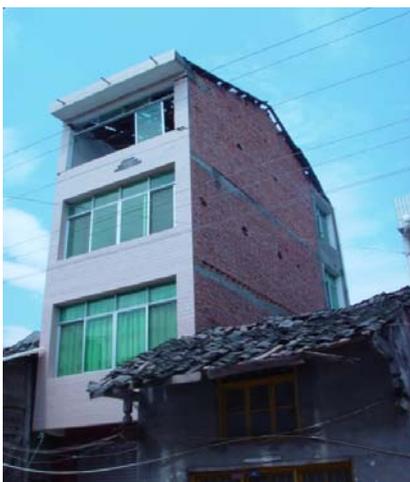
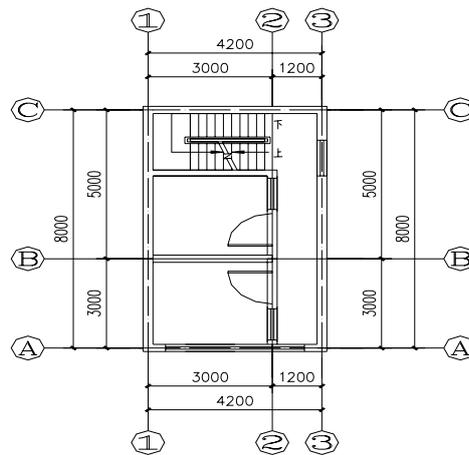
Fig.7 photos and planar graph of a masonry building in Qingxi town

Affected by the Wenchuan earthquake, there were individual transparent declined cracks in the gable wall, and few pervious declined cracks in the inner cross walls. As shown in Fig.7, in the forth floor, the gable wall fractured along the window and the windows deformed seriously and partly fell down, the roof truss collapsed. The damage degree of this masonry building is in the middle level and a little serious than it.

Excepting for that the Wenchuan 8.0(Ms) earthquake is very serious, the building's height-width ratio exceeded the limitation is the very important reason caused the masonry building was damaged seriously. Suggested by the "Seismic Design of Building" (GB50011-2001), the total maximal height-width ratio of the multistory buildings should accordance with that in Table 1.

The masonry building shown in Fig.7 located in 7 degree seismic fortification intensity region, thus according to Table 1, its maximal height-width ratio should be 2.5, according to its planar graph shown as Fig.7, its height-width ratio was 4.3, far beyond 2.5, which made the building's lateral rigidity very weak and is the most important reason caused this masonry building to be damaged seriously.

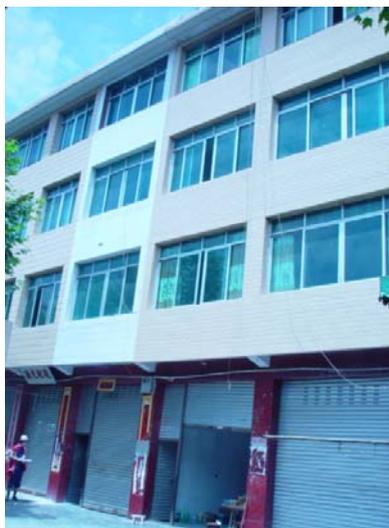
Fig.8 Another masonry building in Qingxi Town damaged slightly

Another four-floor masonry building built in 1998 shown in Fig.8 was far less than 100 meters away to the building above, this building constructed circle-beams in each floor, its height-width ratio is reasonable, was slightly damaged, it can be dwelled in after simple repaired.

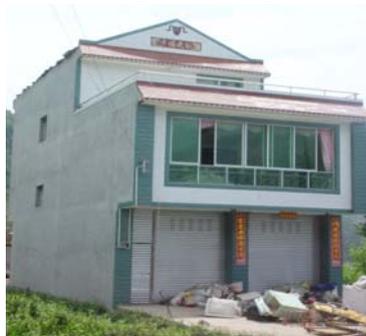
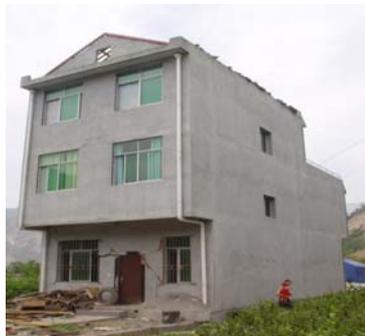
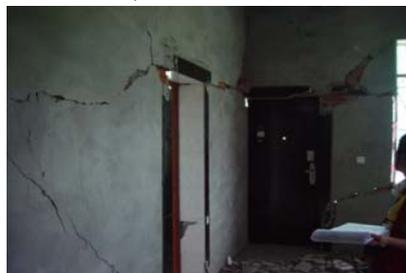
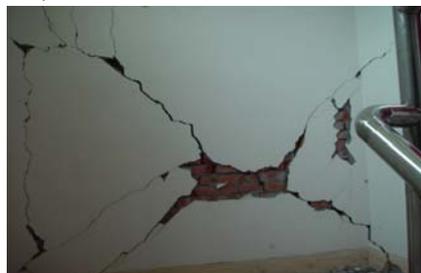
Fig.9 Photos of house building in Leigu town

As shown in Fig.9, affected by the Wenchuan earthquake, there were several X-type transparent ramp cracks and crushed in the first floor's walls, the column broke at its top, there were several transparent declined cracks

in the stairwell's walls, and there were individual slight cracks in the stairwell's wall in the second and third floor, the roof tiles fell wholly. The damage degree of this masonry building is serious.

Excepting for that the Wenchuan earthquake is very serious, the building's irregular plane and elevation is the main reason caused the masonry building damaged. Fig.10 showed the planar graph of the house building's first and second floor in Leigu town. There were just three 450mm\*450mm columns in its front side, but no columns in its back side, thus formed no the enclosed frame structure. The stairwell was constructed in the left side of the house building, and departure from the building's center. According the Fig.10, the width of the second floor was 2.4m larger than that of the first floor, formed a typical top-heavy building, the upper bays were of small room, heavy mass, strong stiffness. Those in the first floor were much smaller than those in the upper bays.

Though the site conditions, good construction quality, high strength cement mortar the house building was of, the house building was severely damaged for the irregular section plane and the Mutation of the elevation stiffness.

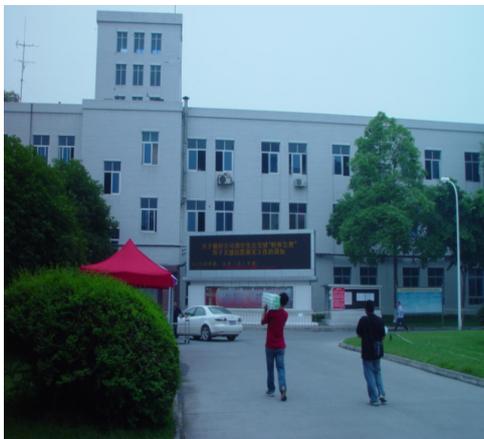
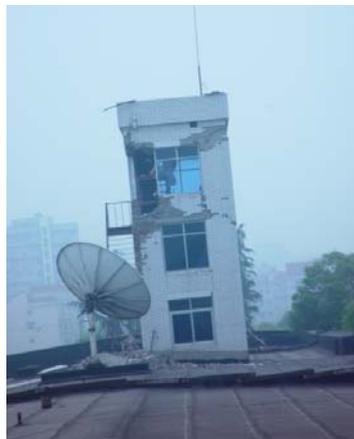
a) Photo of No.2 workshop building b) Photo of damaged roof tower  
 Fig. 11 Photo of the No.2 workshop building of Jiuzhou Group

As shown in Fig.11, the No.2 workshop building's roof tower of Jiuzhou Group, Mianyang City was destroyed seriously because of the whiplash effect.

The design and construction of such masonry building has broken gravely the prescriptive requirement of Seismic Design Code 3.4 "the regularity of architectural design and building's structure". Though the site conditions and the construction qualities were certified, the buildings were seriously damaged, and had no way to be reinforced. Plenty of Multistory chicken-leg type Masonry Buildings with Bottom-frame

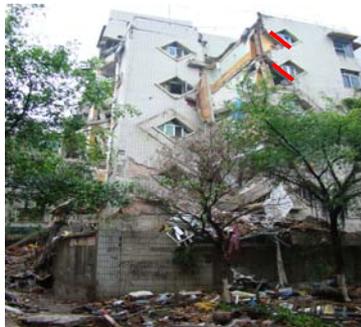
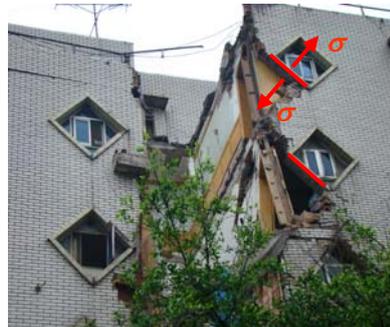
a) Jiannanchun residential buildings b) Principle of damage  
 Fig. 12 Photos of the residential buildings of Jiannanchun Group

Exterior walls of the buildings were split in the same positions where there were no effective link between 45° edge of diamond-shaped windows and the walls, which caused partial constructions completely collapsed. All the survival walls of the buildings had several transparent declined cracks, their failure degree was destroyed.

The main reason for the buildings' partially collapse was that the design of the diamond-shaped windows is unreasonable. As shown in Fig13 a), the micro unit force analysis of the walls was done. According to the shear stress mutual equal theory in Material Mechanics, the micro unit cracked in 45° direction, as shown in

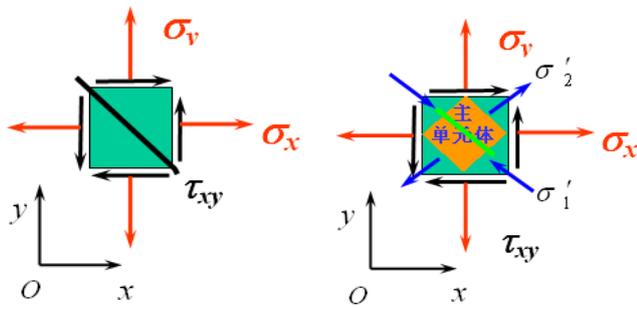
Fig.13 Analysis graph of the stress

Fig13 b), when the principal tensile stress reached the limitation of the material tensile strength, which is just the reason why the exterior walls of the buildings cracked in 45° direction affected by the lateral component of an earthquake motion. The edges of diamond-shaped windows exactly were in 45° direction, moreover, the connection of window frame and the walling is very weak. The link of windows' frames and walls were very weak, which caused the partial constructions of the buildings collapse.

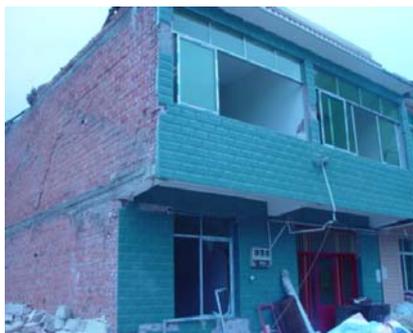
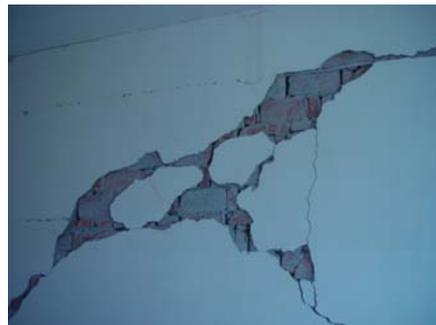
a) Photo of a damaged two-floor building      b) Damage form of the wall  
 Fig.14 Photo of the damaged two-floor house building in Leigu town

in this serious earthquake. The building with height 6.3 meters and building area 220 square meters was built in 2006 by MU7.5 clay brick, lime and cement mortar, the thickness of the walls was 240mm, the circle-beams and the heel posts were constructed in each floor, the floor slab was preformed, wooden roof truss without diagonals were adopted. its plane form is rectangular. The construction qualities were poor, the mortar strength was less than M1.0. The wall was hollow.

As shown in Fig.14 b), there were few inclined perforative cracks on gable and a lot of inclined perforative cracks on the other walls. The wooden roof general collapsed. failure degree of this building is serious damage. Excepting for that the Wenchuan earthquake is very serious, to its own structure, the lower mortar strength and the hollow walls broke the rules of material performance index in "Seismic Design Code of Buildings" 3.9.3,

which made the buildings' shear strength low. The mortar strength and the walls' penetration ratio of the floor space are two important index of determine the seismic behavior of masonry buildings, large width room and lower mortar strength have unfavorable effect on building's seismic.
