## Field Investigation on Industrial Buildings in Mianyang District and Some Advices on Post-earthquake Rehabilitation and Seismic Design

HU Kongguo<sup>1</sup> and WANG Yanke<sup>2</sup>

<sup>1</sup>Senior Engineer, Structure Evaluation & Strengthening Div., China Electronics Engineering Design  
Institute, Beijing, China

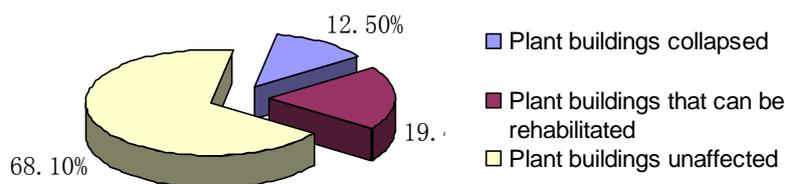
Figure 1 Degree of impact on industrial buildings in Mianyang City by Wenchuan Earthquake  
Looking from the degree of damage to the industrial plant buildings in Mianyang City by Wenchuan

Earthquake, regions suffered severe damage include four counties and cities, which are Beichuan, Pingwu, Anxian and Jiangyou. Total area of plant buildings collapsed in these four counties and cities accounts for 70% of the total area of collapsed plant buildings in Mianyang City, and the area of damage accounts for 57%. Details of these counties and cities in which the industrial buildings suffered severe damage are shown in the following figures:

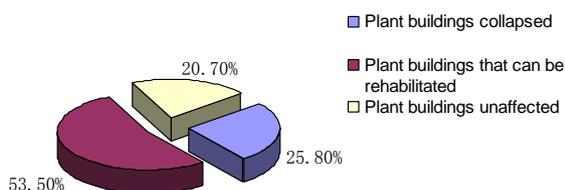
Figure 4 Degree of impact on industrial buildings in Anxian County by Wenchuan Earthquake

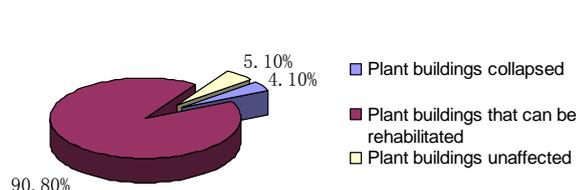
Figure 5 Degree of impact on industrial buildings in Jiangyou City by Wenchuan Earthquake

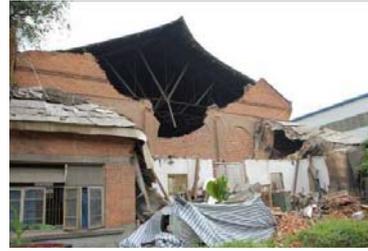
Plant buildings with brick columns were mostly built in the 60's and 70's of last century, most of which had no ring-beams and structural columns. These buildings are partially or completely collapsed in this earthquake, suffering the most severe damage. See Fig. 6 to 10.

Fig. 7 Gable masonry of plant buildings without ring-beams almost completely collapsed

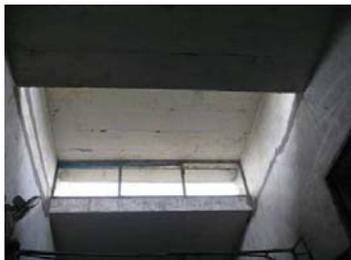
Fig. 10 Protrusion of the skylight of the plant building cracked horizontally

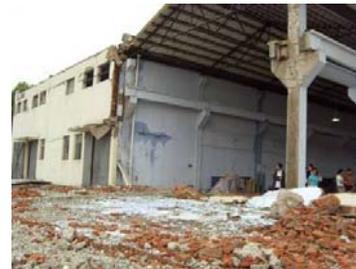
Fig. 11 Bent gable of the plant building completely collapsed

Due to a lack of necessary tie between the bent gable of the plant building and the principal structure, the gable shifted outside under the action of the earthquake and completely collapsed. In this earthquake, a number of injuries and casualties occurred due to collapse of exterior walls. See Fig.11

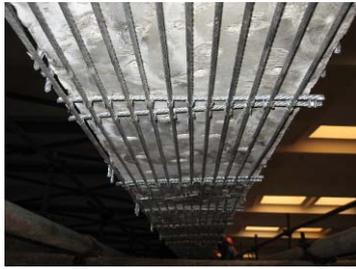
Fig.35 Steel wire mesh placed on bottom of the beam

High-strength stainless steel wire mesh is placed on the beam bottom, beam side or laterally on the column,

which is then fixed with the concrete by using pins. And then polymer mortar is sprayed on the mesh to further strengthen the concrete elements and improve the earthquake resistance of the beams and columns.

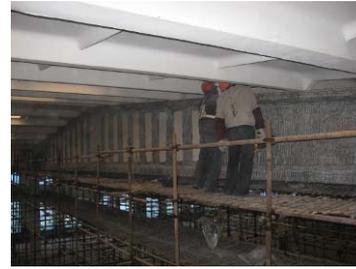
Fig.36 U-shaped steel wire mesh placed on side of the beam
