## THE DAMAGE CHARACTERISTIC OF MOBILE COMMUNICATION SYSTEM IN THE GREAT WENCHUAN EARTHQUAKE

### ABSTRACT :

### ***3.1. Earthquake damage of communication station at traffic administrative bureau in city Dujiangyan***

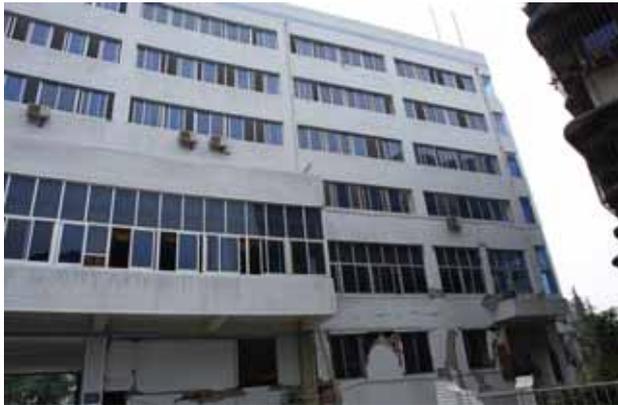
The longitudinal wall facing the street is without damage on the surface, while from first to third floor another longitudinal wall and both outboard cross walls appeared obvious crack and partly collapsed. Serious collapse of filler wall appeared in the staircase, and some part of reinforced concrete column formed plastic-hinge. The walls and columns on fourth floor and above have no obvious damage. (See Figure 1 and Figure 2)

Fig.1 outside longitude wall of the traffic administrative bureau

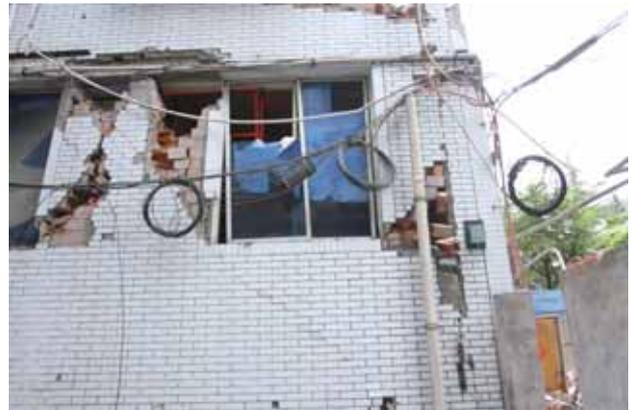
Fig.2 outside longitude wall's damage at the first floor of the traffic administrative bureau

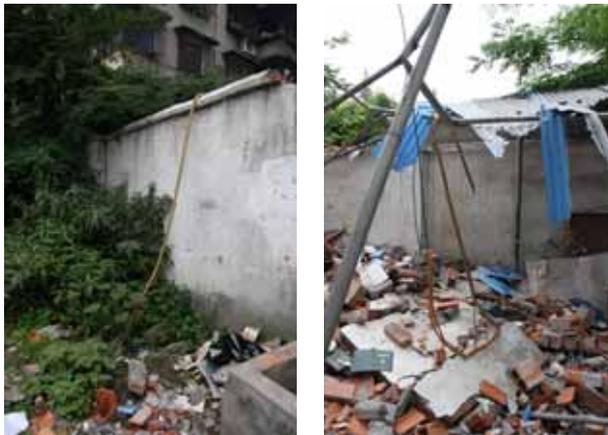
Optical fiber cable outside the machine room ran over the enclosing wall. The collapse of enclosing wall

causing by earthquake led to the optical fiber cable cut. (See Figure 3 and Figure 4) The communication optical fiber cable hanged at outboard cross wall without any fastens point from the top to the bottom. The earthquake poured out a few of blocks of fillers wall between first floor to third floor, which caused the optical fiber cable and other electric cables broken. (See Figure 5 and Figure 6)

Fig.3 and 4 broken optical fiber cable run cross enclosing wall

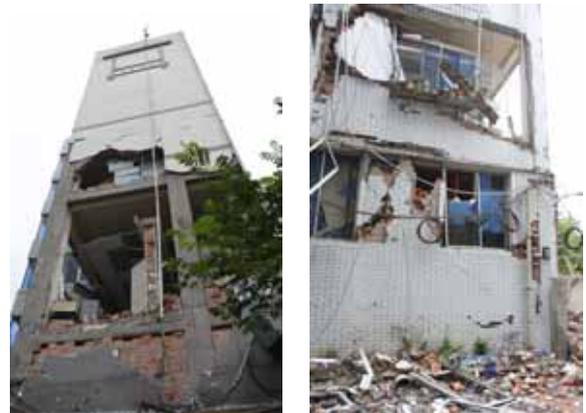
Fig.5 and 6 outside cross wall and cables' damage of three floors of the traffic administrative bureau

(4) Cables' vertical distribution should be along the column of steel frame structure, frame construction, and masonry structure instead of wall.

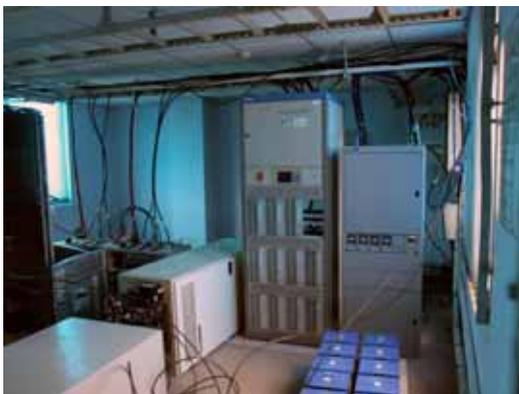
The machine room of communication station located at fifth floor facing the street and with inside cross wall. It is equipped with unify cabinets which Huawei Optix 2500 + Mrtro 3000 installed. The feet of cabinets have no any fastening points on the floor, but the displacement was not heavy, its equipments are still in good condition. So did another 6 cabinets which 6 QSM900 installed and power supply cabinets (See Figure 7). Two groups of 12 accumulators laid active on platform before the quake, and slid down on the floor in the aftermath. Another group of 12 accumulators installed in iron frame, and was in good condition with small displacement. 2 empty cabinets were only container that fell down. (See Figure 7-9)

Fig.7 cabinets with no fasten points are safe

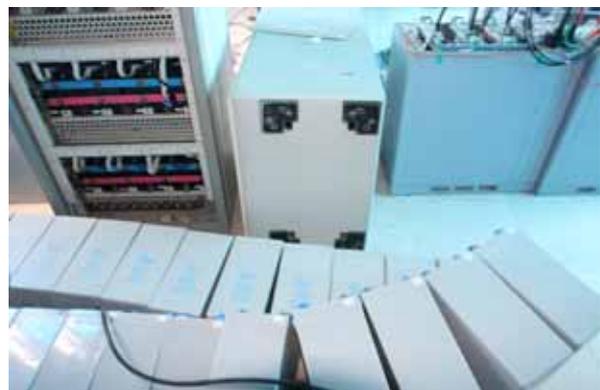
Fig.8 empty cabinet and accumulators fell down

- Equipments lean against and parallel to interior wall.
- Cabinet for transmission communication and power supply should arrange side by side.
- Cabinets should fasten on the floor and air condition should fix with wall and floor.
- Accumulator should arrange in iron frame and lay down on the floor. Accumulators should fix firmly to avoid sliding when special platform as required.

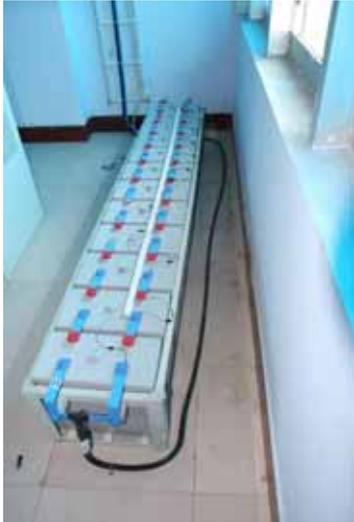
Fig.9 accumulators in iron frame

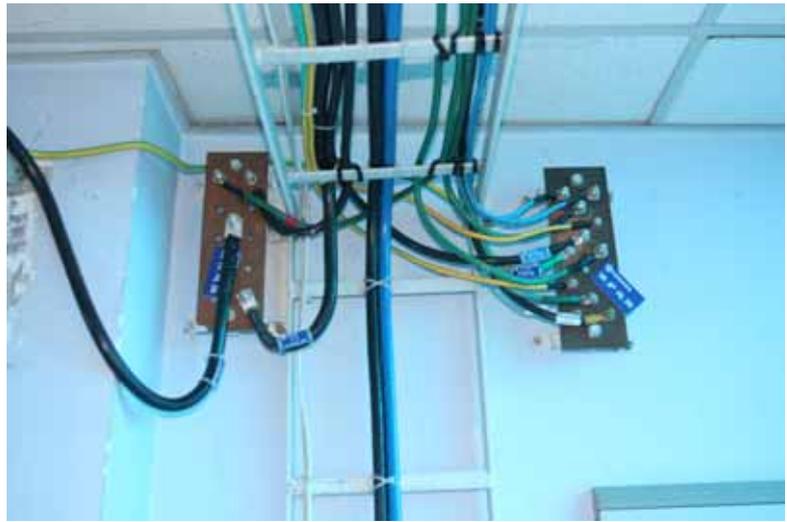
Cables inside machine room are fastened along and protected by the iron frame in consistent with safety demands, and still in effect. The communication optical fiber cable had no signal in post quake test, indicating that signal had interrupted outside the machine room. (See Figure 10)

Fig.10 cables fixed on wall

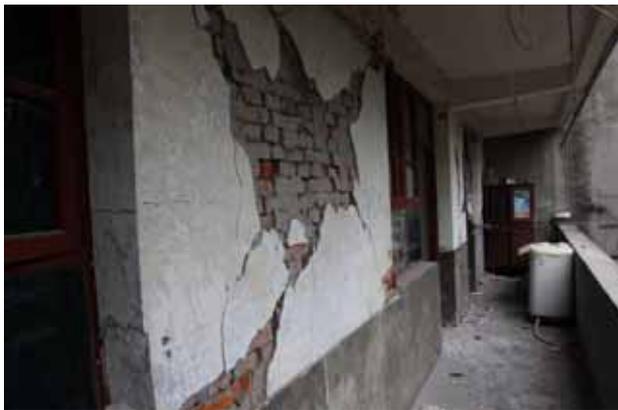
The communication station located at room rent from Suiyuan hotel. The building of Suiyuan hotel constructed in early 1980s. This 5 story masonry building (brick-concrete structural building) had less structural quality for low mortar strength of brickwork joints. The building was seriously damaged in the quake, it appeared the connectivity crack on part of load bearing wall in the first and second floor, and less or more crack on load bearing wall of the second third and fourth floor. (See Figure 11)

Fig.11 wall damage of first floor at Suiyuan Hotel

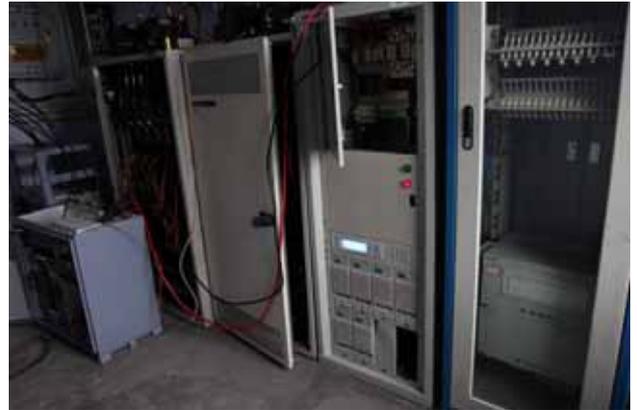
The communication station laid in fourth floor. There are transmission equipment, communication primary equipment and air conditioning in the machine room. The cabinets with equipment had no fastening point on the floor, their displacements are not heavy, and equipments were in good condition. While air condition lean forward nearly falling. (See Figure 12)

Fig.12 communication equipments are in good condition

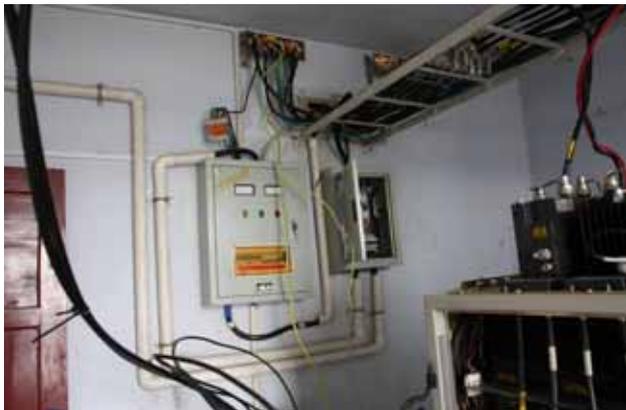
Cables inside machine room are fastened along and protected by the iron frame in consistent with safety demands, and still in effect. Transmitting Antenna located at roof of building without any fault. (See Figure 13-14)

Fig.13 inside cable distribution of communication station

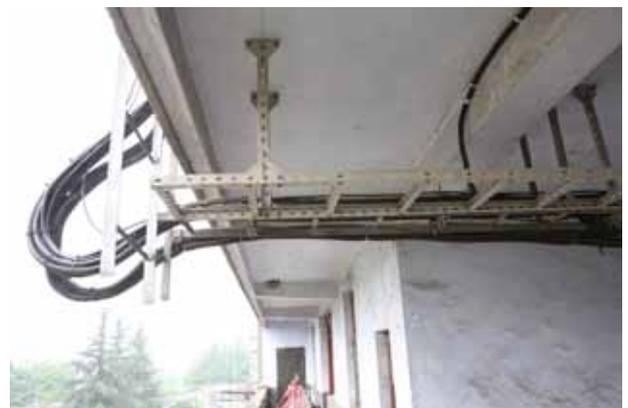
Fig.14 outside cable distribution of communication station

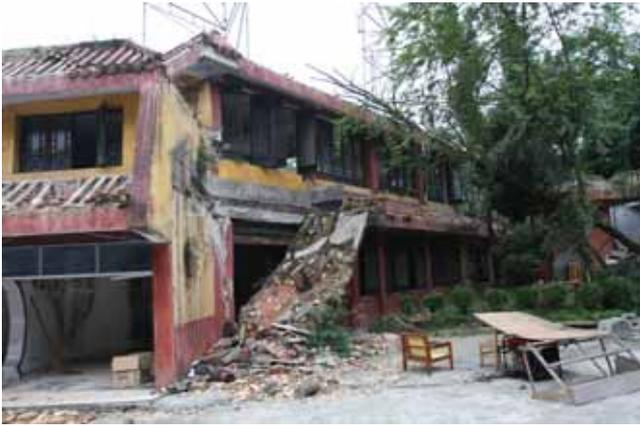
Mount Lingyan mobile communication station located in two floor masonry building (brick-concrete structural building) within the section of mount Lingyan cableway. The building was constructed in 1990s, with qualify mortar strength of brickwork joints, but the layout rooms are irregularity, led to oversize bay. The building was serious damage by the quake; collapses took place at partly wall, staircase wall and roof of first floor. (See Figure 15-16).

Fig.15 serious damage of building near the Mount Lingyan cableway

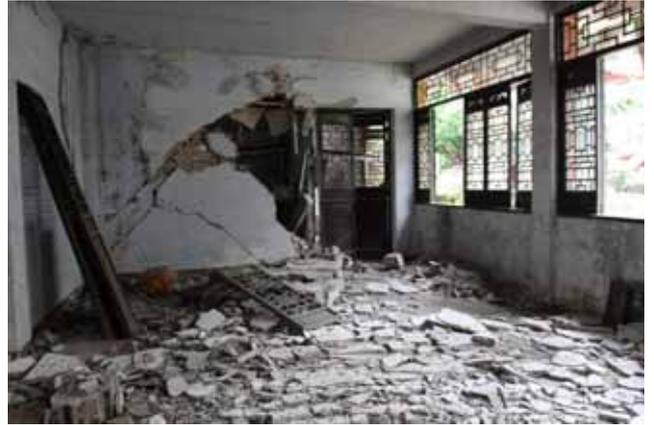
Fig.16 serious damage of inner walls

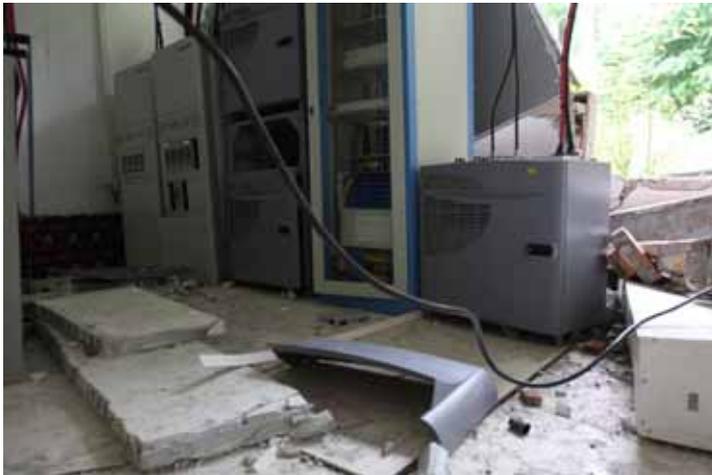
The mobile communication station located at machine room facing the street in first floor. There is transmission equipment, communication primary equipment and air conditioning along the rear of outboard inside, and cabinet had no fasten point on the floor. Since the wall partly collapsed, air condition cabinet was crashed. The cabinets of communication equipment appeared some displacement, but equipments were all in good condition. (See Figure 17-18)

Fig.17 outside cross wall of the communication machine room inward collapse

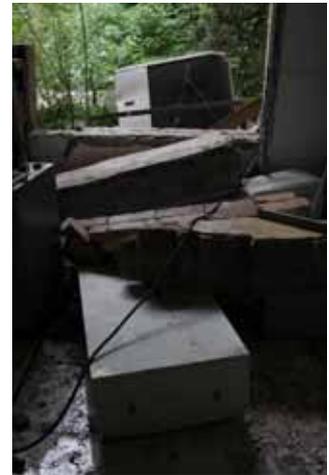
Fig.18 air condition crack by inward collapsed cross wall

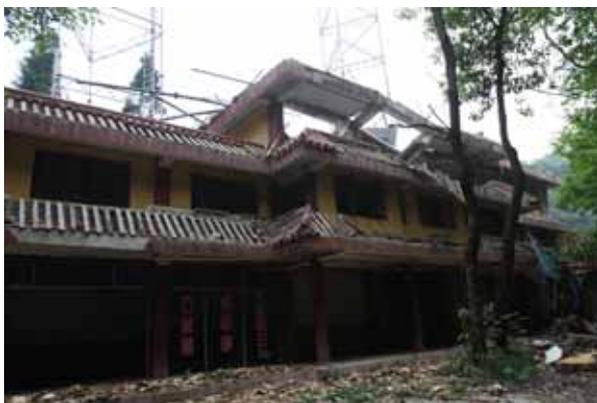
One of three antennas damaged with the fall of roof. (See Figure 19)

Fig.19 roof collapse of building near the Mount Lingyan cableway

(6) Antennae should be regular shape and avoid installing on protrusive roof. And antennae should be far away from the prominence such as cell room on the roof.

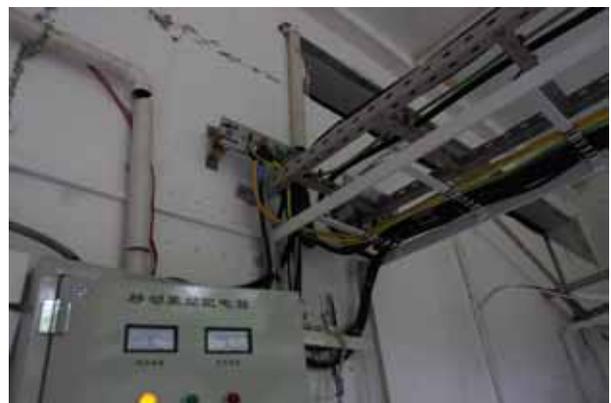
Though part of wall and roof collapsed, the cable distribution was fasten firmly without any fault. (See Figure 20)

Fig.20 cables of communication station fixed well
