## Lessons from the 2011 Great East Japan Earthquake Focused on Building Damage

M. Motosaka<sup>(1)</sup>

### **Abstract**

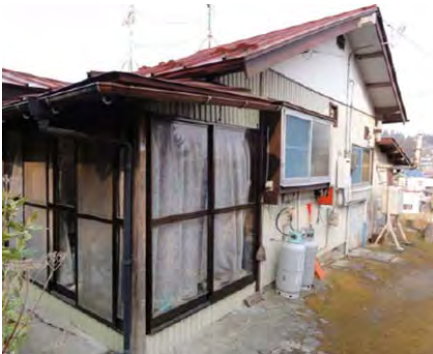
Fig.3 shows the observed acceleration waveforms of the 3 components at K-NET Tsukidate (MYG004) during the March 11, Tohoku earthquake. The horizontal PGA in the NS component is 2,700 gal and in the EW component is 1,269. The high acceleration record was reported as, ‘JMA intensity of VII, no victim’ and a house adjacent to the site was not damaged as shown in Photo 1.

Photo 1 – Features of a house adjacent to MYG004 site

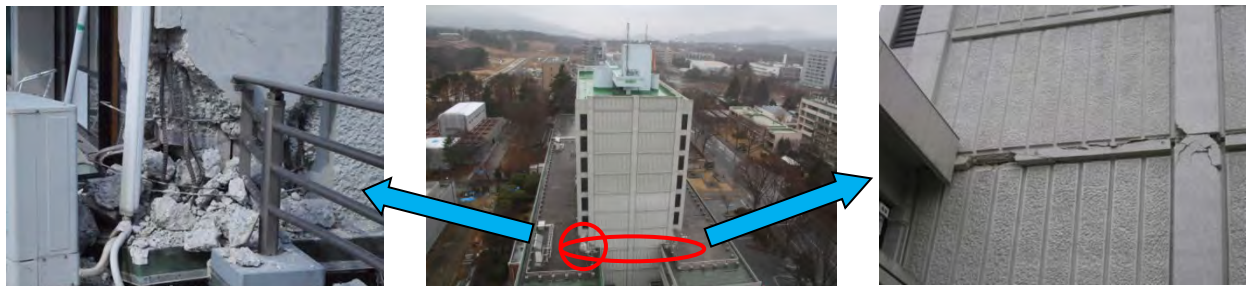
Photo 3 – Damage features of THU building

The research building for Civil Engineering and Architecture & Building Science Department of Faculty of Engineering, Tohoku University (9-story SRC building indicated as hereafter THU building) was damaged severely at the bottom of corner columns at the set backed 3rd floor and demolished. The ‘School Building’ for graduates of the departments was constructed in 1969 at Aobayama campus on a hill, where the ground motion of 1s period content was amplified 2 times compared to diluvium terrace of central area in Sendai. The response spectral velocity value (damping factor 5%) at around 1s period was 180cm/s. The 8- and 9 story SRC buildings were damaged due to resonance to the amplified ground motion on the hill even though these buildings were retrofitted. The moving resonance phenomenon was recognized based on the non-stationary analysis using the observation records at the 1st floor and the top floor (9th fl.) of THU building. The damage of THU building to which structural engineering specialists were engaged was shocking to Tohoku University. The THU building was damaged but endured well during the 1978 Miyagi-ken Oki earthquake. The building was later retrofitted in 2000.

(a) Damaged corner column bottom

(c) Crack at the setback 3rd floor

It is meaningful that the cause of the damage of THU building was scientifically investigated using very valuable observation records of the building together with those at other observation sites in Sendai City. The lessons learned from the THU building are as follows; 1) The hidden damage of main bar’s failure at the corner column could not be detected, 2) The retrofit work was not appropriate such that earthquake forces were applied to the hidden damage parts, 3) Connection between the replaced shear wall and the existing frame was weak, which led consequently to partial uplifting of upper part from the 3<sup>rd</sup> floor of the building.

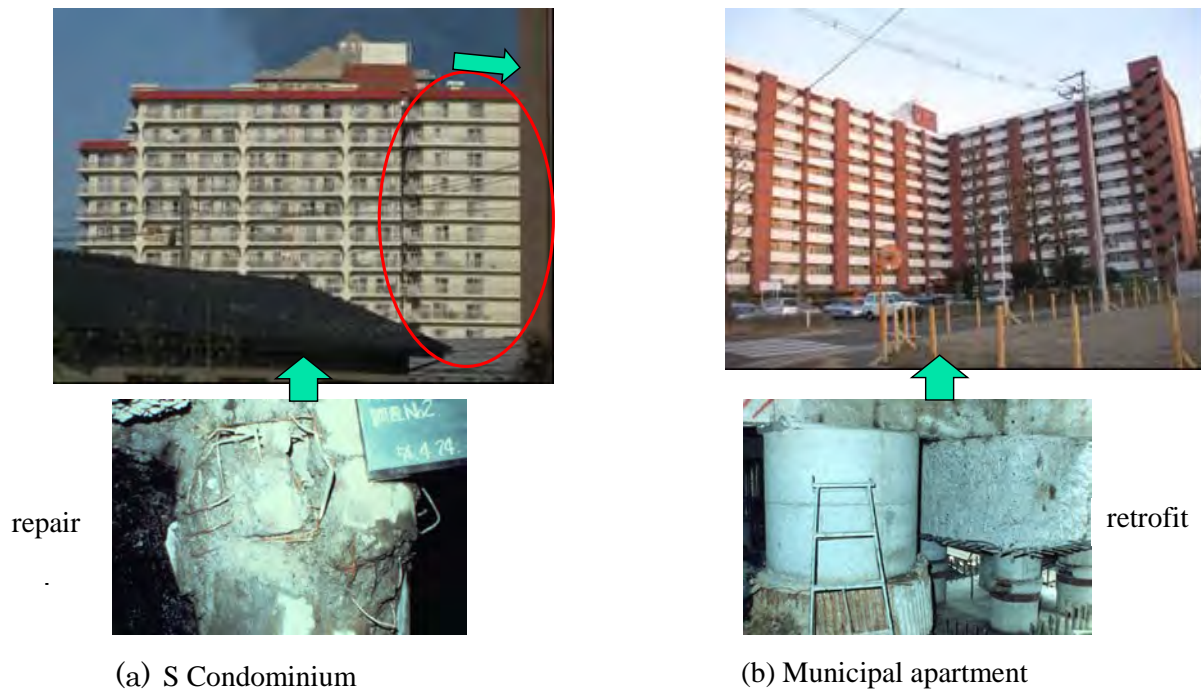
The two buildings with pile foundation damage during the 1978 Miyagi-ken Oki earthquake were divided into black and white during the 2011 Great East Japan earthquake. This was due to after treatments of the 1978 earthquake. One is a 14-story SRC building used as a condominium (S-Building) and the other is an 11-story SRC building used for municipal housing (N-Building) [13] (ref. to Photo 4).

In case of the former building, the damaged piles' heads (the two of 7 inspected piles) were repaired by steel rings but it did not increase the seismic resistant capacity of the foundation. This building was toppled by damage of pile foundation during the 2011 Great East Japan earthquake. It is noted that the ground motions of the Great East Japan earthquake is about 30% larger than those of the 1978 earthquake at the same observation point in Sendai.

On the other hand, the latter building toppled by piles' damage during the 1978 earthquake. But after the earthquake, the toppled building could be jacked up and the foundation reinforcement was performed by installation of peers and thick foundation beams. The foundation resistant capacity became larger by 2.5 times. Due to this reinforcement, no structural damage was recognized during the Tohoku earthquake, even though very large shaking (velocity response spectral value of 5% damping is 300 cm/s at around 1s period). At S-building, the consensus building problem among the residence people was raised for the recovery process. The condominium apartment and the municipal apartment were divided into black and white.

(a) S Condominium (b) Municipal apartment  
 Photo 4 – The two pile-foundation buildings damaged during 1978 Miyagi-ken Oki earthquake divided black and white

As for pile-foundation buildings, seismic capacity of buildings constructed by old building code would be checked especially for those with high aspect ratio.

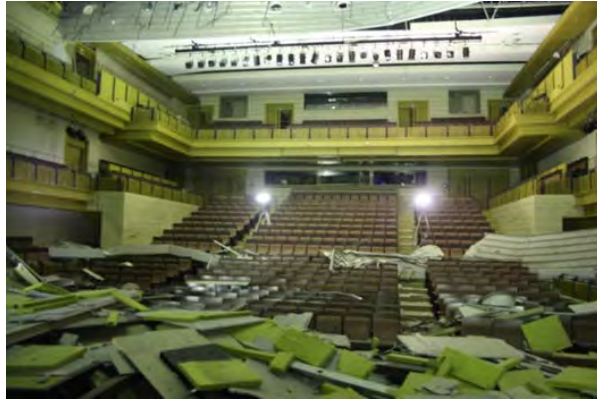
As the typical building damage during the Great East Japan earthquake, drop of suspended ceiling board occurred at many multi-purpose halls, local government halls and shopping center and so on, some of which

caused human casualty (ref. to Photo 5). It is noted that many halls with ceiling board damage were luckily not in use during the earthquake. The damage problem would not be solved by setting only ‘vibration stopper’ recommended by Ministry of Land, Infrastructure, Transport and Tourism (MILT).

(b) Multi-purose hall in Sendai

In design of important non-structural elements and equipment, it is recommended to consider the dominant periods of building structure and its supporting soil by adopting the floor response spectra method. It is also important that the vibration energy transmitting from the roof should not propagate horizontally, which leads to wave-like motion of ceiling board [14]. In the case, earthquake load applied to the ceiling board becomes very large compared to that of accumulative area. The regulations of local seismic intensity method would be tightened for important equipment.

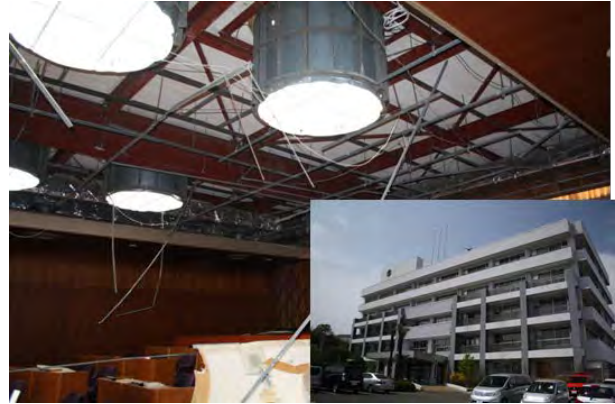
(a) City office building in Shiroishi

Photo 5 – Damage feature of ceiling board drop

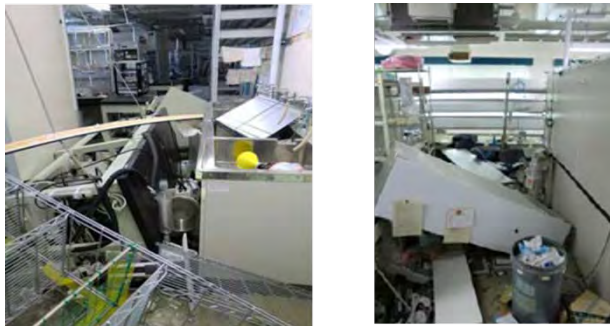
As above-mentions, Aobayama campus of Tohoku University was severely damaged. The damage was not only structural damage but also interior equipment such as very expensive experimental equipment (ref.to Photo 6), which leads to huge amount of loss. The reason of the damage is due to extraction of fixture from the wall by long-duration shaking. Consequently, the problem of fixture becomes apparent to verify the safety for the shaking with long-duration.

Photo 6 – Damaged experimental equipment building at Aobayama campus, Tohoku university

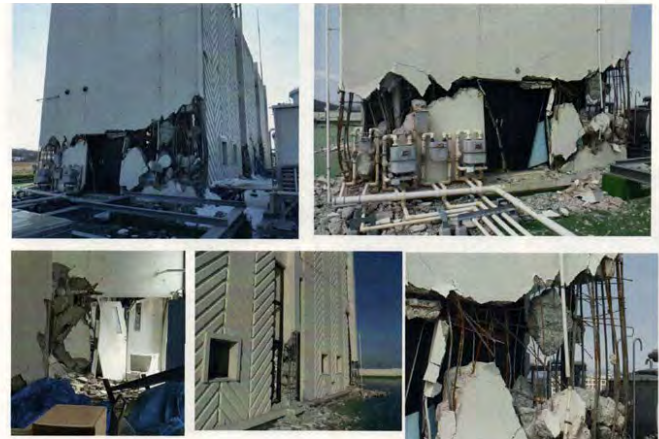
Photo 7 – Damaged pent house of a research building at Aobayama campus, Tohoku university

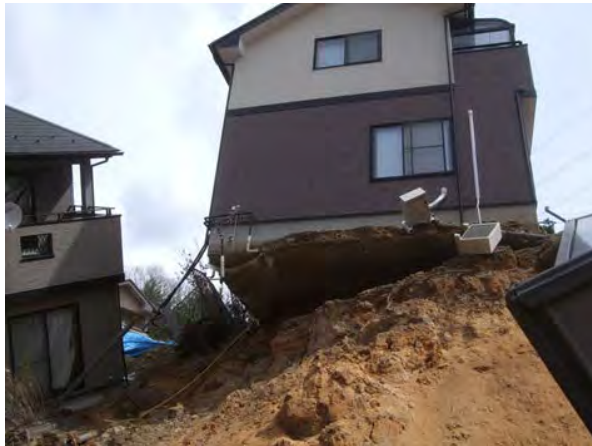
During the Great East Japan earthquake, housing lands in Sendai city experienced major damage. Land failures at more than 5,000 points of 9 artificial housing lands were reported. Residence people at one housing land became the situation where they cannot help moving to other place. The common points of the damaged housing lands are valley filled housing land and high water level. These conditioned housing lands were damaged due to a number of cyclic severe shaking with long-duration as shown in Photo 8. The author has indicated that the balance of seismic capacity between the house and its supporting housing land as a member of the Housing Land Committee of Sendai City.

(a) Oritate housing land in Sendai

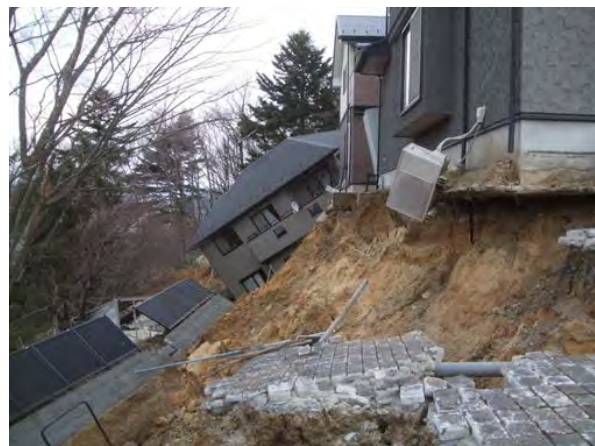
(b) Seikaen housing land in Sendai
