PERFORMANCE OF MASONRY AND CONCRETE BUILDINGS DURING M7.8 GORKHA (NEPAL) EARTHQUAKE OF APRIL 25, 2015

D. C. Rai⁽¹⁾, V. Singhal⁽²⁾, S. Bhushan Raj⁽³⁾ and S. Lalit Sagar⁽⁴⁾

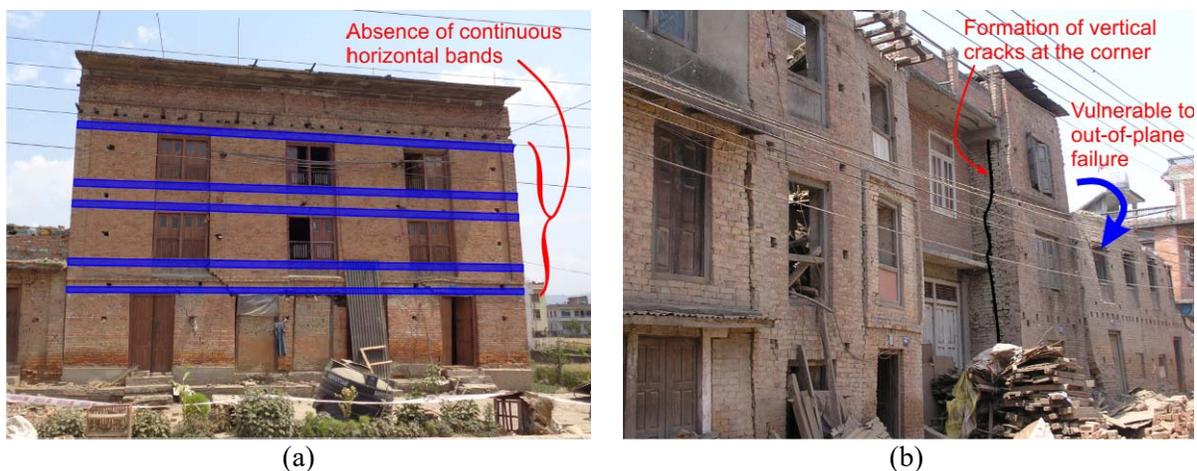
Fig. 6 – Typical URM construction in Nikosera: (a) Absence of continuous horizontal bands, and (b) formation of vertical cracks at corners which resulted in separation of cross wall from main wall

According to the mandatory rules of thumb of Nepal building code, for URM buildings built with mud mortar [14], the height of the wall should be less than eight times the thickness of the wall, openings should not be closer than 600 mm and compulsory timber or RC horizontal bands, collar bands and diagonal bands at the corners have to be provided in such buildings. However, it has been observed that many URM structures do not abide by such mandatory guidelines.

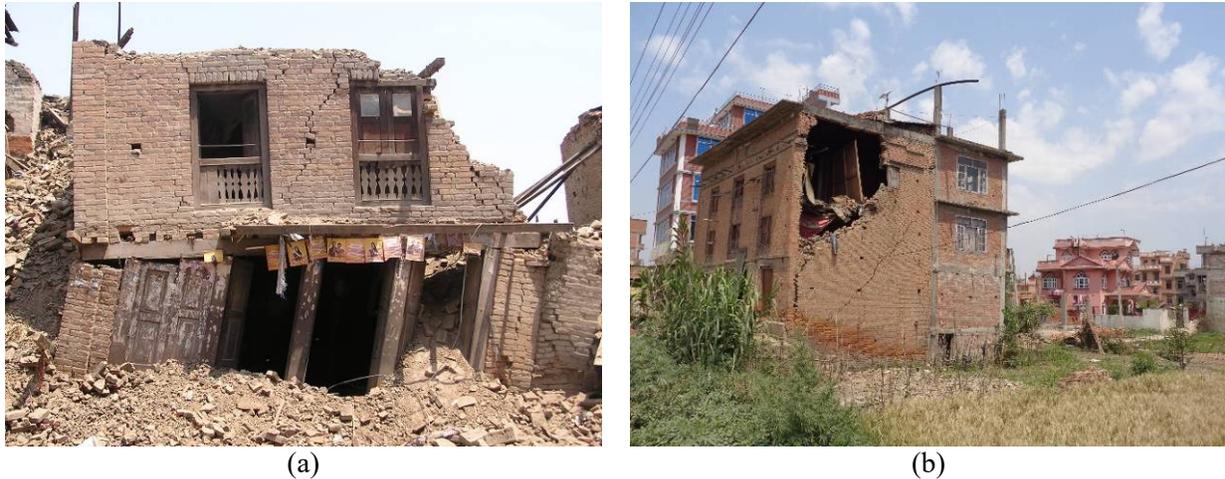
Though the out-of-plane failure of walls in unreinforced masonry buildings was more common, the in-plane damage by step-type diagonal cracks in masonry walls extending to the full storey height was also observed which further reduced the out-of-plane strength of walls and increased the risk of out-of-plane collapse (Fig. 7a). From the failure pattern of building shown in Fig. 7b it can be observed that the in-plane damage was followed by out-of-plane collapse. Closely spaced large openings are detrimental to the seismic performance of masonry structures, which was also observed in the partially collapsed URM buildings in Bhaktapur (Fig. 8a) and provision of openings of irregular sizes is also not a good earthquake resistant practice (Fig. 8b).

Fig. 7 – URM buildings failures in Nikosera: (a) Collapse of three storey unreinforced masonry building, and (b) combined in-plane and out-of-plane failure of the wall

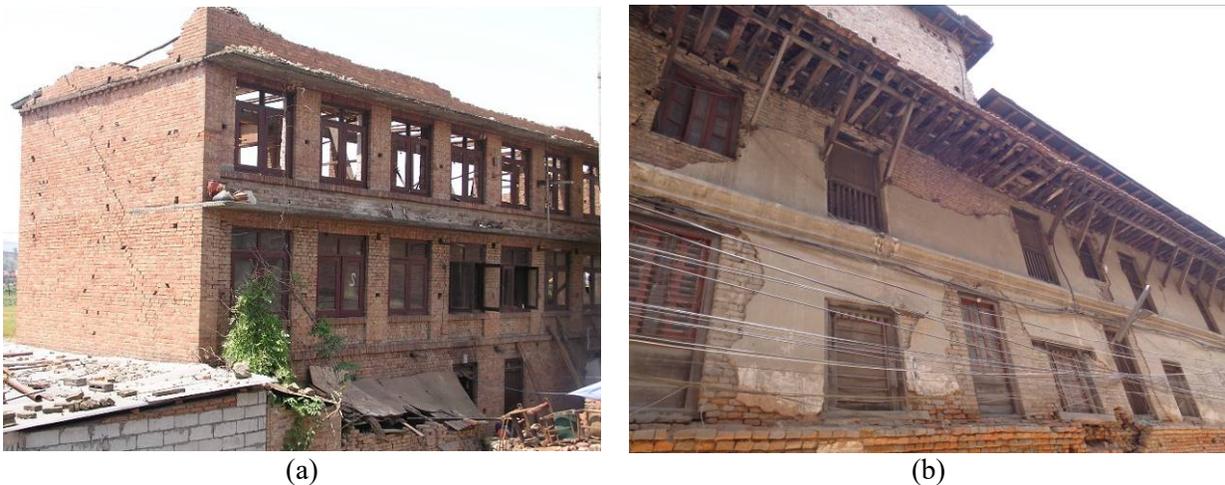
Fig. 8 – (a) Partial collapse of URM building with large openings, in Nikosera, and (b) typical view of the residential building with too many opening placed haphazardly near Kathmandu Durbar Square

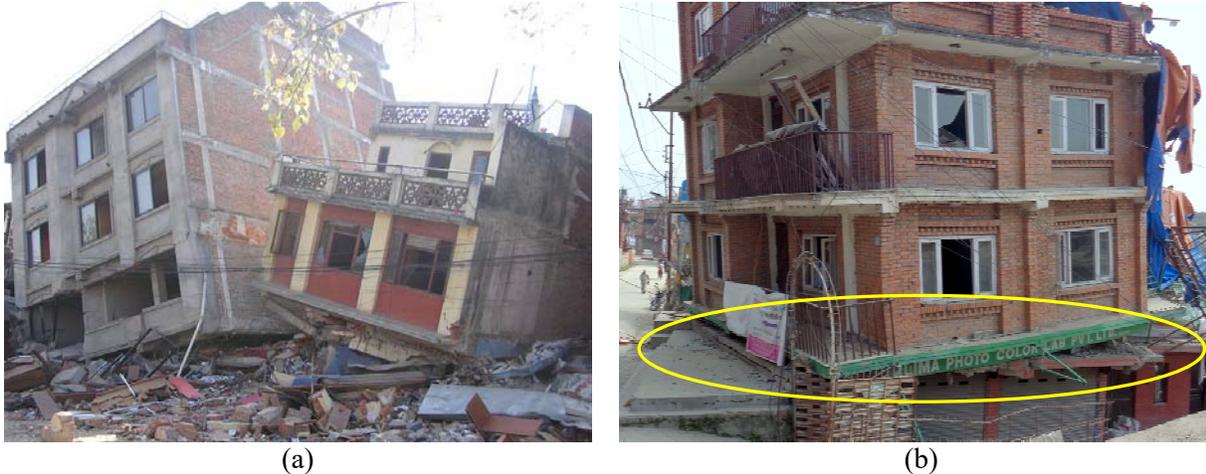
Buildings with open ground and weak storeys are infamous for their poor behaviour in the past earthquakes and this event was not an exception. Many open ground storey buildings collapsed completely due to soft/weak storey mechanism (Fig. 10). Buildings which were partly used for commercial purposes collapsed, often with

pancaking of floor slabs, due to open ground and intermediate storeys in the absence of infills. The collapse of these buildings was primarily triggered by the formation of soft/weak storey mechanism due to the inadequate wall area, small sizes of RC frame members and poor reinforcement detailing at critical locations.

Fig. 10 – Open ground and weak storey failures (a) Four storey buildings in Sitapaila, Kathmandu and (b) Building with basement near Kalopul, Kathmandu.

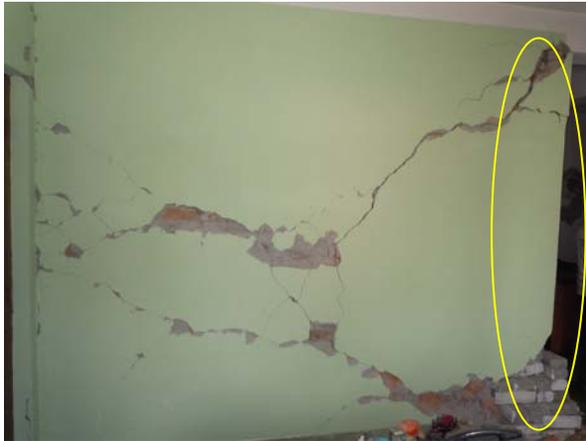
Fig. 11 – Various structural defects in newly constructed buildings: (a) absence of column at the intersection of two walls, (b) damage to the wall panel due to absence of confinement all around openings, (c) projection of masonry wall beyond the column grid line, and (d) damage to masonry infills in multi-storied buildings

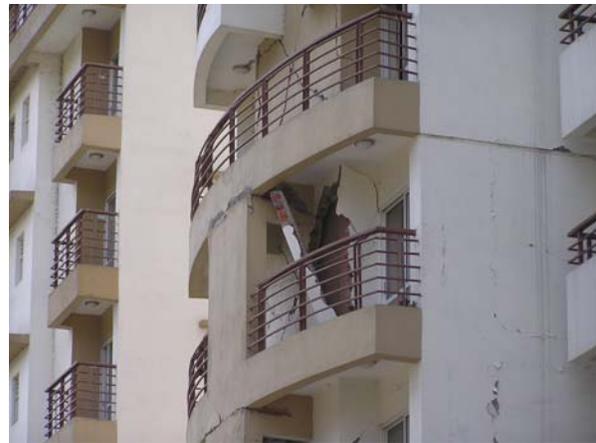
(d)

Large multi-storey commercial buildings and residential apartments which were supposed to be the engineered construction, design and built under professional guidance also suffered extensive damage though they did not collapse completely. The damage to the masonry infill walls such as large diagonal cracks in masonry panels and cracks at the frame-masonry interface was very common in these high-rise structures (Fig. 11d). The projection of walls outside the framing elements is widely prevalent in the rapidly urbanizing valley region driven by need to utilize the space to its maximum. However, these slender projecting walls when not positively connected or integrated with the building frame become extremely vulnerable to collapse along both in-plane and out-of-plane directions as observed in 15+ storey buildings in Kathmandu and Lalitpur. Moreover, such high-rise buildings weakened by the damage to infills posed serious danger to neighboring buildings in densely built areas in the event of a strong aftershock ground motion. Diagonal shear cracks in masonry piers near openings were commonly observed in the wall panels where the continuous horizontal RC bands were not provided.

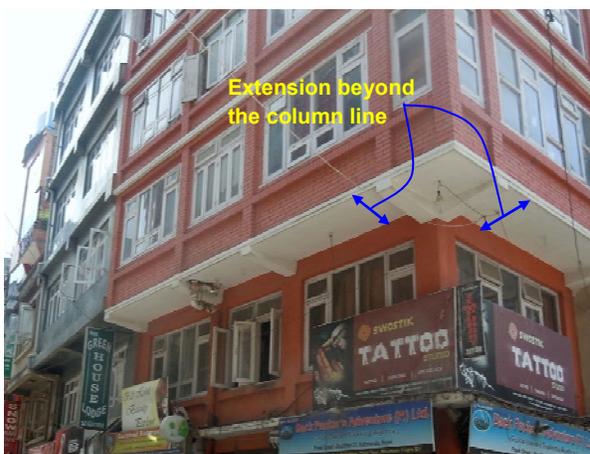
Vertical irregularity in buildings leading to discontinuous load transfer path is not preferred for ensuring good performance of buildings under seismic forces. The codal provisions also prohibit extending the floor area in upper storeys beyond the ground plan area. However, there are many buildings in the study region, where upper storeys are supported on long cantilever slab or beams (Fig. 12a). Buildings with aspect ratio (such as

Fig. 12 – (a) An example of RC building with upper storeys supported on long cantilever slab or beam, and (b) a building with very large length to width ratio (L/B)

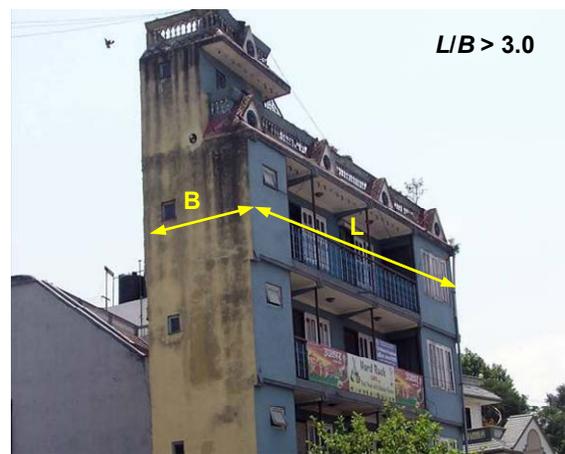
(b)

length to width ratio and height to width ratio) much larger than the code prescribed value of three were surprisingly common in the region (Fig. 12b). Such configurations are generally weak in resisting lateral forces and buildings with such plan and vertical irregularities which did escape with minor damage this time are likely to suffer severe damage in case of stronger shaking expected in the design level earthquake. Many buildings in the worst affected areas were built very close to each other and in many cases with almost no gap between them as they extend upto property lines. Pounding of such buildings either led to chain of collapses involving surrounding buildings or left them leaning out of plumb (Fig. 13).

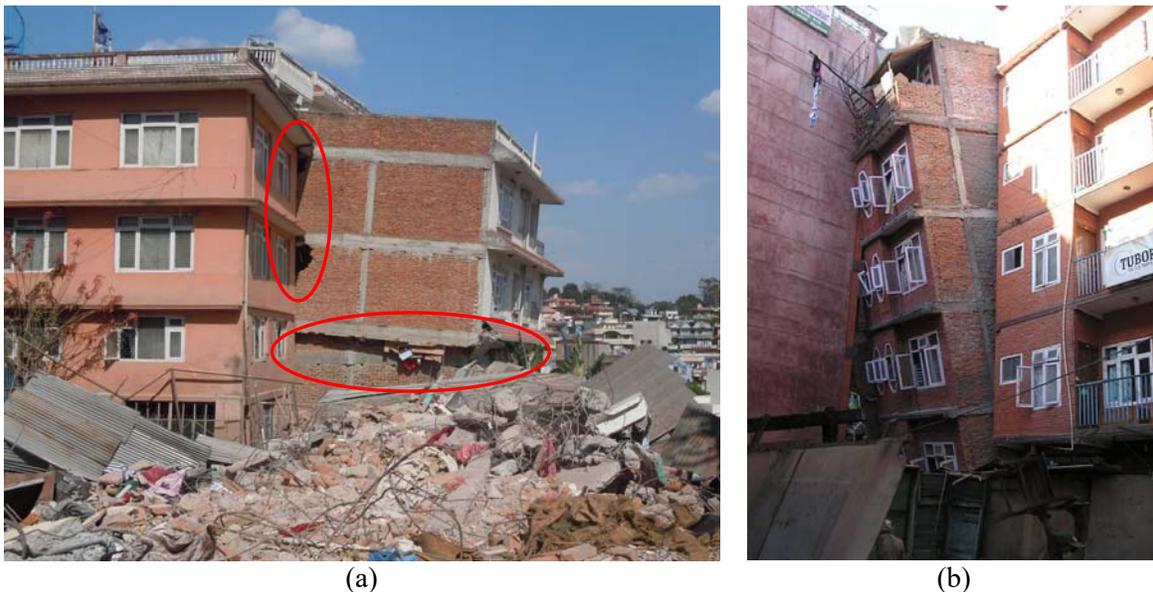
Fig. 13 – (a) Collapse of intermediate storey due to pounding of adjacent building, and (b) collapse due to extension of the upper storey plan beyond the column grid lines which created vertical irregularity
