## ANALYSIS OF THE SEISMIC PERFORMANCE OF A STRENGTHENED PAGODA TEMPLE DURING GORKHA EARTHQUAKE

### **Abstract**

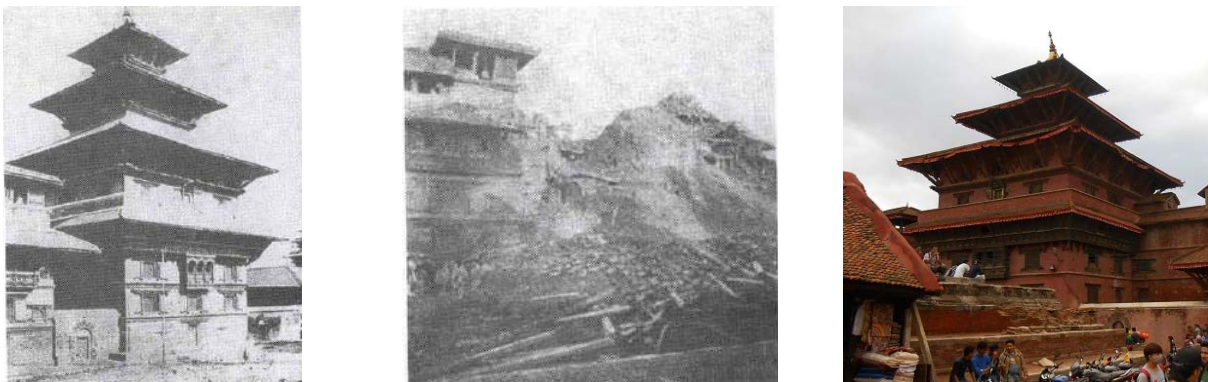
Fig. 3 – Degutale temple before (left) and after (centre) the 1934 earthquake [13] and, on the right, after the 2015 Gorkha earthquake.

Although most of pagoda temples performed well during both the 1934 and 2015 earthquakes (Fig. 3), many other pagoda temples suffered destruction during the 2015 earthquake, despite low level of shaking in the Kathmandu Valley (Fig. 4). The performance of pagoda structures varied extensively from case to case, even in the presence of similar construction materials, technologies, and architectural features. Damage levels range from local mechanism activation to global failure [14].

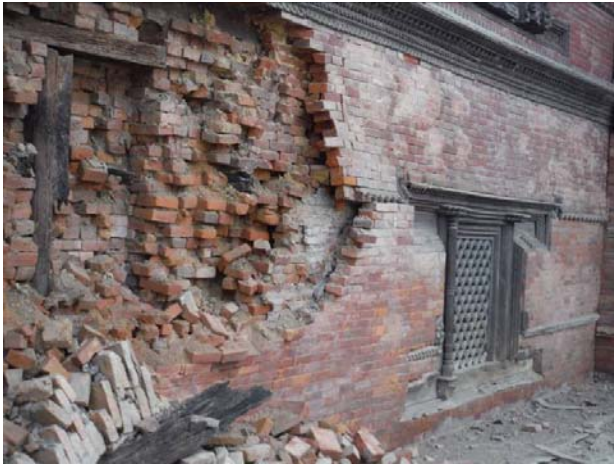
Although out of plane toppling of walls was not observed, possibly due to the large wall thickness and tying of the walls by timber members, other local failures were observed.

Fig. 4 – Delamination of multi-leaf wall veneer (left); diagonal sliding shear failure (right).

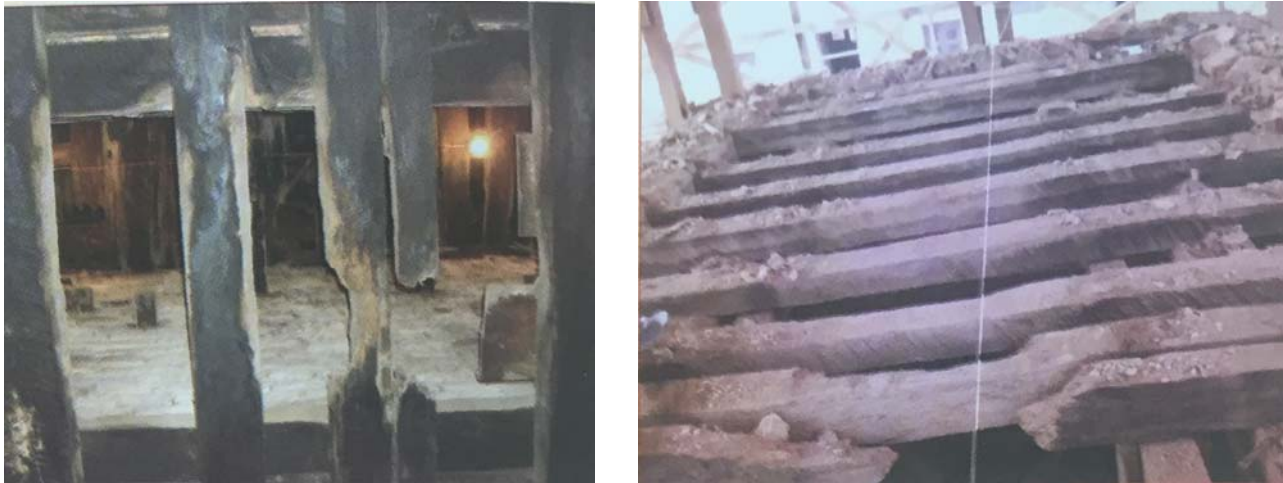
Renovation works for this temple began in 2008 and were completed in 2012 with the assistance of SCAEF, the Society of Consulting Architectural and Engineering Firms in Nepal. The building survived the 2015 earthquake with only minor damage. The temple was in a fairly rough condition before it was renovated. Many wooden members were rotting, and areas of masonry were significantly deteriorated.

Fig. 6 – Deteriorated timber elements (before interventions) [16].

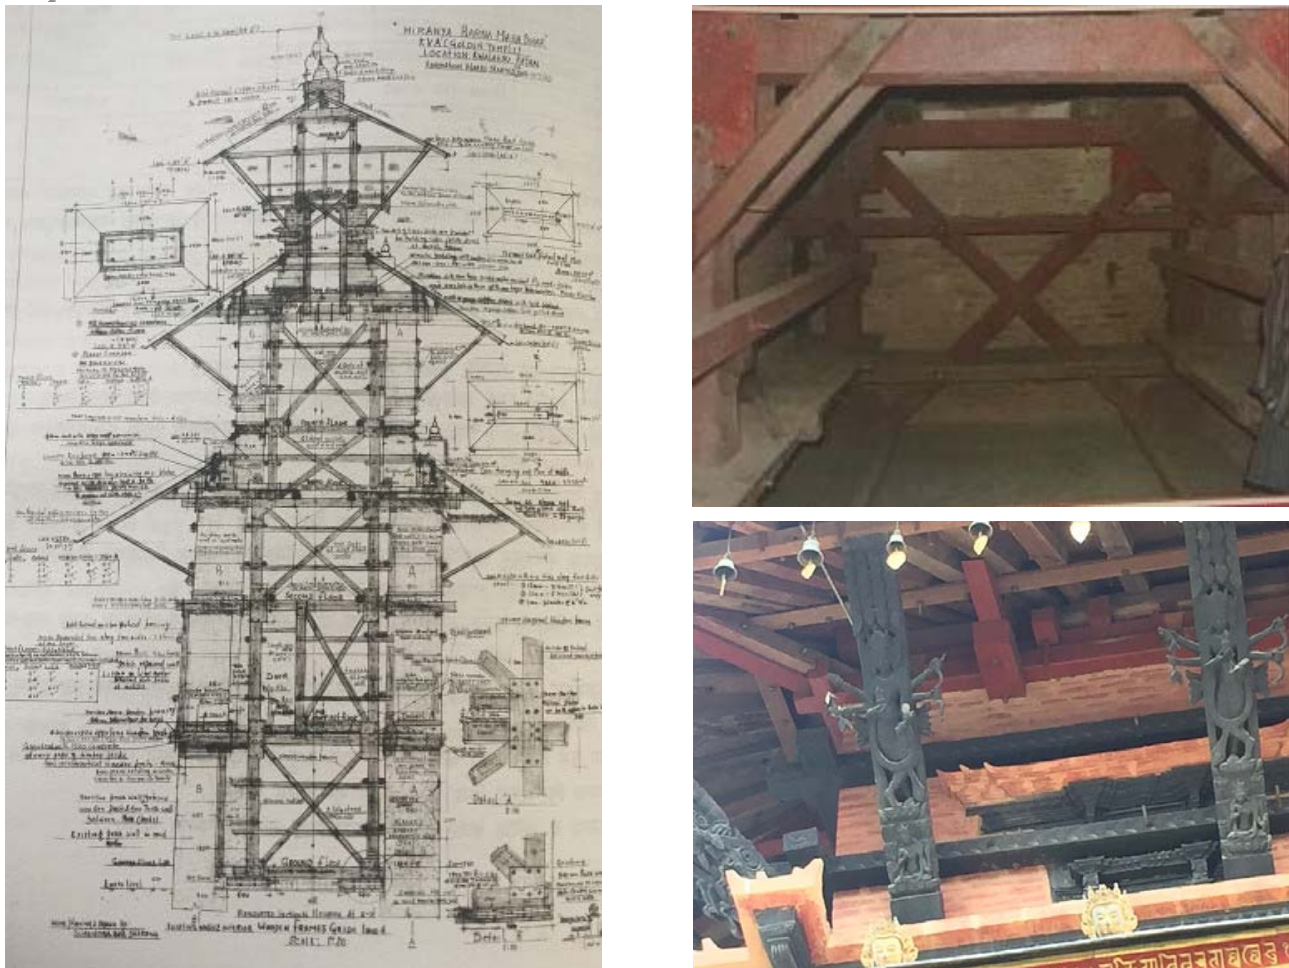
Fig. 7 – Strengthening interventions design and execution [16].

Strengthening interventions were designed in 2004-05 and actual onsite works started in 2008, see Fig. 7. As part of the building strengthening, wooden frames were constructed within the temple from the ground to the roof. Large wooden beams are supported by the full width of walls at each story. In some cases, these beams extend beyond the outer face of the wall in order for vertical wooden pegs to connect the beams to the wall. Timber trusses were attached to these beams, creating a continuous truss up to the fifth floor. In addition to beam wall connections, the truss engages the walls with steel rods attached to steel bearing plates on the external face of the building. Horizontal wooden beams were used internally and externally (at higher stories) as an out of plane support at the floor midpoints. A concrete ring beam was placed at the building mid height, at the third floor level.

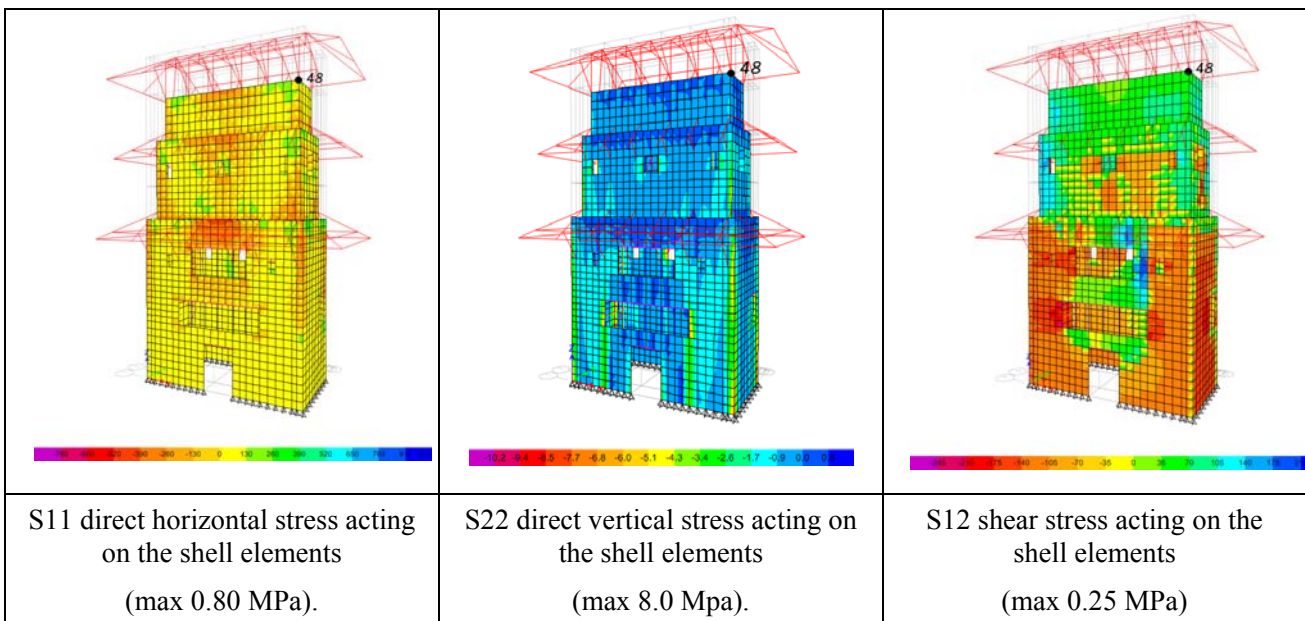
Fig. 9 – Time history analysis: stress distributions.

Stress distributions generated by the 2015 earthquake (see Fig. 9) can be compared to the working stress values proposed by Shakya for brick masonry [15]. Maximum compression stresses (S22) are much higher than the limit values, but are located at corners of walls and openings, while at other locations maximum values are less than 1.0 MPa. Maximum horizontal displacements are 4.0 mm in the X direction and 6.9 mm in the Y direction at the top of upper walls.
