Seismic Response of a Historical Unreinforced Masonry Building Damaged in the 2014 South Napa Earthquake

Several unreinforced masonry buildings damaged during the 2014 South Napa earthquake, California, USA, were investigated after the earthquake. The numerical analyses conducted on a representative example are presented in this paper. The building is the Sam Kee laundry building, the oldest stone commercial building in Napa, built in 1875. The geometry of the building was accurately captured by a laser scanner. Using this geometry information and material data available in literature for similar buildings, a finite element model of the building was developed according to the equivalent frame approach and was subjected to nonlinear time history analyses. The investigated building was closely located to a strong motion station on Main Street, Napa, California. This record was used as seismic excitation input to the numerical model. Results of the conducted analyses accurately predicted the observed damage in the building which consisted of shear cracks and shear damage in the south and north walls and failure of piers from the east wall. Analysis results are used to describe the re

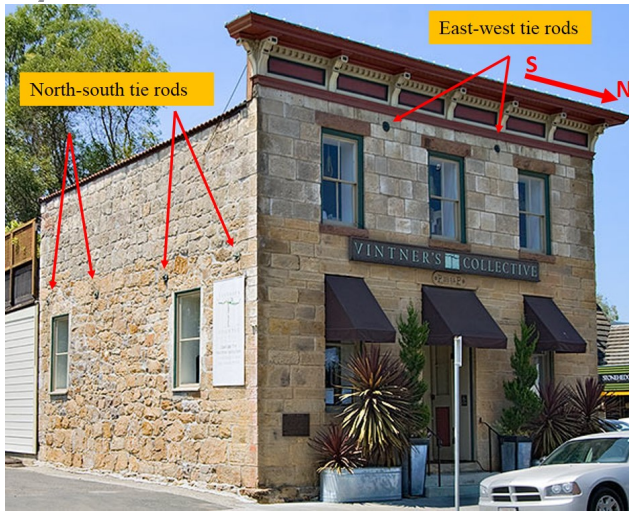
The conditions of the building in 1972 and right before the 2014 South Napa earthquake are presented in Fig. 1. The building was restored in the past and the masonry and grout materials used in these restorations differed from the original ones. The difference in the material used for the restorations is easily noticeable from the difference of colors in the photographs of Figs. 1a and b. To reinforce the building, the following measures were introduced in the past restorations: 1) two tie rods in the east-west direction with anchor plates right below the roof level and 2) four tie rods in the north-south direction at the first floor ceiling level as marked in Fig. 2a and as identified in the point cloud in Fig. 2b.

a) Reinforcement measures

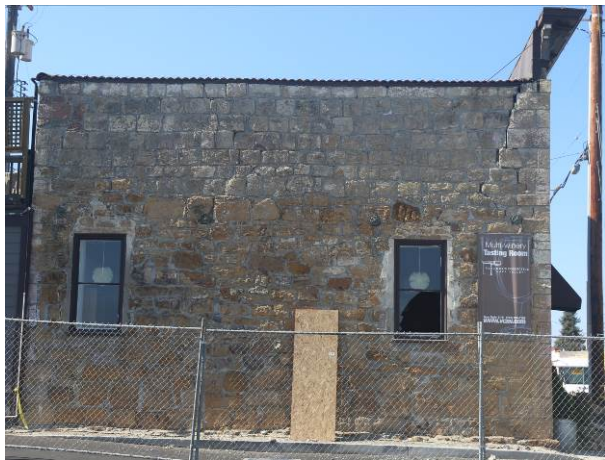
As mentioned above, the building was damaged during the 2014 South Napa earthquake. The south and north walls cracked right next to the east wall and several failure surfaces appeared in the east wall. As a result, a significant number of bricks from the façade fell down on the walkway right next to the building. Since the earthquake occurred at night time without any pedestrians on the streets, nobody was hurt. Photographs of the observed damage are presented in Figs. 3a to d.

a) South wall

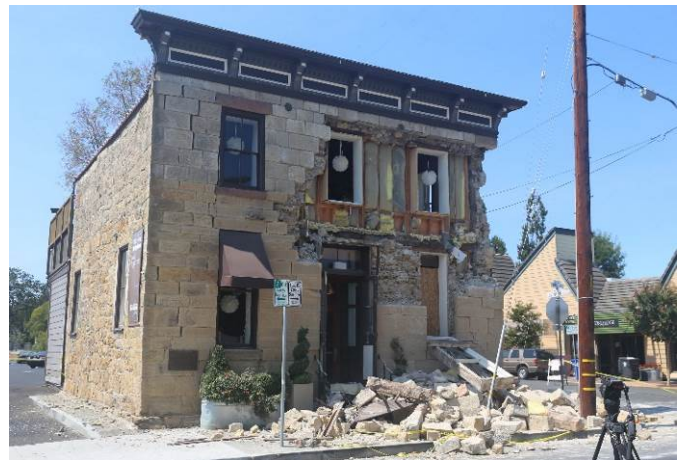
b) East and south walls

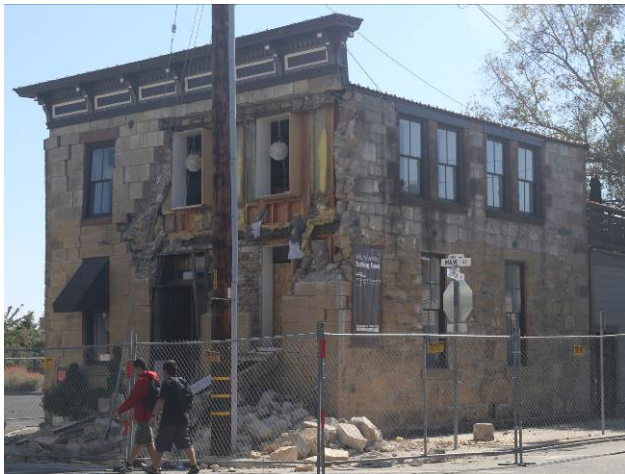
c) East and north walls

As observed in Figs. 2 and 4, the piers EP7 and EP8 failed during the 2014 South Napa earthquake. The in-plane force-displacement relationships shown in Fig. 10 indicate that the strength of these piers has been reduced considerably and the response is significantly degraded, which explain the reason of these collapses. To investigate the reason of having EP8 collapsed, while EP5 on the other corner remaining intact, the out-of-plane accelerations that these two piers experienced are compared in Fig. 11, from which it is observed that these accelerations have similar amplitudes. Not plotted here, the interstory drifts in the out-of-plane direction (i.e. along y direction) are also similar. On the other hand, from Fig. 12, the displacements in the out-of-plane direction (i.e. along the y direction) are about 60% larger (corresponding to a ratio of $2.8/1.8 = 1.6$ based on the peak values from Fig. 12) in the N-E (i.e. near EP8, refer to Fig. 4) corner than that in the S-E corner (i.e. near EP5, refer to Fig. 4) of the East wall. This observation together with a larger number of out-of-plane deformation cycles and larger residual deformation somewhat explain the reason why the damage was observed in EP8 but not in EP5.

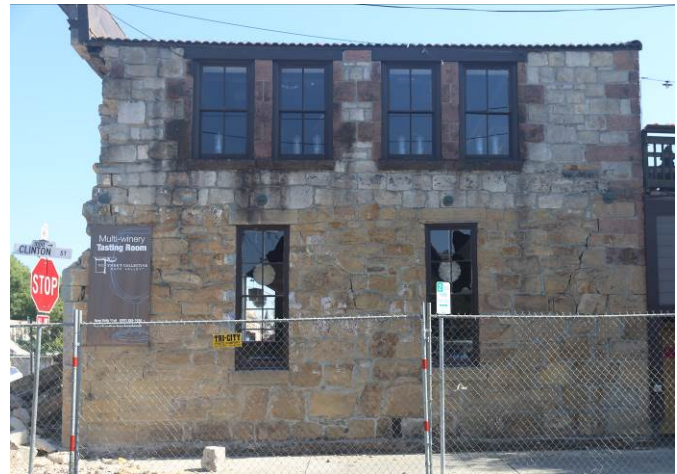
d) North wall

One other clear damage pattern that can be observed from the photographs of Figs. 3 and 4 is the shear cracks in the north wall piers NP1, NP2, and NP3. The in-plane force-displacement relationships of these piers are plotted in Fig. 13, where it is observed that all of the piers have reached their shear strength, explaining the observed shear cracks. The force-displacement relationship of pier SP2 is also plotted in Fig. 13, which shows that pier SP2 also reaches its capacity. However, the post-elastic displacements are smaller for SP2 than those of NP1, NP2, and NP3, which is a reasonable explanation why the shear cracks of the north piers are visible, while those of the south are not detected in the photographs of Fig. 3.

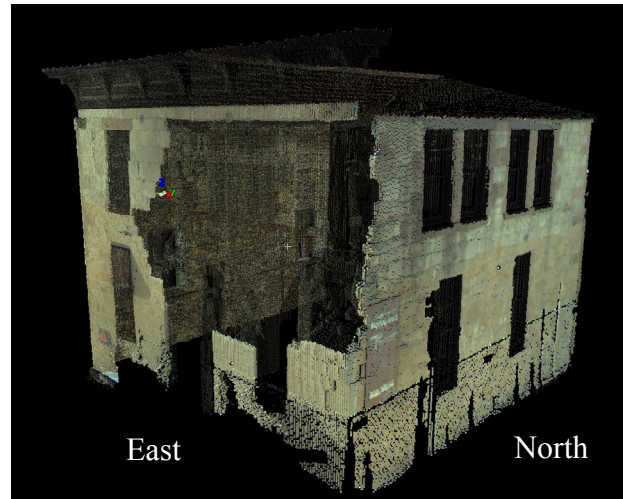
application [2] and the final point cloud is presented in Fig. 4a. The failure surfaces of the masonry walls are shown in Fig. 4b and the corresponding dislocations of the bricks are presented in Figs. 4c and d. The plots were generated in Matlab [3] and they present color contour maps of distances from a vertical plane (Deviations in North and East are positive).

b) Outer skin showing failure surfaces of masonry walls

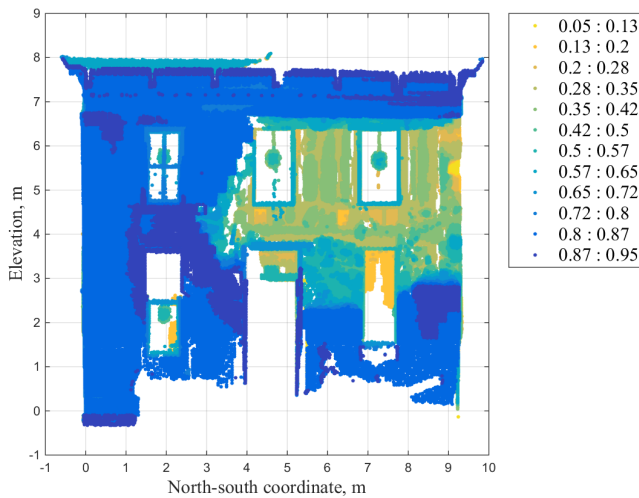
c) Contours of east-west deviations [m]: east wall

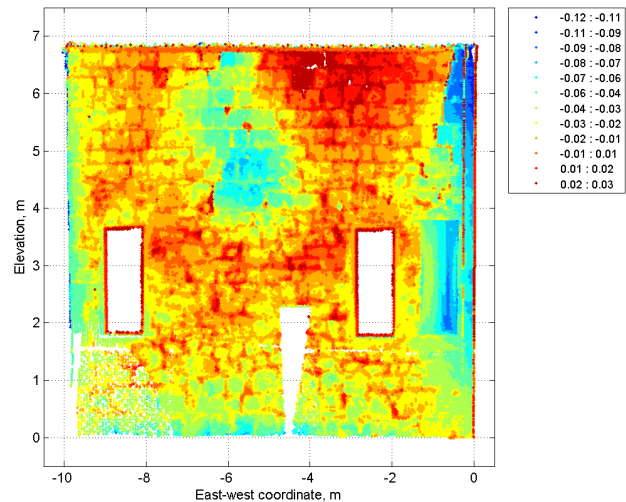
d) Contours of north-south deviations [m]: south wall

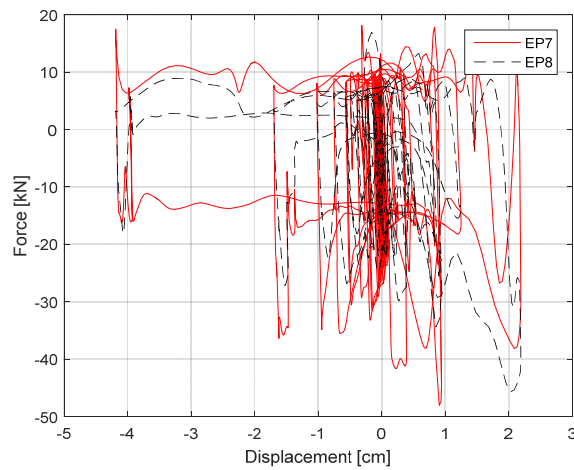
Fig. 10 – Force-displacement relationships of EP7 and EP8

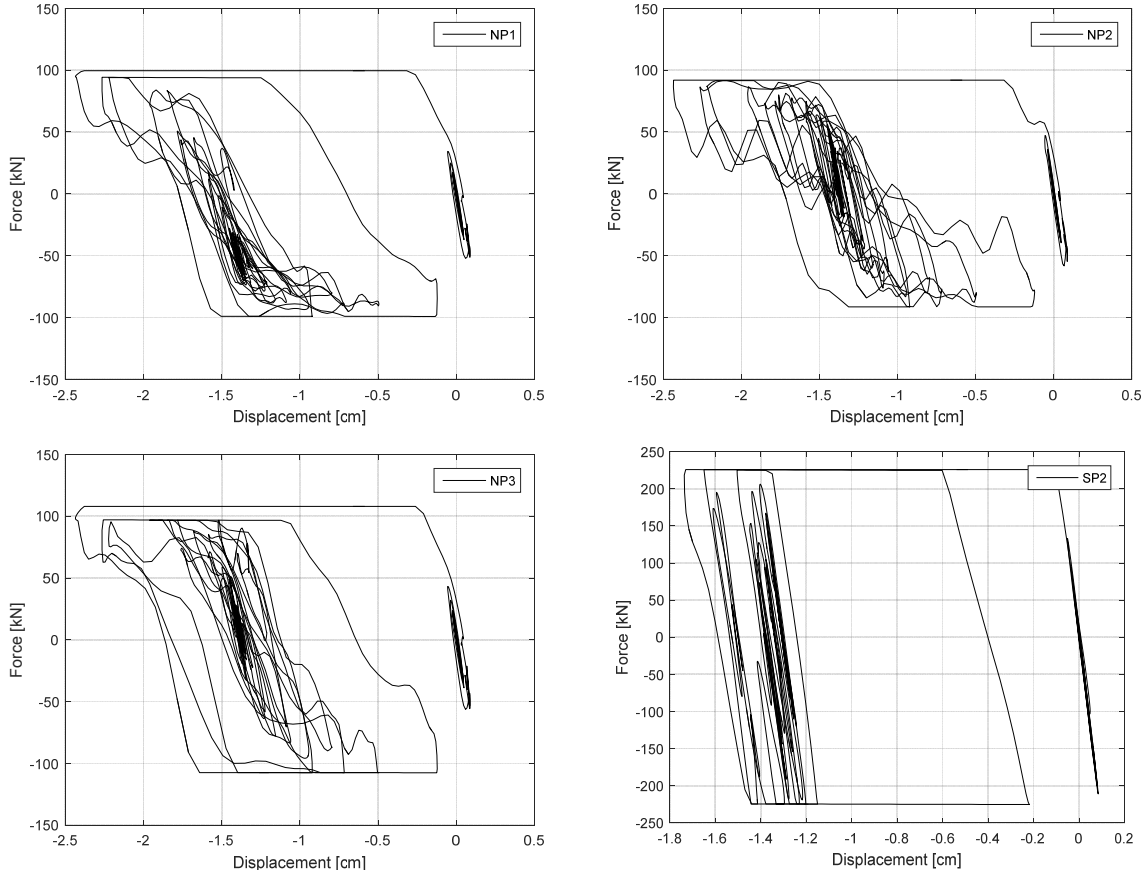
Fig. 13 – In-plane force-displacement relationships of the piers in the south and north walls
